THE TWO RIVERS GREENWAY TRAIL MAINTENANCE PLAN  
JULY-AUGUST 2019  
BINGHAMTON METROPOLITAN TRANSPORTATION STUDY

APPENDIX & TRAIL ASSESSMENTS

### Two Rivers Greenway Trail Maintenance Assessment

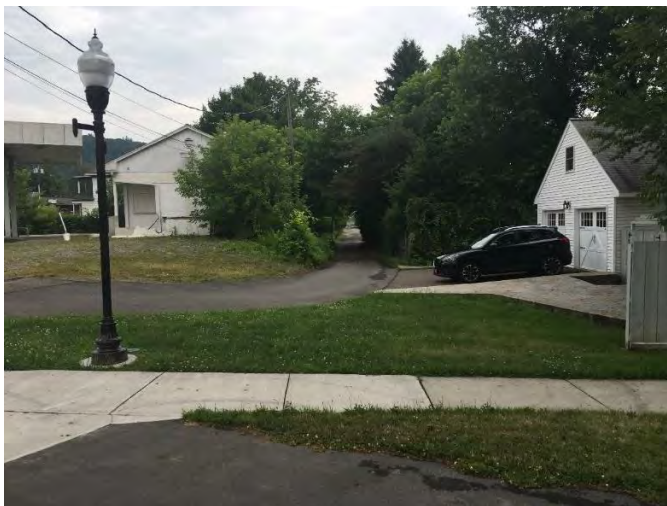
Figure 1 Ronin Road Entryway, Adjacent Closed Gas Station, Facing West

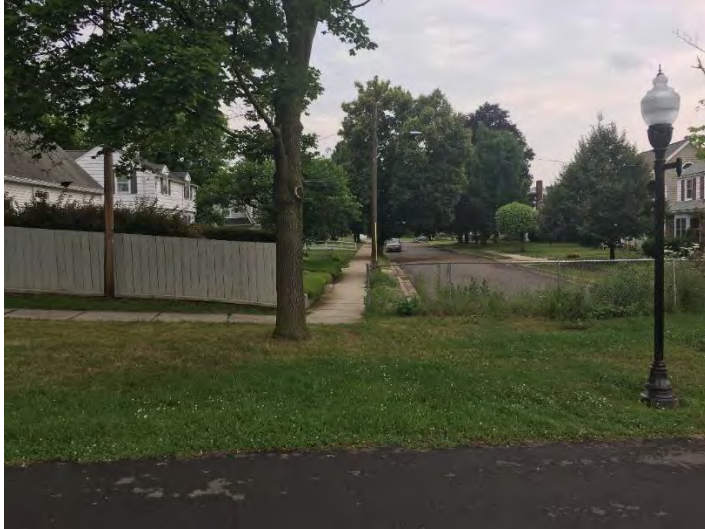
Figure 2 Zane Road Entryway, Perpendicular to the Beginning of Bike Loop Path, Facing West

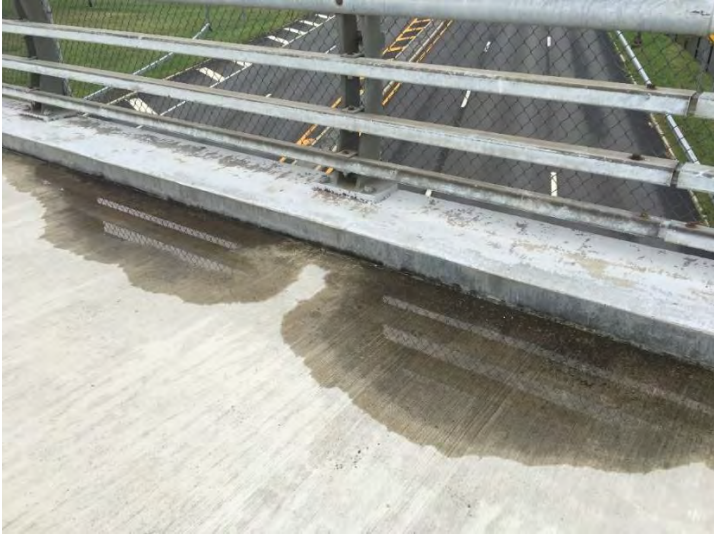
Notes: Slight dead grass residue from mowing, encroachment of grass along edges, weeds along the side, some puddling in indented trail areas

Figure 3 Examples of Puddling on Pennsylvania Avenue Bridge

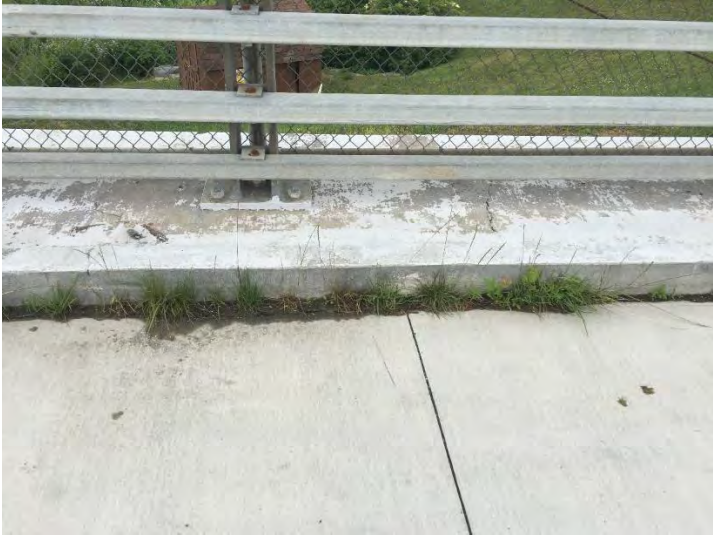
Figure 5 Weeds and Dead Grass Residue Along Cement Trail Portion

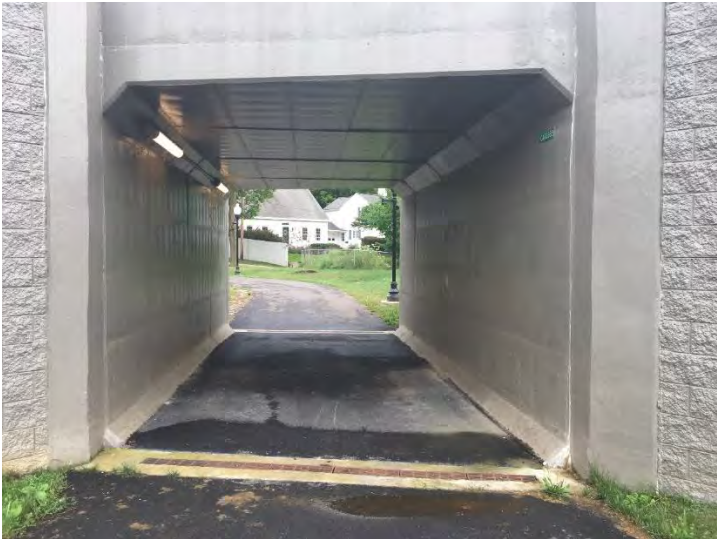
Figure 6 Puddling Near Tunnel

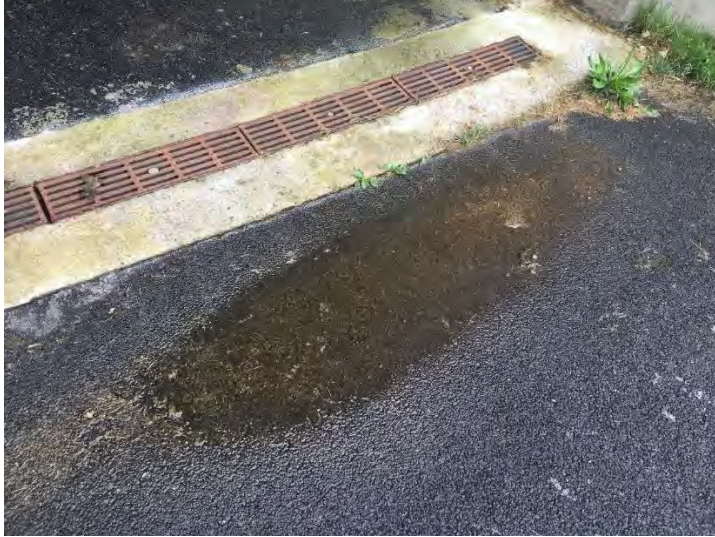
Figure 7 Puddling Near Tunnel Close-Up

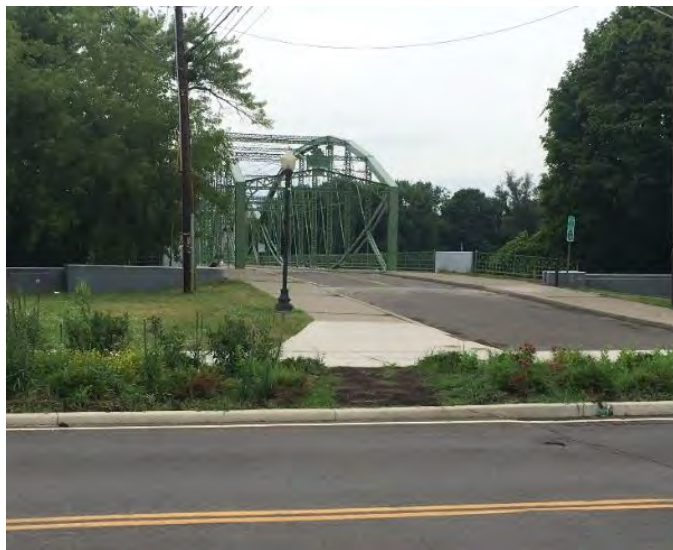
- On the north side of the crossing between the Pennsylvania Avenue bike and pedestrian loop to the South Washington Street bridge there is a worn path through a garden that separates the two crossing lanes

Figure 9 Informal Walking Path Through Garden

Action	Timeline			
Replace Lampposts	<input type="checkbox"/> <6 months	<input checked="" type="checkbox"/> 6-12 months	<input type="checkbox"/> 12-24 months	<input type="checkbox"/> 24+ months
Replanting Worn Garden Path	<input checked="" type="checkbox"/> <6 months	<input type="checkbox"/> 6-12 months	<input type="checkbox"/> 12-24 months	<input type="checkbox"/> 24+ months

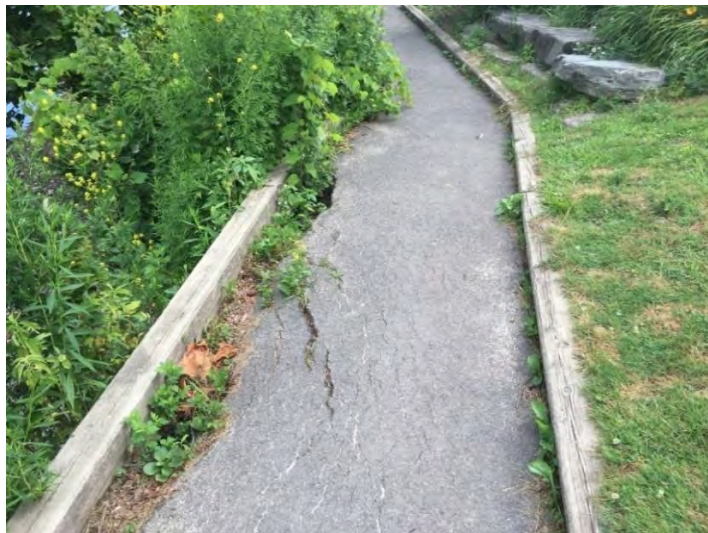
Figure 14 Hole in Paved Bike Walkway

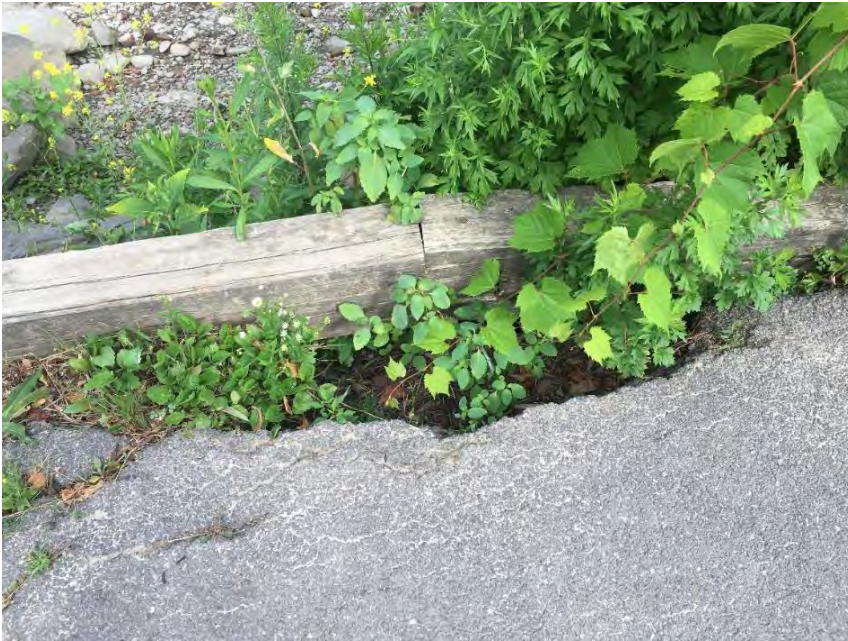
Figure 15 Hole in Paved Bike Walkway Close-up

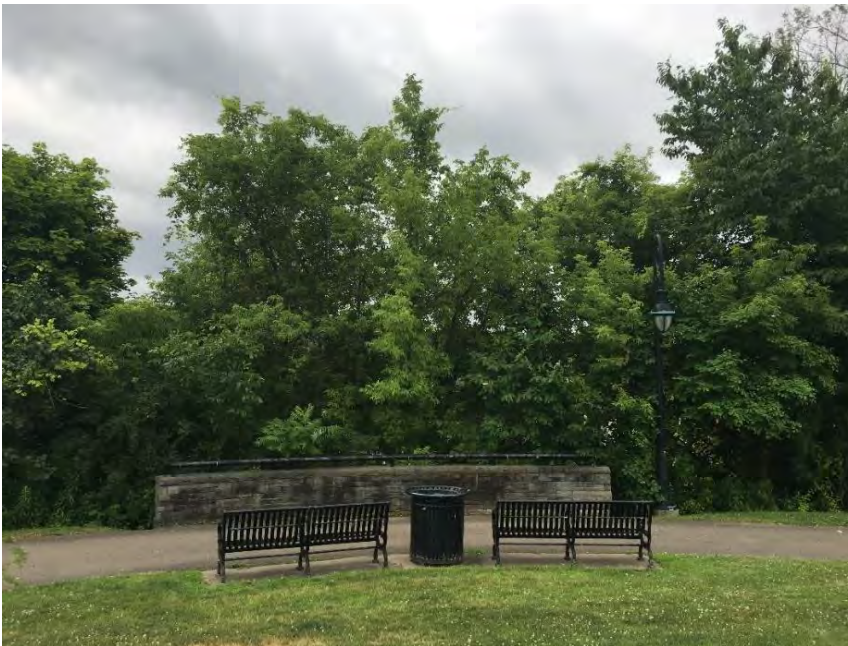
Figure 16 Overgrown Vegetation Blocking View

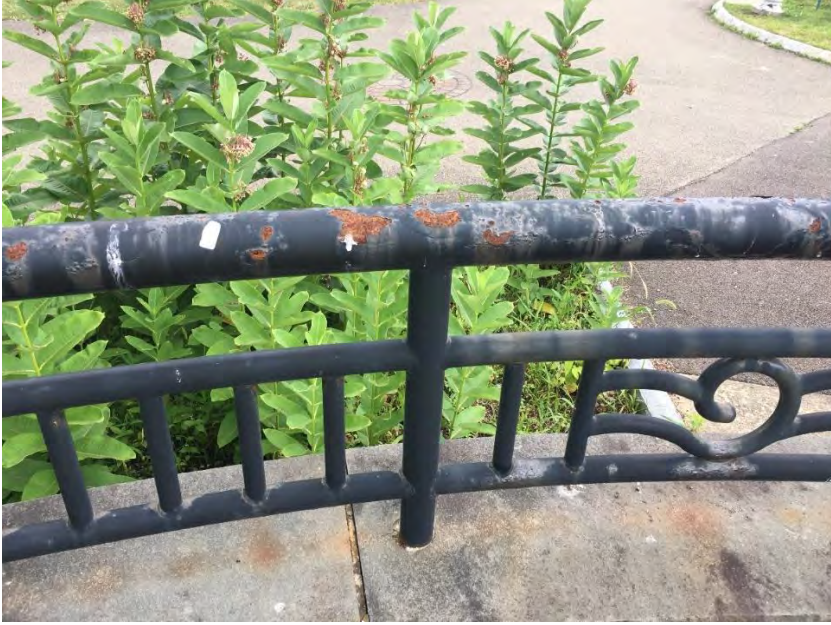
Figure 17 Chipped Paint and Rust

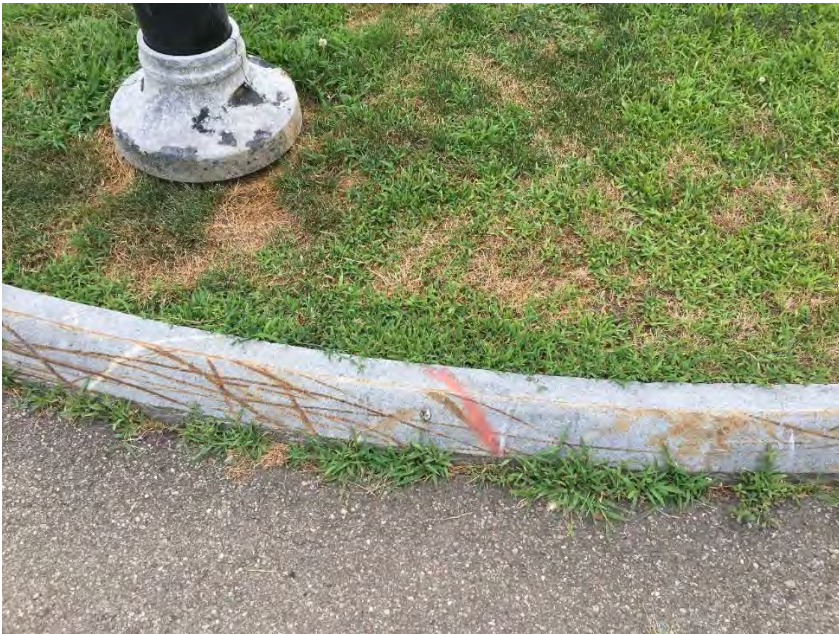
Figure 18 Scratches from Skateboards

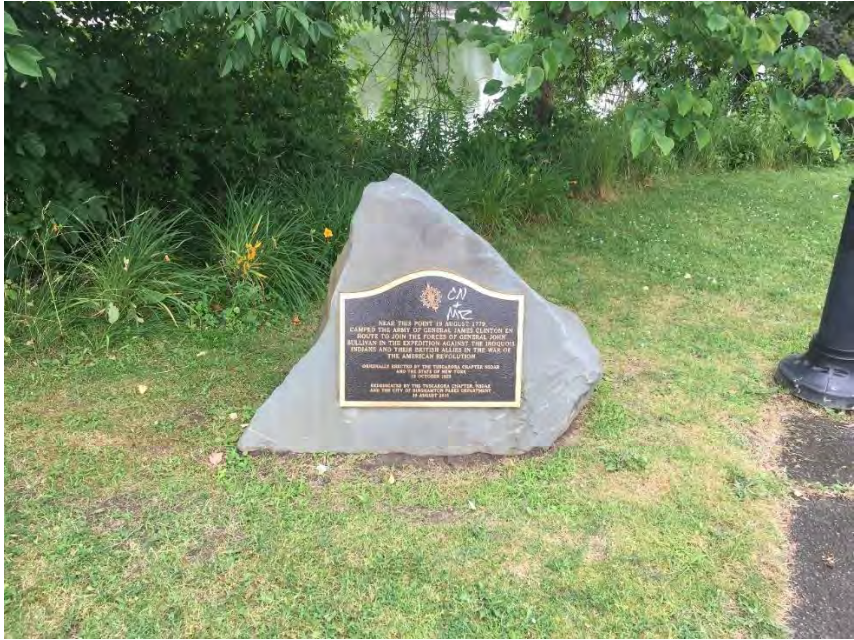
Figure 19 Memorial Graffiti

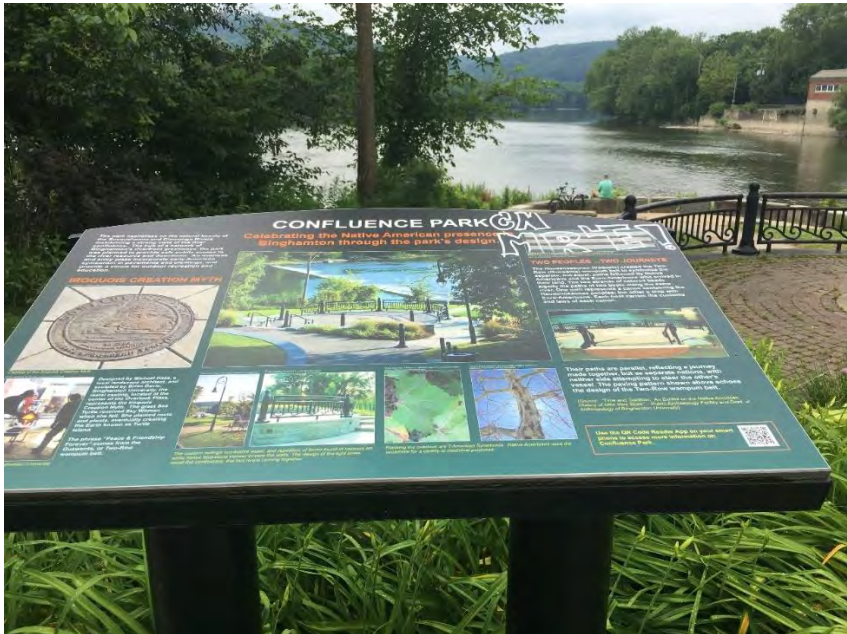
Figure 20 Greenway Sign Graffiti

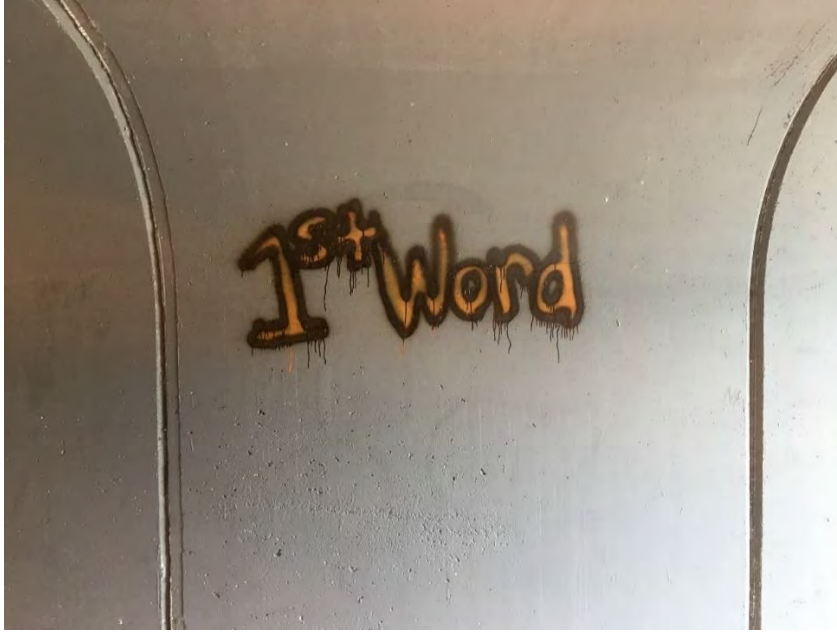
Figure 21 Tunnel Graffiti

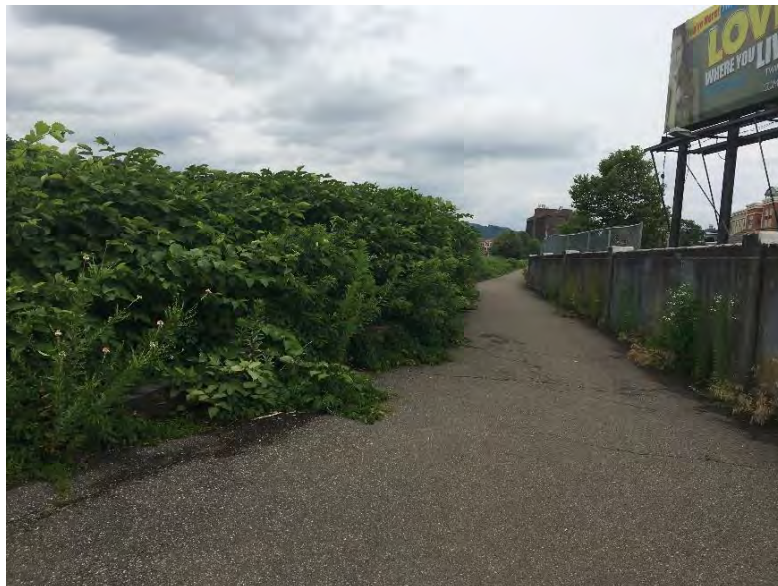
Figure 22 Severely Overgrown Vegetation and Weeds on the Side of the Floodwall

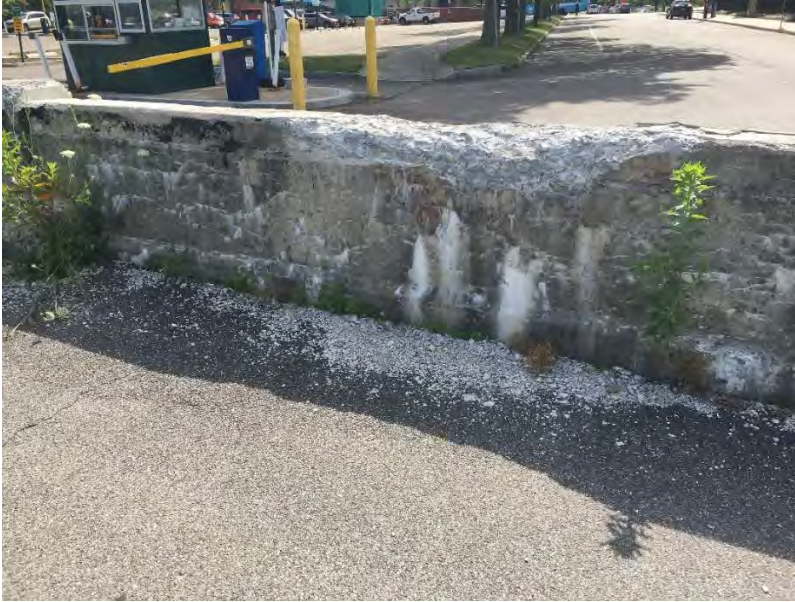
Figure 25 Rock Debris from Floodwall Adjacent to Outlook Platform

Action	Urgency			
Clean Debris from Floodwall	<input checked="" type="checkbox"/> <6 months	<input type="checkbox"/> 6-12 months	<input type="checkbox"/> 12-24 months	<input type="checkbox"/> 24+ months
Design schedule for more frequent trimming of vegetation along the trail and weeds along the floodwall	<input checked="" type="checkbox"/> <6 months	<input type="checkbox"/> 6-12 months	<input type="checkbox"/> 12-24 months	<input type="checkbox"/> 24+ months
Replace informal outlook ramp with an ADA compliant formal ramp	<input type="checkbox"/> <6 months	<input type="checkbox"/> 6-12 months	<input checked="" type="checkbox"/> 12-24 months	<input type="checkbox"/> 24+ months

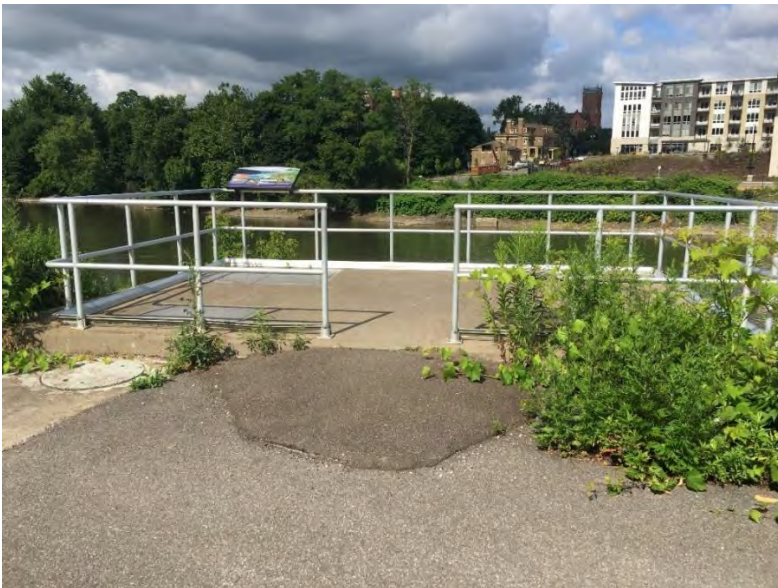
Figure 26 Abrupt Asphalt Ramp to Outlook Platform

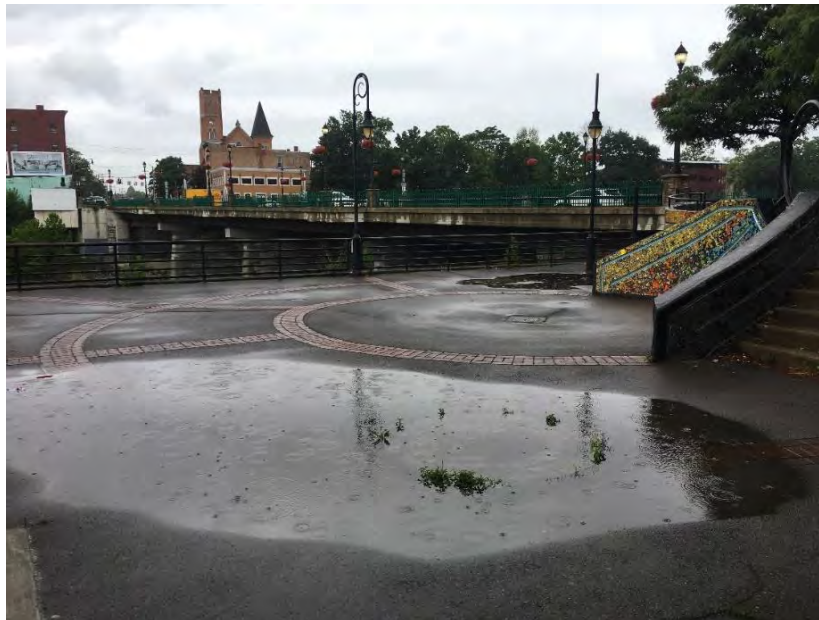
Figure 27 Puddling in Mosaic Area

Action	Urgency			
Fix Puddling in Mosaic Area	<input checked="" type="checkbox"/> <6 months	<input type="checkbox"/> 6-12 months	<input type="checkbox"/> 12-24 months	<input type="checkbox"/> 24+ months
Weeding and trimming overgrown plants	<input type="checkbox"/> <6 months	<input type="checkbox"/> 6-12 months	<input checked="" type="checkbox"/> 12-24 months	<input type="checkbox"/> 24+ months
Repaint worn and rusting areas	<input checked="" type="checkbox"/> <6 months	<input type="checkbox"/> 6-12 months	<input type="checkbox"/> 12-24 months	<input type="checkbox"/> 24+ months
Repair Mosaic Area Bench	<input checked="" type="checkbox"/> <6 months	<input type="checkbox"/> 6-12 months	<input type="checkbox"/> 12-24 months	<input type="checkbox"/> 24+ months
Fill Pavement Hole next to EcoCounter	<input checked="" type="checkbox"/> <6 months	<input type="checkbox"/> 6-12 months	<input type="checkbox"/> 12-24 months	<input type="checkbox"/> 24+ months

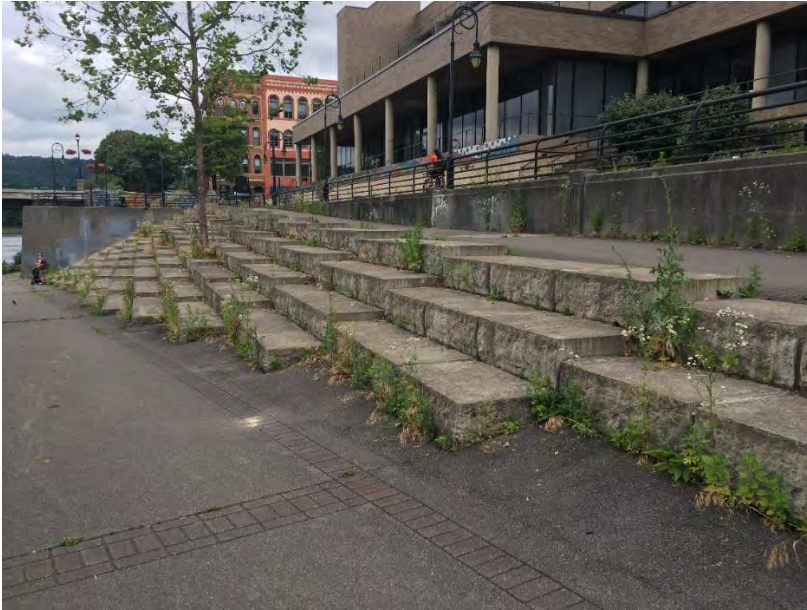
Figure 28 Weeds in Stairs/Seating Area

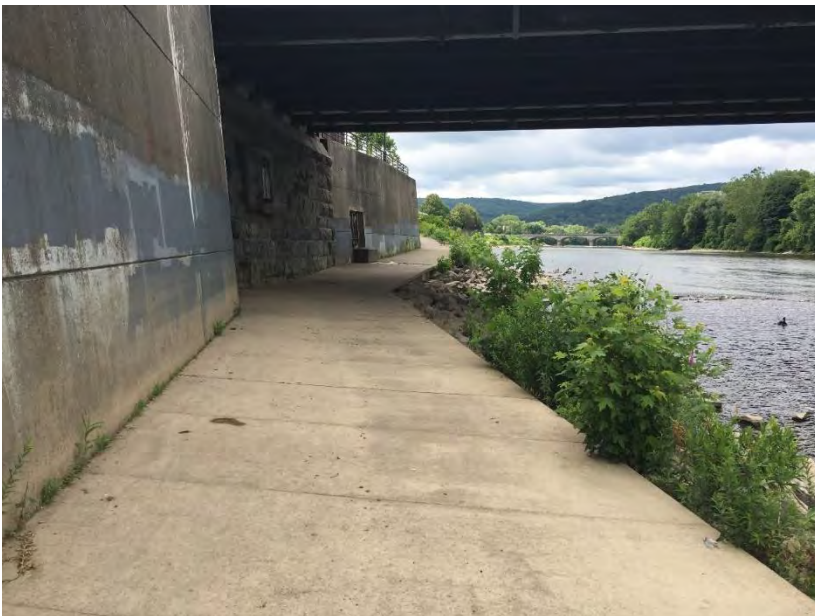
Figure 29 Prevalent Weeds in Walkway, Rest Area, and Low Path

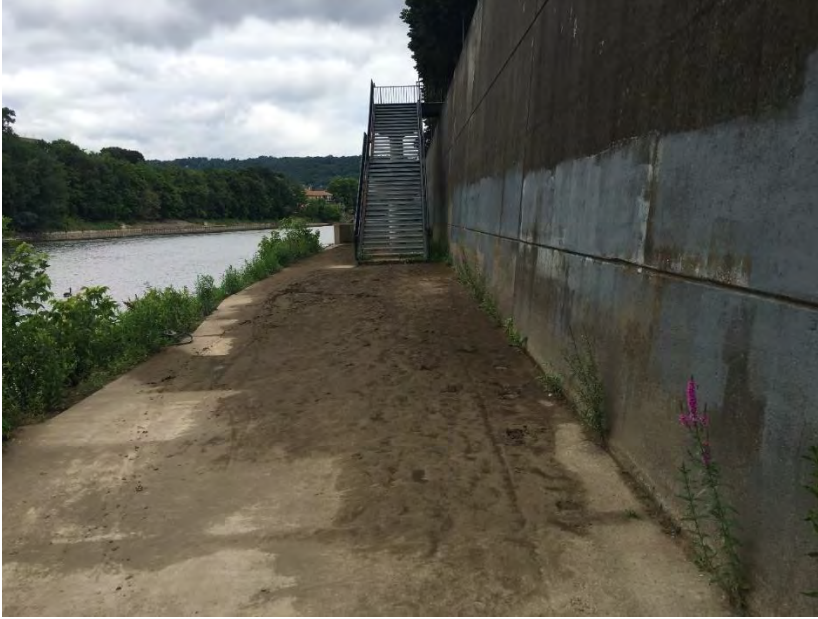
Figure 30 Mud Around Stairwell

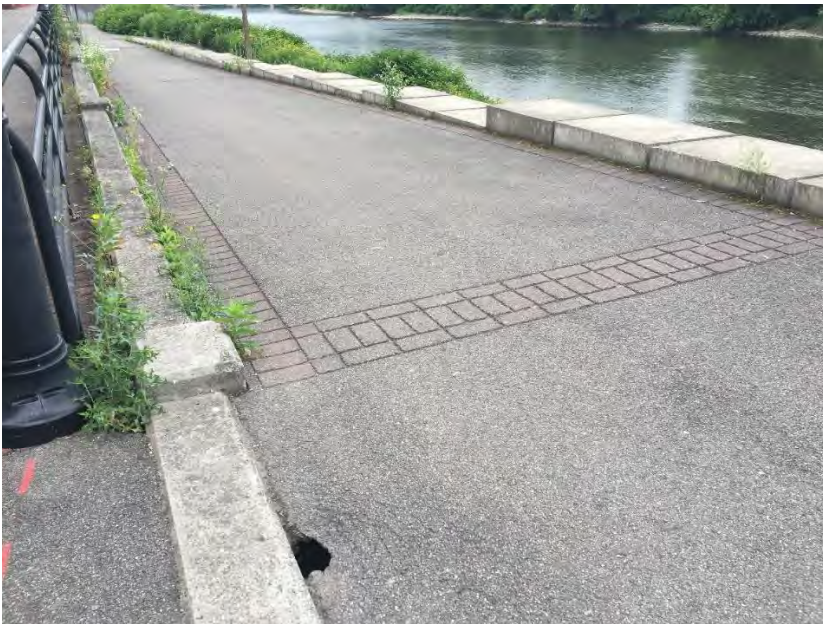
Figure 31 Deep Hole in Pavement Near Traffic Counter

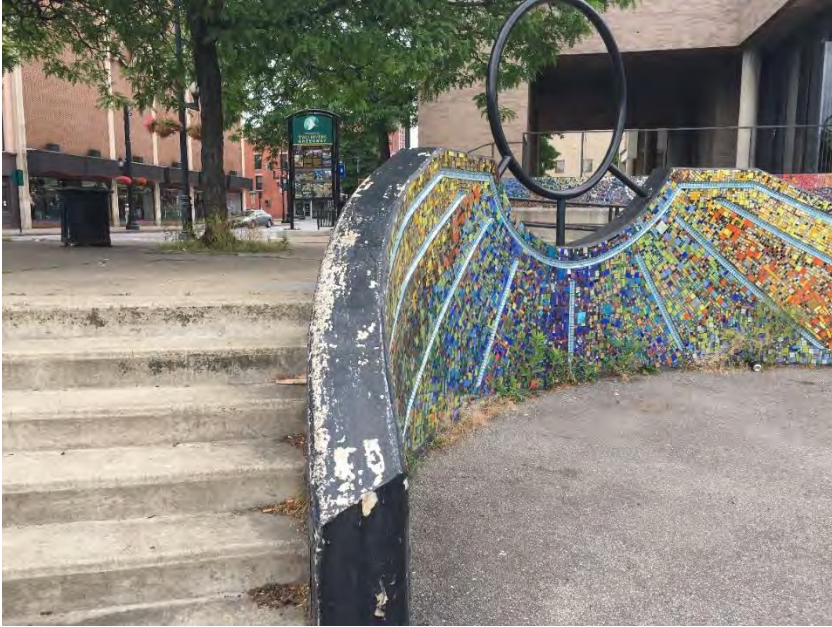
Figure 32 Worn Paint and Weeds Along the Edges

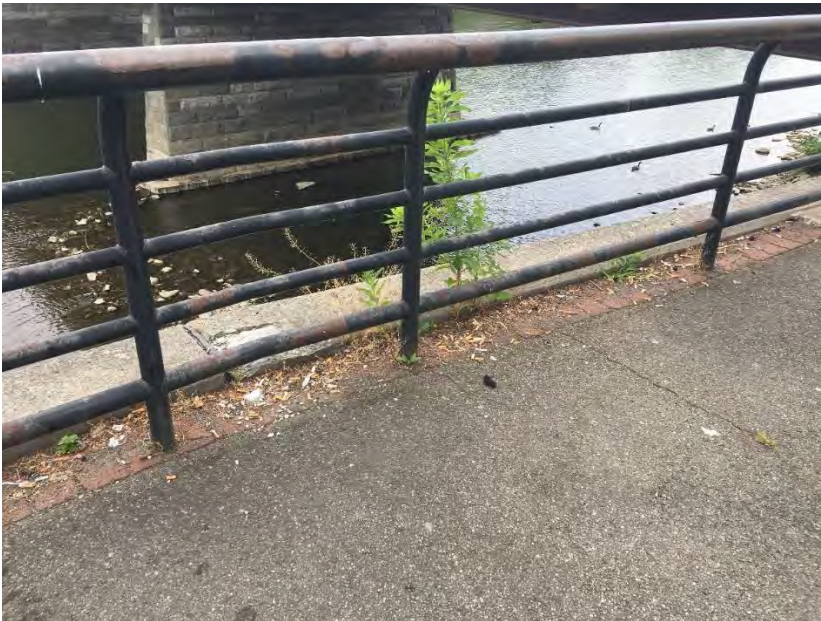
Figure 33 Rust on Railings and Cigarette Butts Along the Edge

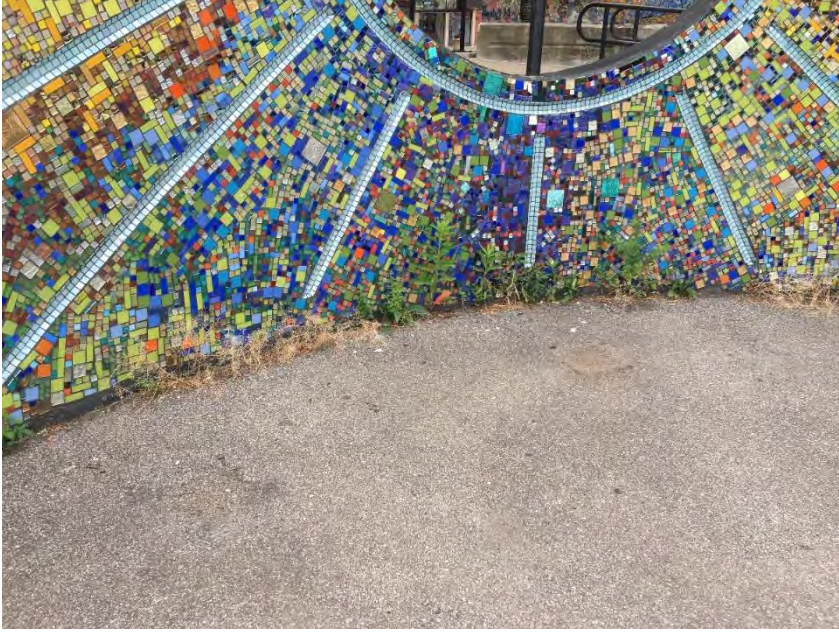
Figure 34 Wear, Rust, and Weeds in Mosaic Area

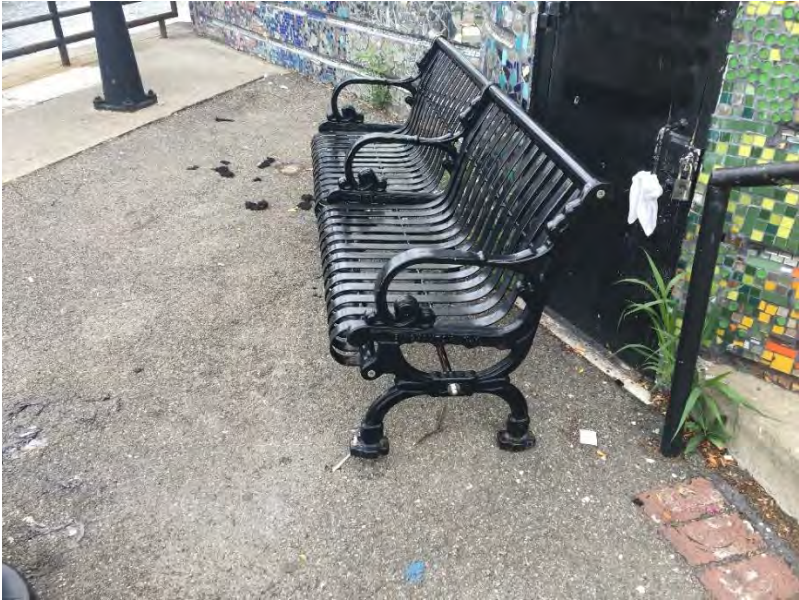
Figure 35 Bench Bent Out of Place

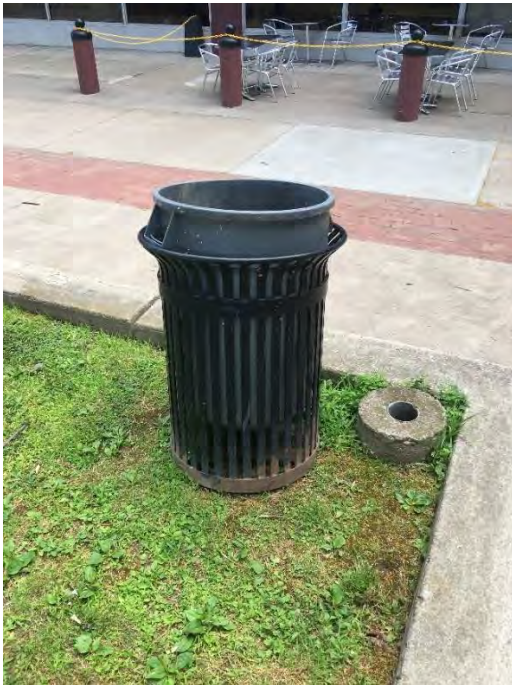
Figure 38 Unfit Garbage Cans

- Plastic garbage cans do not fit in their metal shells
- Graffiti
- Missing plaques

Action	Urgency			
Fix Garbage Cans	<input checked="" type="checkbox"/> <6 months	<input type="checkbox"/> 6-12 months	<input type="checkbox"/> 12-24 months	<input type="checkbox"/> 24+ months
Weeding and Trimming Overgrown Plants	<input checked="" type="checkbox"/> <6 months	<input type="checkbox"/> 6-12 months	<input type="checkbox"/> 12-24 months	<input type="checkbox"/> 24+ months
Remove Graffiti	<input checked="" type="checkbox"/> <6 months	<input type="checkbox"/> 6-12 months	<input type="checkbox"/> 12-24 months	<input type="checkbox"/> 24+ months
Replace Missing Plaques	<input checked="" type="checkbox"/> <6 months	<input type="checkbox"/> 6-12 months	<input type="checkbox"/> 12-24 months	<input type="checkbox"/> 24+ months

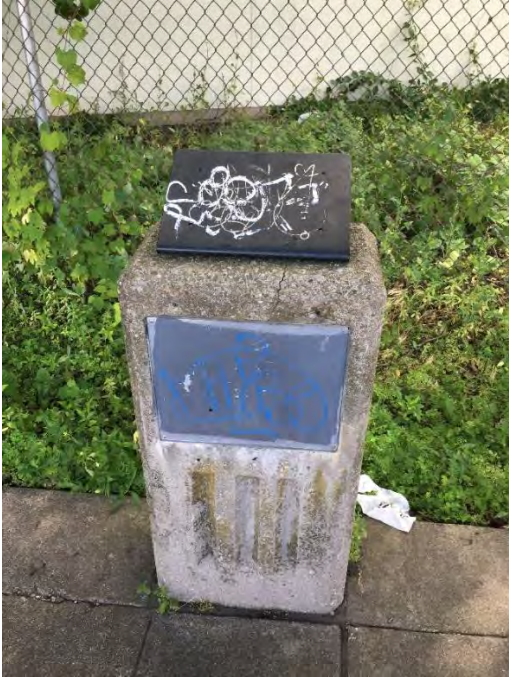
Figure 39 Graffiti and Missing Plaque

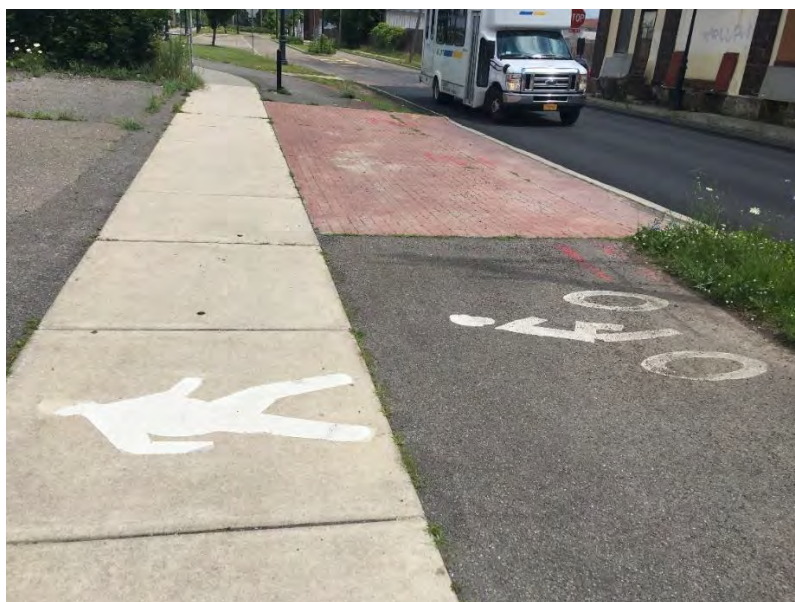
Figure 40 Non-Ideal Pedestrian and Cyclist Divisions

- Pedestrian and Bike path divisions were not constructed as designed
- Significant pavement cracking next parking lots

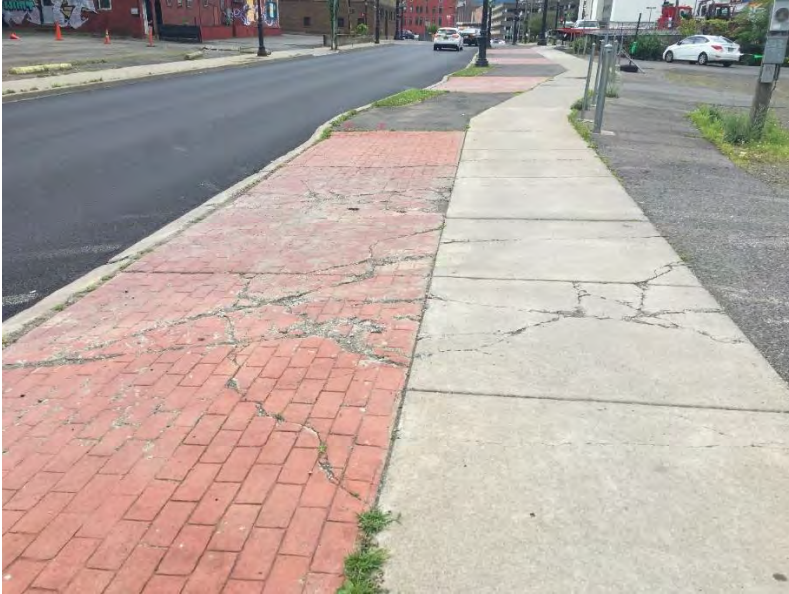
Figure 41 Cracked Cement Next to Driveways

Improvement	Timeline			
Cracked Cement Next to Driveways	<input checked="" type="checkbox"/> <6 months	<input type="checkbox"/> 6-12 months	<input type="checkbox"/> 12-24 months	<input type="checkbox"/> 24+ months
Small Pavement Cracks	<input checked="" type="checkbox"/> <6 months	<input type="checkbox"/> 6-12 months	<input type="checkbox"/> 12-24 months	<input type="checkbox"/> 24+ months
Repaint Pedestrian Cyclist Indicators	<input checked="" type="checkbox"/> <6 months	<input type="checkbox"/> 6-12 months	<input type="checkbox"/> 12-24 months	<input type="checkbox"/> 24+ months

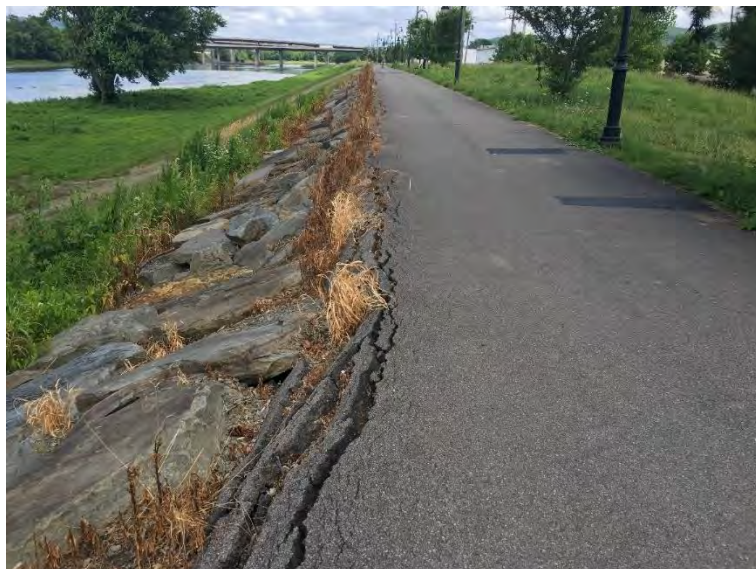
Figure 42 Severe Pavement Cracks at Trail Edge

- Severely cracked pavement along trail edge
- Overgrown weeds

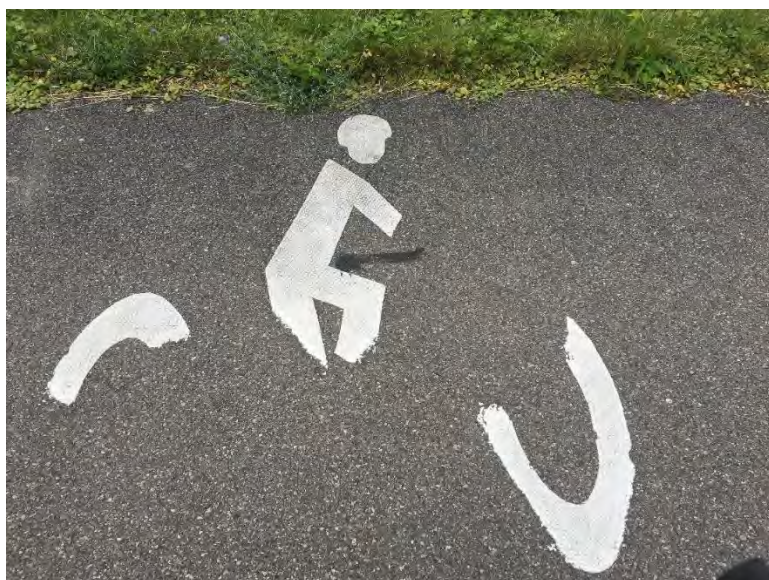
Figure 43 Worn Bike Path Marking

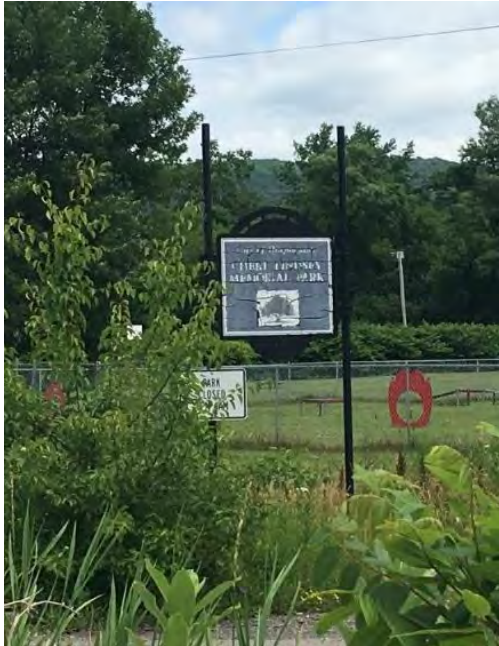
Figure 44 Weathered Sign

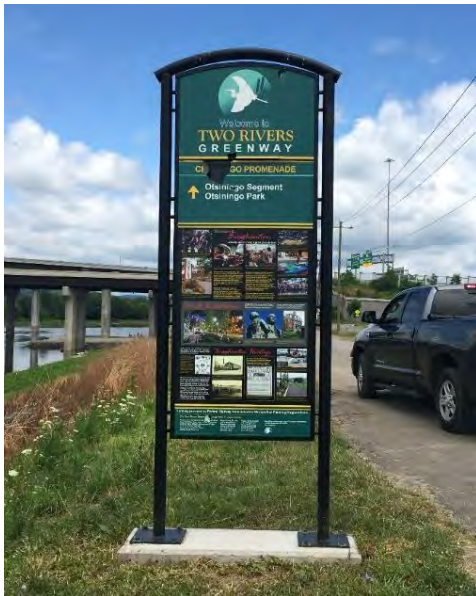
Figure 45 Damaged Two Rivers Greenway Sign

Notes: Two Rivers Greenway sign is damaged.

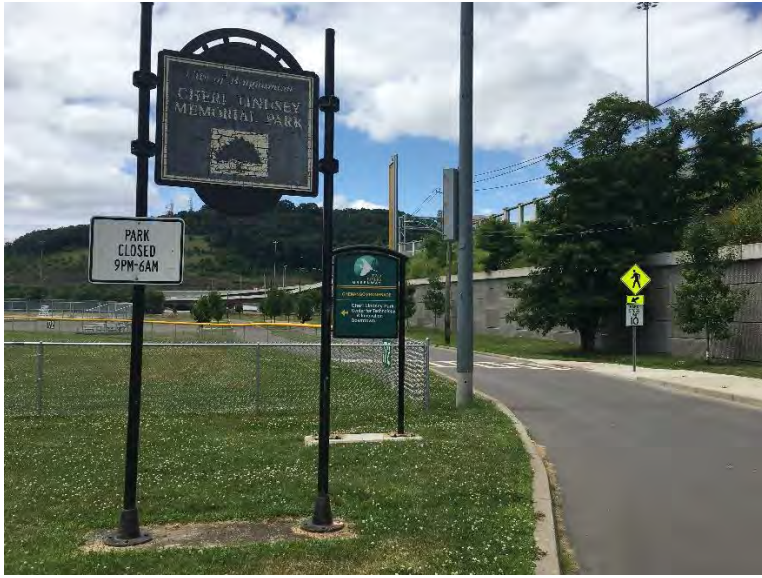
Figure 46 Worn Park Sign

- Severely worn out Cheri Lindsay Memorial Park signs

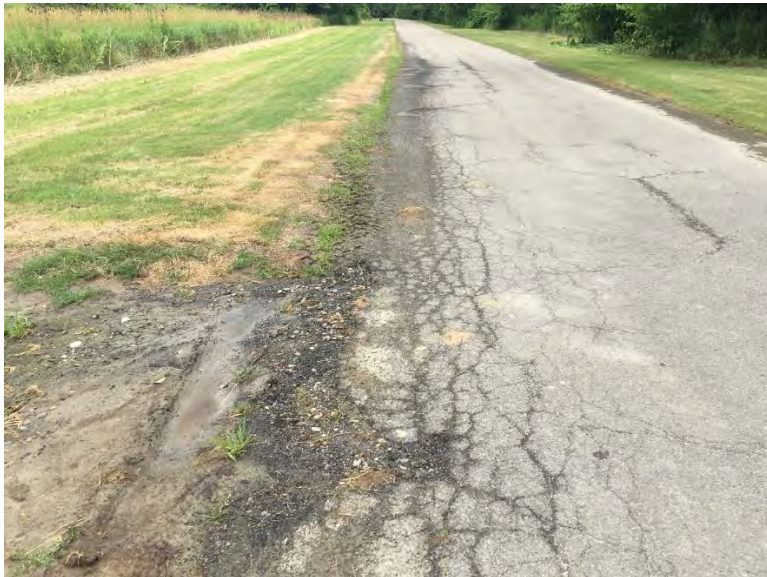
Figure 50 Cracks on Side of Pavement

Action	Urgency			
Crack filling	<input type="checkbox"/> <6 months	<input checked="" type="checkbox"/> 6-12 months	<input type="checkbox"/> 12-24 months	<input type="checkbox"/> 24+ months

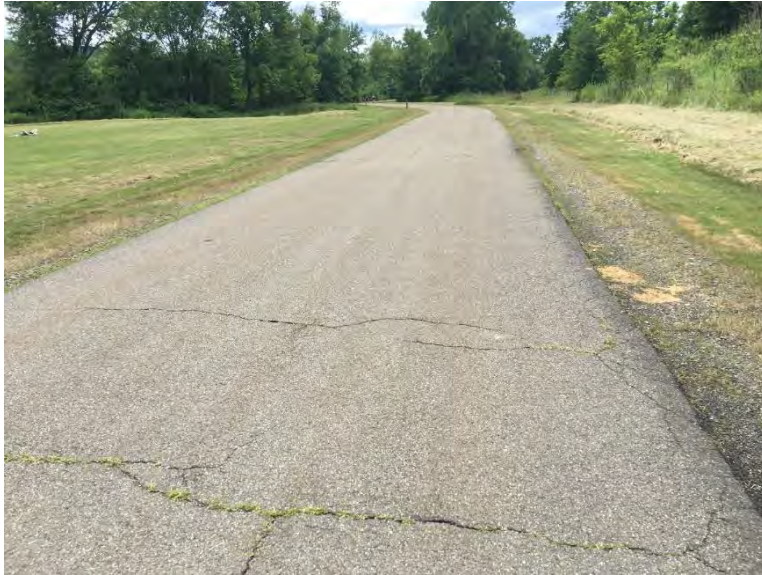
Figure 51 Semi-regular Cracks Across Pavement

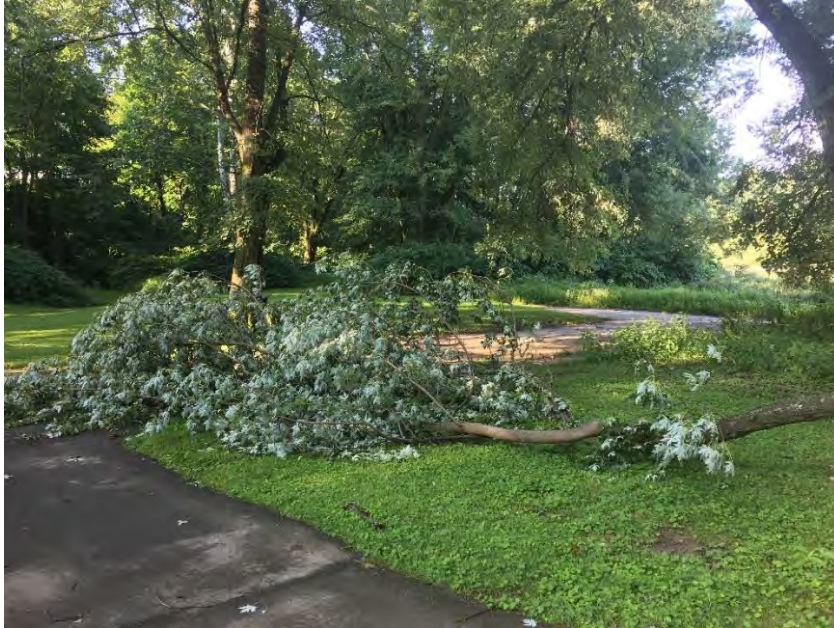
Figure 71 Fallen Tree Branch

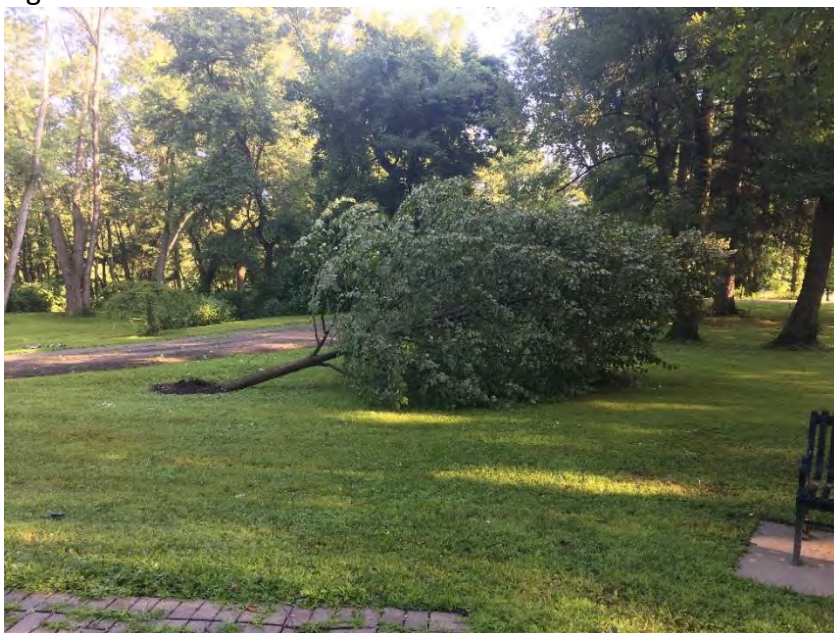
Figure 72 Fallen Tree

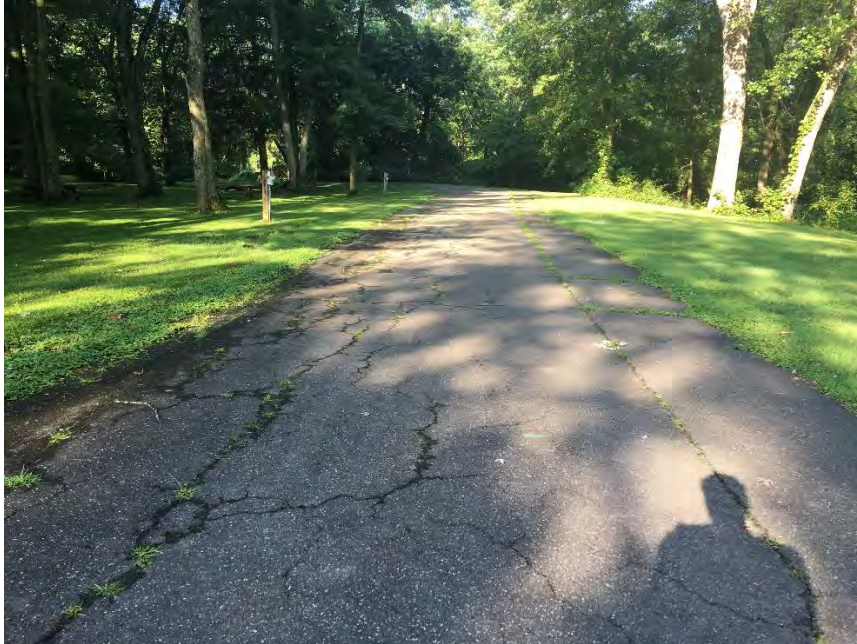
Figure 73 Cracked Pavement

Action	Urgency			
Seal Pavement Cracks	<input checked="" type="checkbox"/> <6 months	<input type="checkbox"/> 6-12 months	<input type="checkbox"/> 12-24 months	<input type="checkbox"/> 24+ months
Address Puddling	<input checked="" type="checkbox"/> <6 months	<input type="checkbox"/> 6-12 months	<input type="checkbox"/> 12-24 months	<input type="checkbox"/> 24+ months
Address Tree Root Infiltration	<input checked="" type="checkbox"/> <6 months	<input type="checkbox"/> 6-12 months	<input type="checkbox"/> 12-24 months	<input type="checkbox"/> 24+ months
Remove Fallen Branches and Trees	<input checked="" type="checkbox"/> <6 months	<input type="checkbox"/> 6-12 months	<input type="checkbox"/> 12-24 months	<input type="checkbox"/> 24+ months

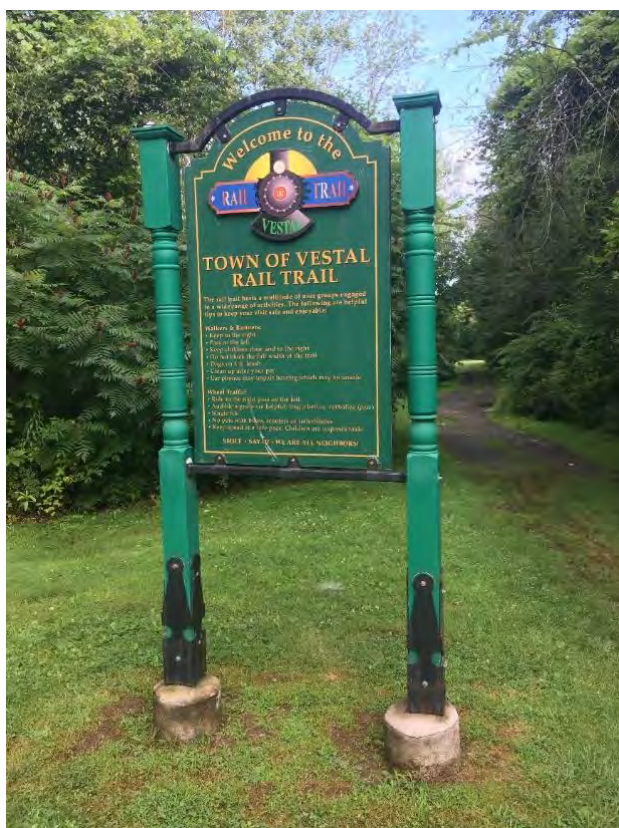
Figure 52 Vestal Rail Trail Sign, Some Cracks

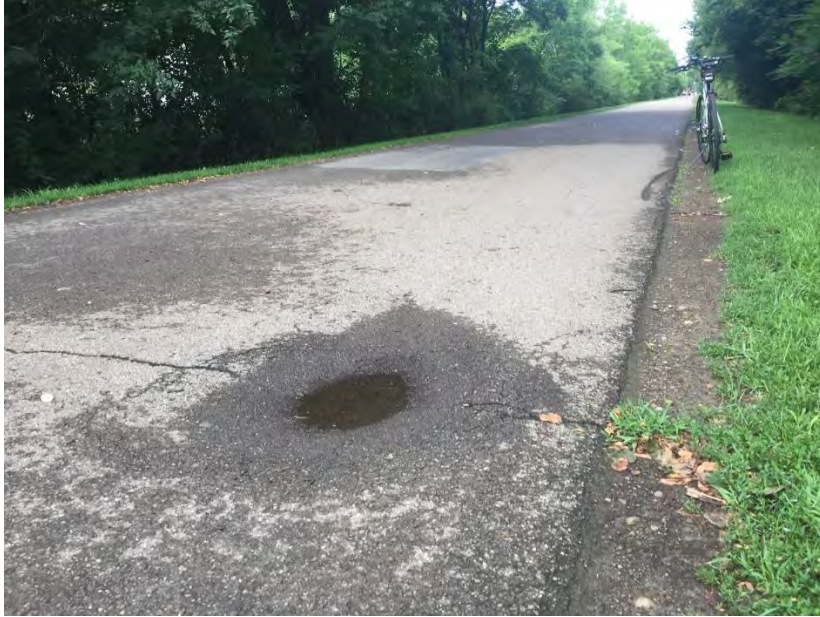
Figure 53 Puddling in Dip in Pavement

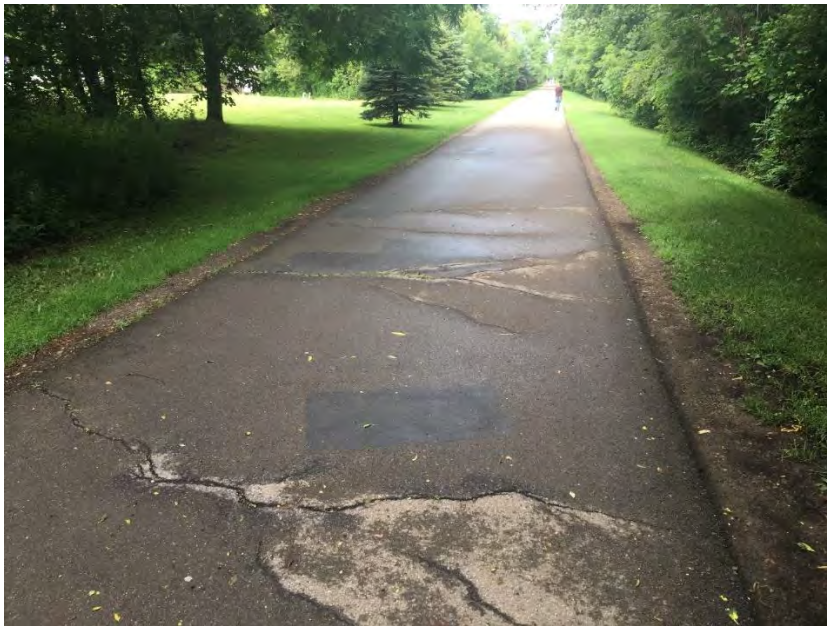
Figure 54 Significant Bumps and Cracks

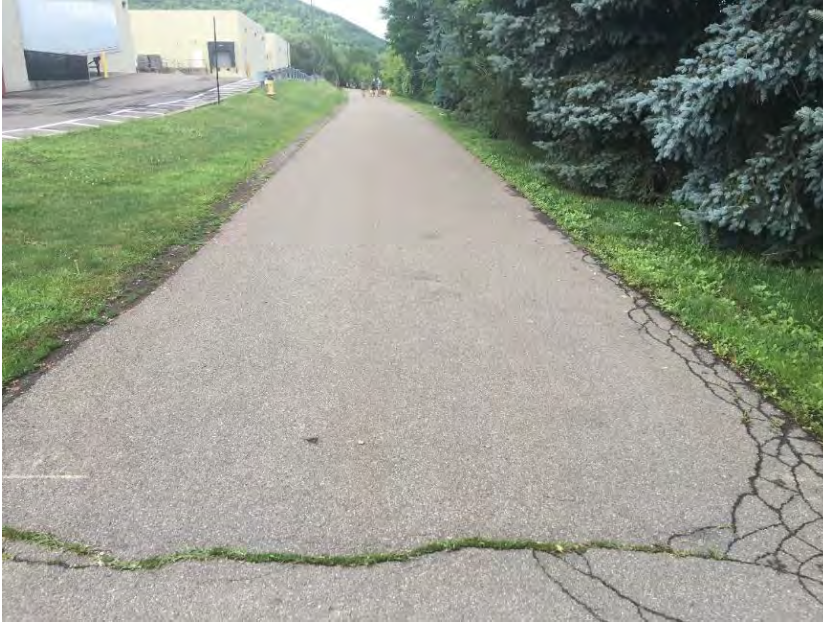
Figure 55 Slight Cracks
