THE TWO RIVERS GREENWAY TRAIL MAINTENANCE PLAN  
JULY-AUGUST 2019  
BINGHAMTON METROPOLITAN TRANSPORTATION STUDY

APPENDIX & TRAIL ASSESSMENTS

### Two Rivers Greenway Trail Maintenance Assessment

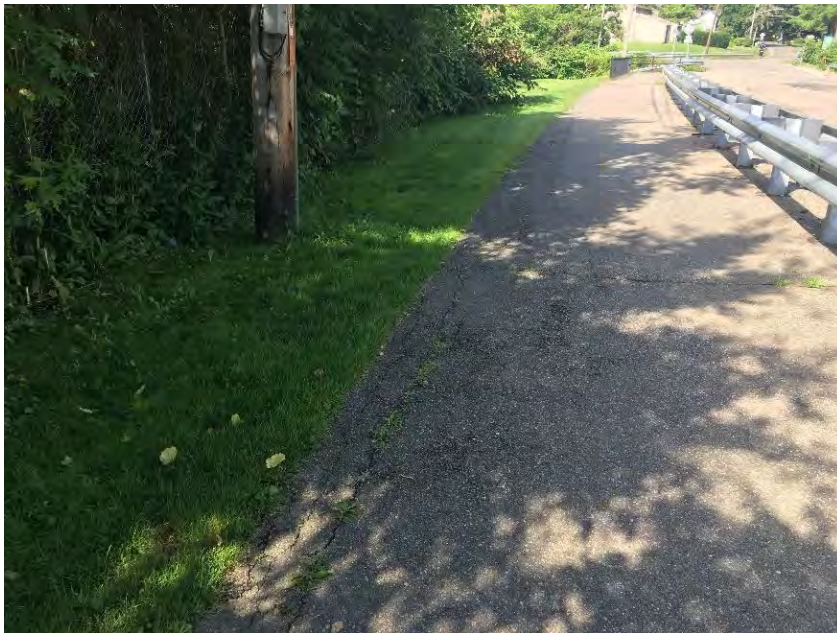
Figure 56 Slight Cracks in Pavement

Action	Urgency			
Fill Pavement Cracks	<input type="checkbox"/> <6 months	<input checked="" type="checkbox"/> 6-12 months	<input type="checkbox"/> 12-24 months	<input type="checkbox"/> 24+ months
Address Edge Cracking	<input type="checkbox"/> <6 months	<input checked="" type="checkbox"/> 6-12 months	<input type="checkbox"/> 12-24 months	<input type="checkbox"/> 24+ months

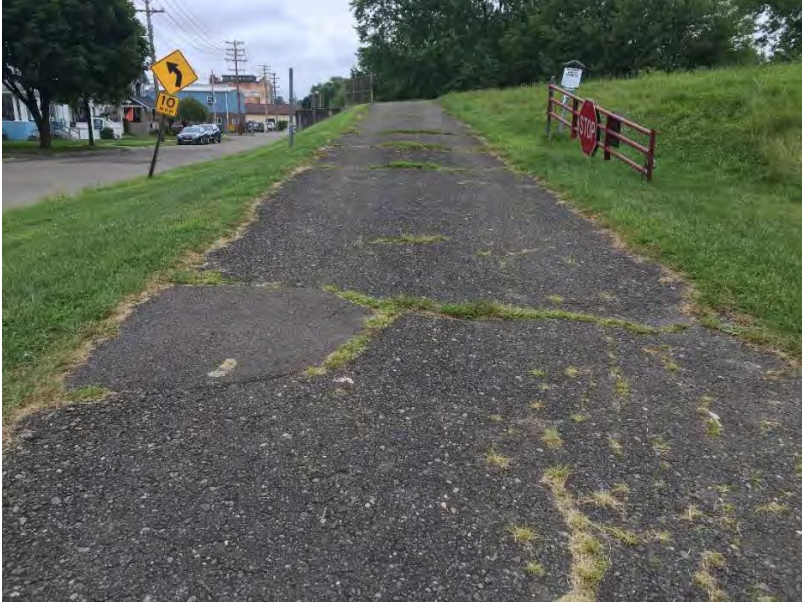
Figure 60 Cracked and Patchy Pavement

Action	Urgency			
	<6 months	6-12 months	12-24 months	24+ months
Repave Trail	<input checked="" type="checkbox"/> <6 months	<input type="checkbox"/> 6-12 months	<input type="checkbox"/> 12-24 months	<input type="checkbox"/> 24+ months
Trim Vegetation Especially Surrounding Benches	<input checked="" type="checkbox"/> <6 months	<input type="checkbox"/> 6-12 months	<input type="checkbox"/> 12-24 months	<input type="checkbox"/> 24+ months

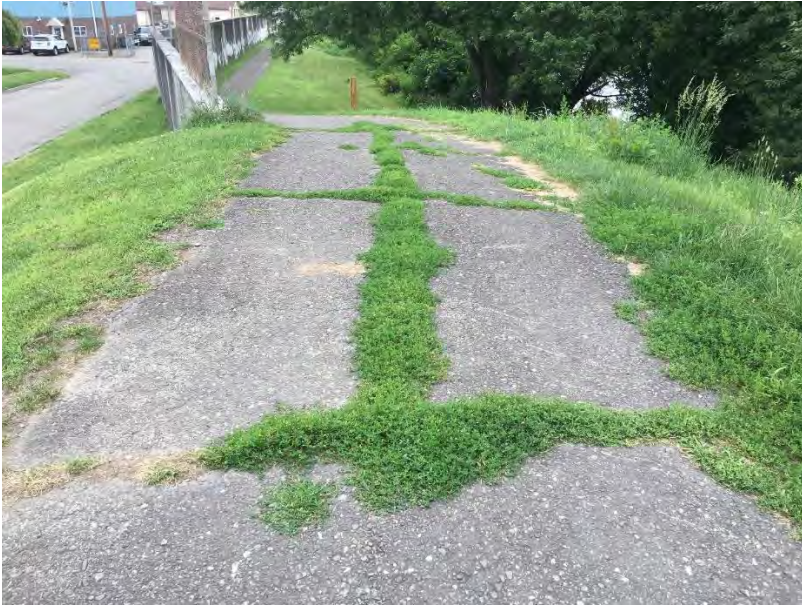
Figure 61 Plant Growth in Pavement Cracks

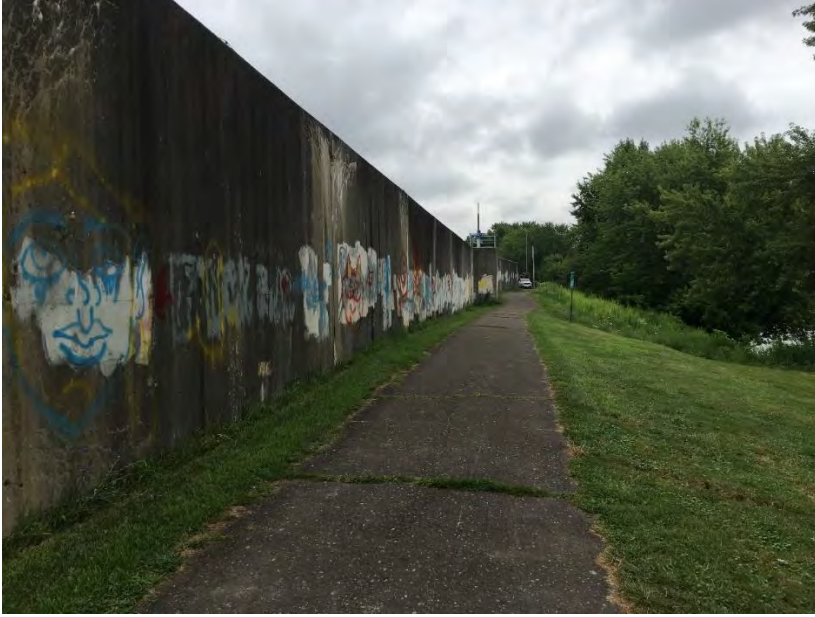
Figure 62 Graffiti Along the Floodwall

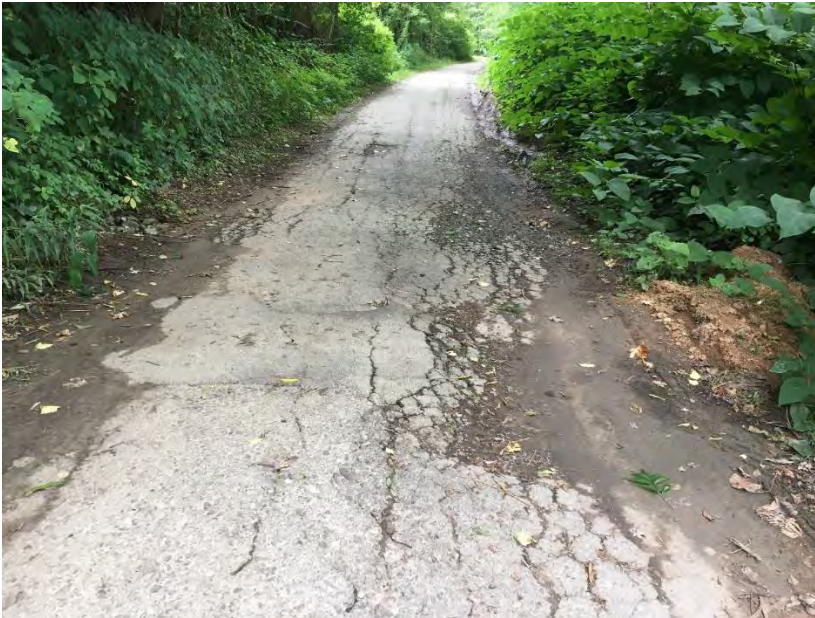
Figure 63 Severe Edge Cracking

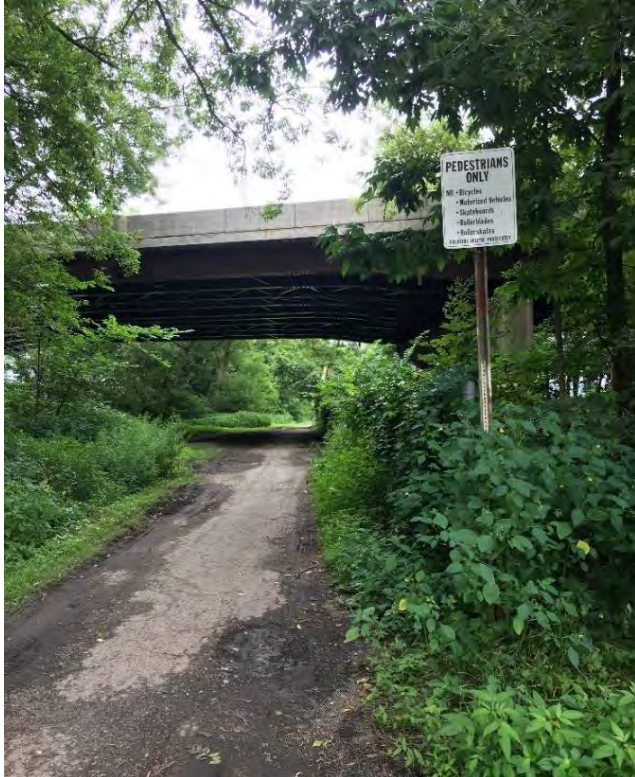
Figure 64 Cracked Pavement Especially Along the Side

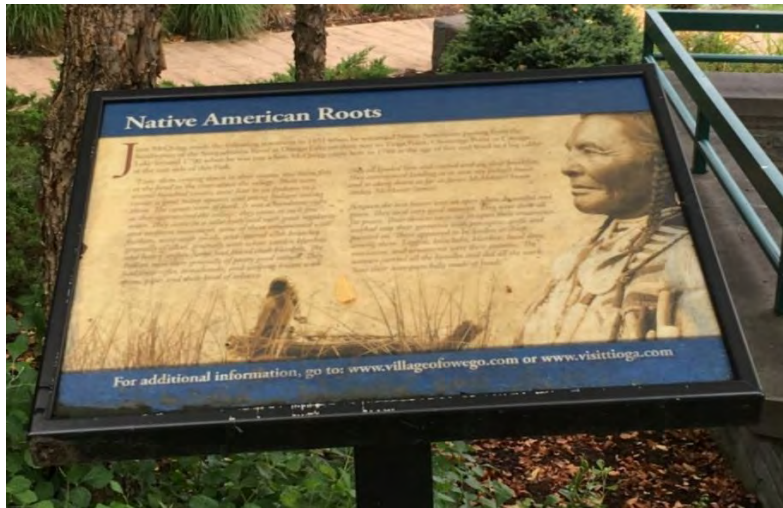
Figure 65 Dirty Sign

Action	Urgency			
Clean Signs	<input checked="" type="checkbox"/> <6 months	<input type="checkbox"/> 6-12 months	<input type="checkbox"/> 12-24 months	<input type="checkbox"/> 24+ months
Weeding	<input checked="" type="checkbox"/> <6 months	<input type="checkbox"/> 6-12 months	<input type="checkbox"/> 12-24 months	<input type="checkbox"/> 24+ months
Address Puddling Sources	<input checked="" type="checkbox"/> <6 months	<input type="checkbox"/> 6-12 months	<input type="checkbox"/> 12-24 months	<input type="checkbox"/> 24+ months
Repair Benches	<input checked="" type="checkbox"/> <6 months	<input type="checkbox"/> 6-12 months	<input type="checkbox"/> 12-24 months	<input type="checkbox"/> 24+ months

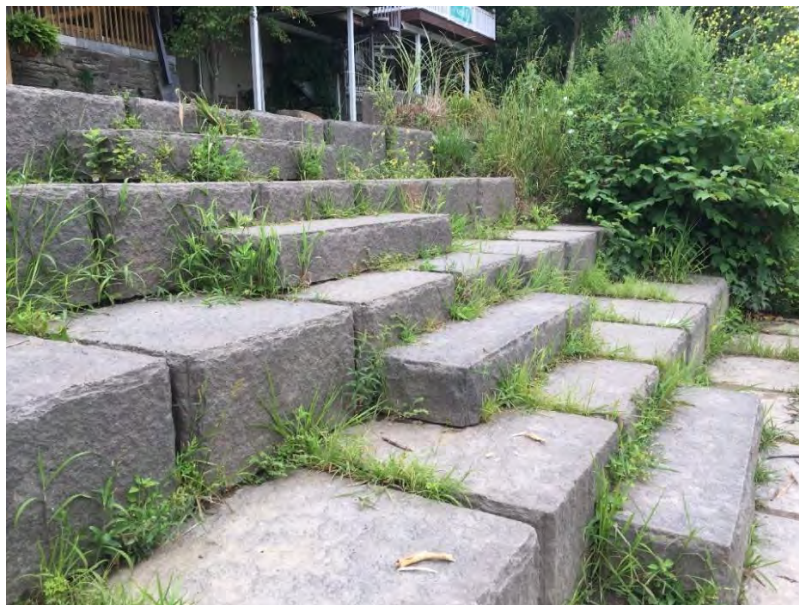
Figure 66 Overgrown Weeds

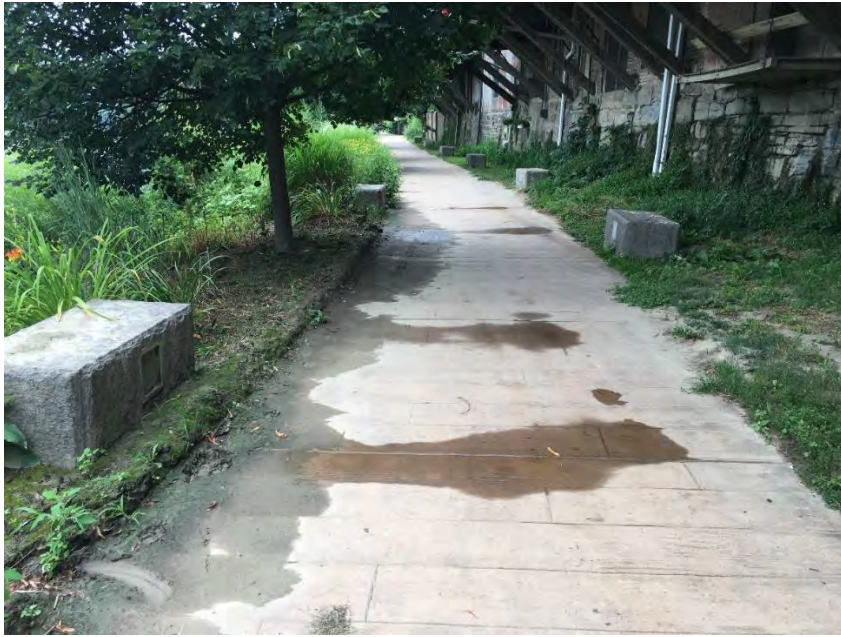
Figure 67 Puddling Under Overhanging Buildings and Trees

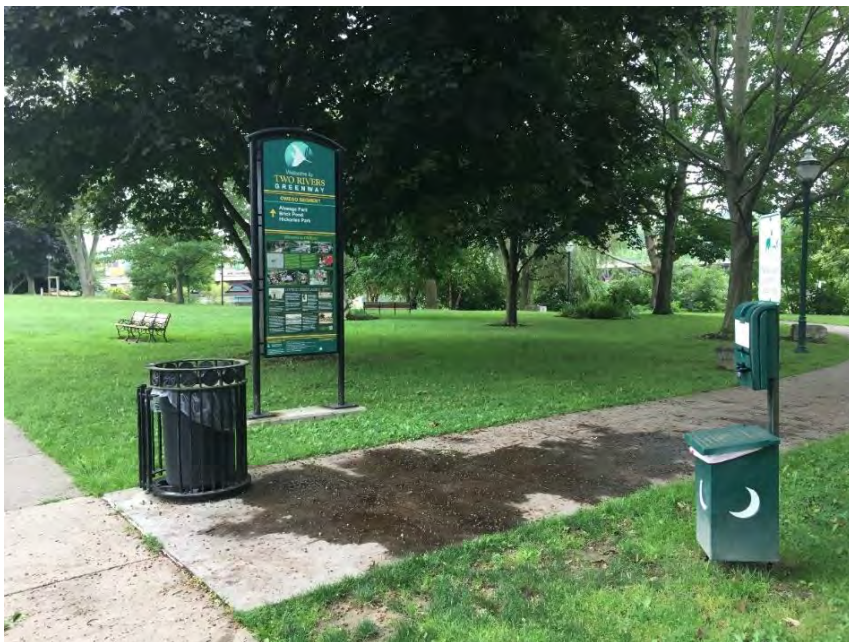
Figure 68 Puddling from Overhanging Trees

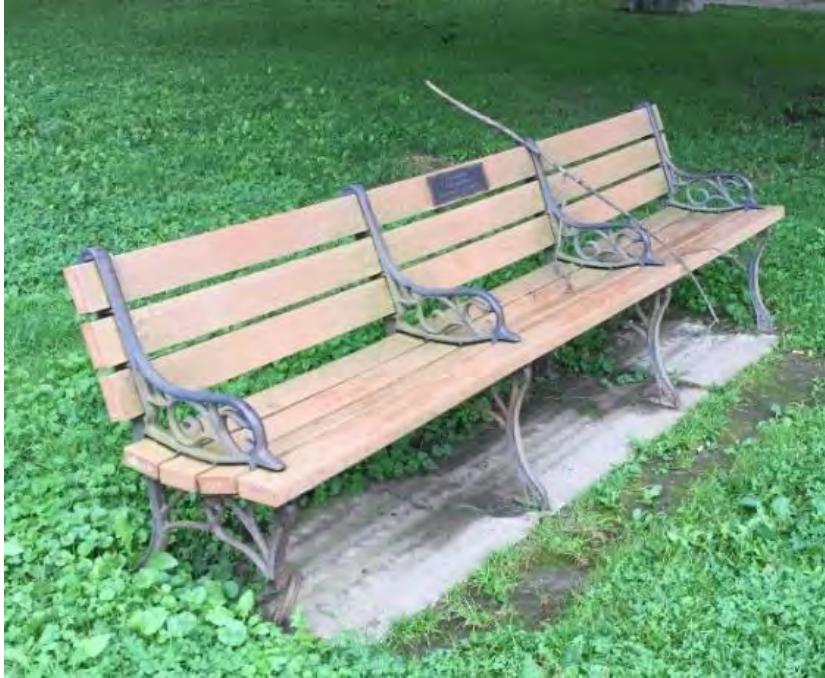
Figure 69 Broken Bench Leg

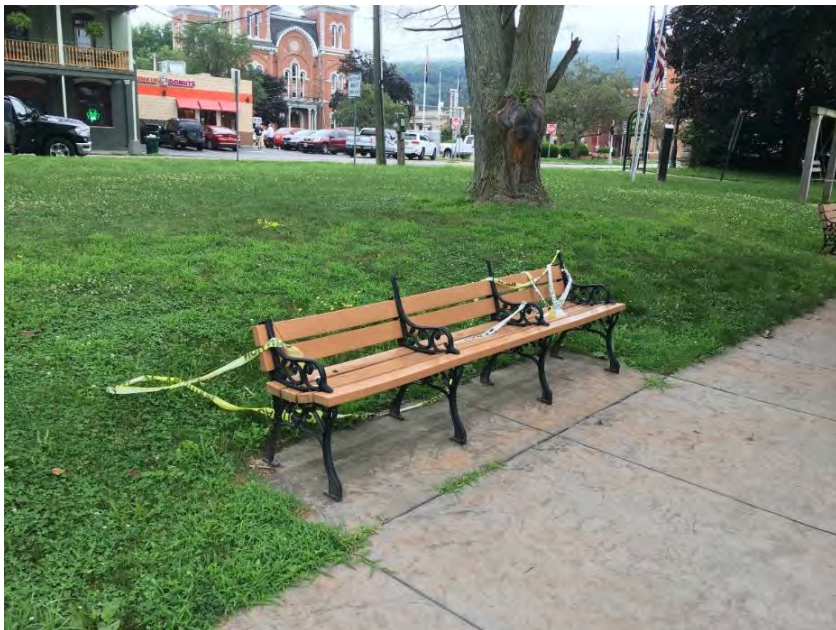
Figure 70 Damaged Bench
