# NORTH STREET ROAD SAFETY ASSESSMENT CITY OF BINGHAMTON

## BINGHAMTON METROPOLITAN TRANSPORTATION STUDY SEPTEMBER 2021

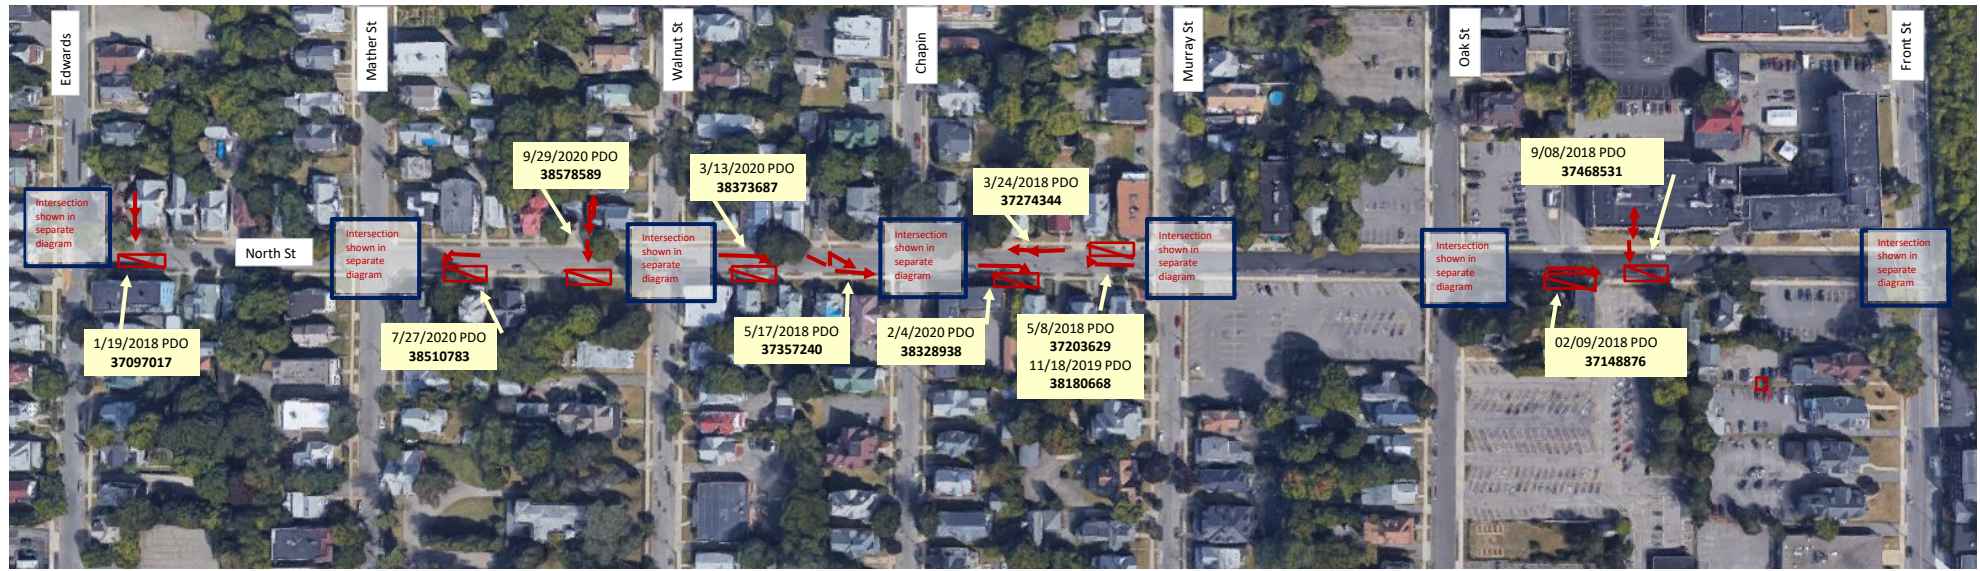
Municipality City of Binghamton County Broome File  
 Intersection: North/Edwards  
 Period 3 Years 0 Months From 1/1/2018 To 12/31/2020 By AS Date Aug-21

Crosswalks are missing.  
 ADA compliant curb ramps on Edwards Street at North are missing.

'No parking' sign is faded.

- Paint a double center line along the entire length of Edwards Street.
- Stripe in parking spaces.
- Paint ladder style crosswalks across all four legs of the intersection.
- Add painted stop bars in conjunction with crosswalks at stop signs.
- Install ADA compliant curb ramps across Edwards Street at North.
- Consider re-establishing the intersection street art. While street art is not technically approved by the MUTCD, it may slow traffic.
- Repair sidewalks on Edwards.
