Two Rivers Greenway Trail Maintenance Report - 2024 Snapshot

About The 2024 Trail Maintenance Report

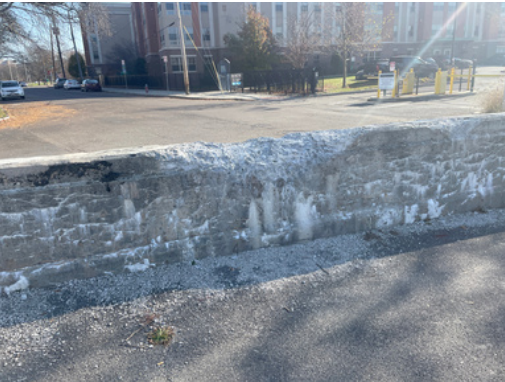
The flood wall is deteriorating at the Water Street and Susquehanna Street intersection. Along most of the lower riverwalk from Water Street to Court Street there is sediment on the path. North of East Clinton Street there is frequent deep cracking and constant pavement changes on the trail which could be dangerous for pedestrians and cyclists. Along the West State Street Section of the trail there is a massive hole in the trail that could lead to someone being seriously injured. Lastly, when the trail connects to Cheri Lindsey Park, there is a section of gravel that is from broken down pavement and it is difficult to tell where the rest of the trail is.

Photo 1: Binghamton- Floodwall deteriorating at Water and Susquehanna Street

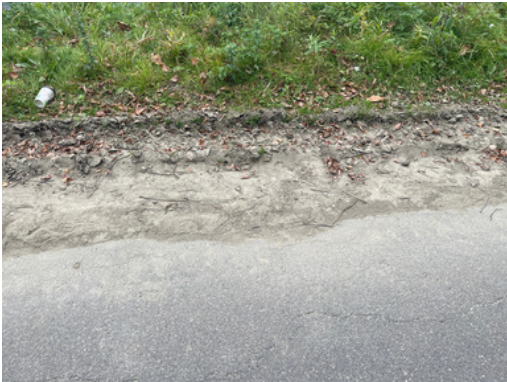
Photo 2: Binghamton- Sediment on path on lower riverwalk in Downtown Binghamton

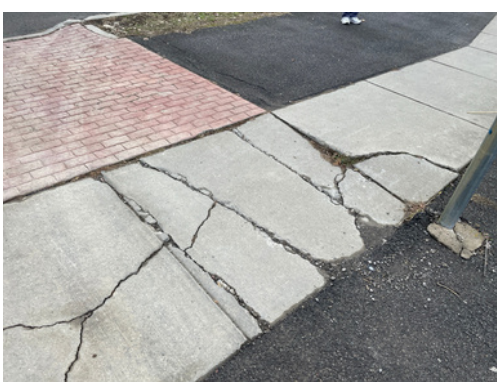
Photo 3: Binghamton- Cracking and pavement changes above East Clinton

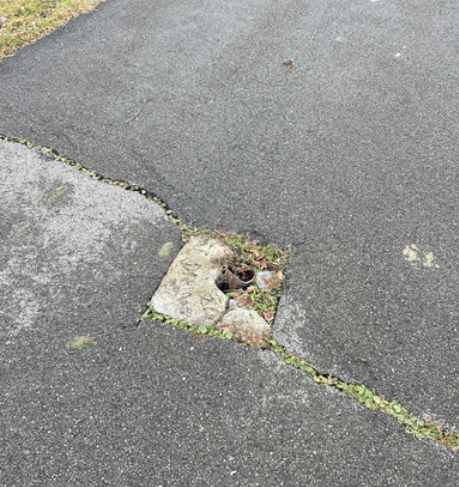
Photo 4: Binghamton- Hole near West State Street

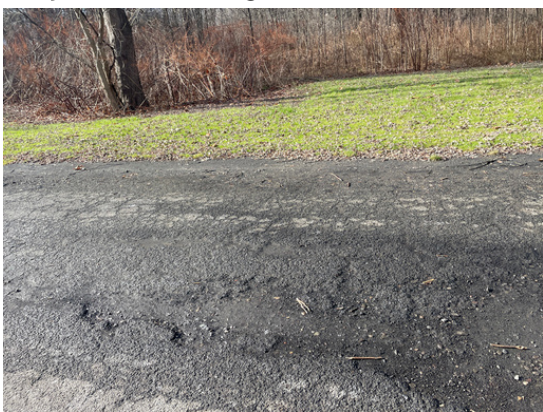
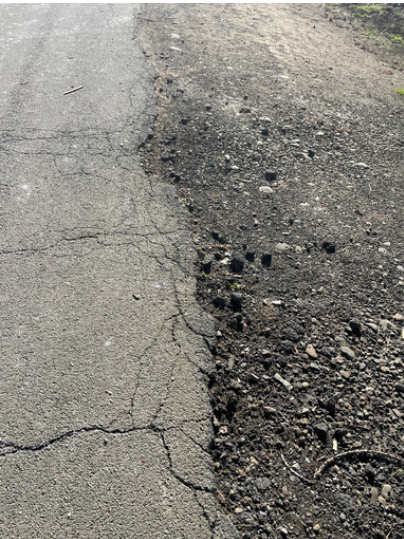
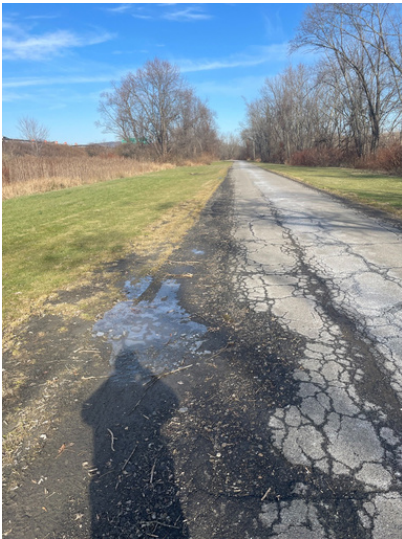
- **Pavement:**
Pavement in the Otsiningo Park Loop is excellent condition. At the southern pedestrian and bicyclist entrance to the park, pavement has frequent and deep cracking. The north end of the trail that extends to Howell Drive experiences frequent deep lateral cracks that should be addressed.
- **Maintenance:**
This trail is somewhat well maintained. On stretches of the loop there is dirt and feces on the walking trail. There are some cracks along the sides of the pavement of the loop. The north end of the trail experiences severe cracking as well as stretches of the trail falling apart. It could be potentially dangerous for cyclists and pedestrians.
- **Major Issues:**
The north end of the trail should be repaved as there are massive potholes along it and the trail is falling apart along the sides.
- **Signage:**
No issues with signage was noted.

Photo 6-8: Otsiningo- Cracking and Puddling on north end of trail

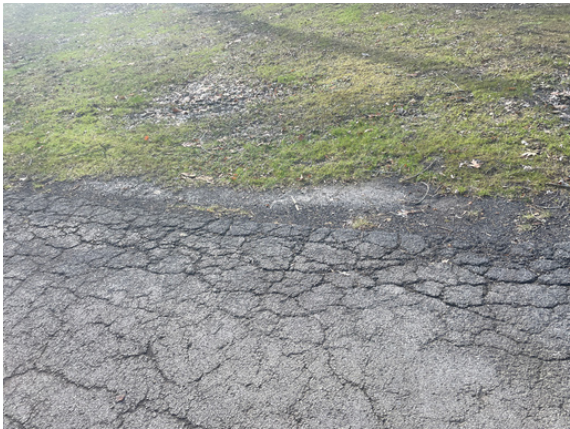
- **Pavement:**
The pavement in stretches of the park seem to be freshly repaved. There is still some parts of the park that need to be repaved but it seems like they repaved the worst parts from 2 years ago.
- **Maintenance:**
There are no real maintenance issues but there is cracking on the the portions of trail that have not been freshly repaved
- **Major Issues:**
Severe cracking at north most part of the loop.
- **Signage:**
No issues with signage was noted.

Photo 9: Port Dickinson- Severe Cracking at northmost end of the loop

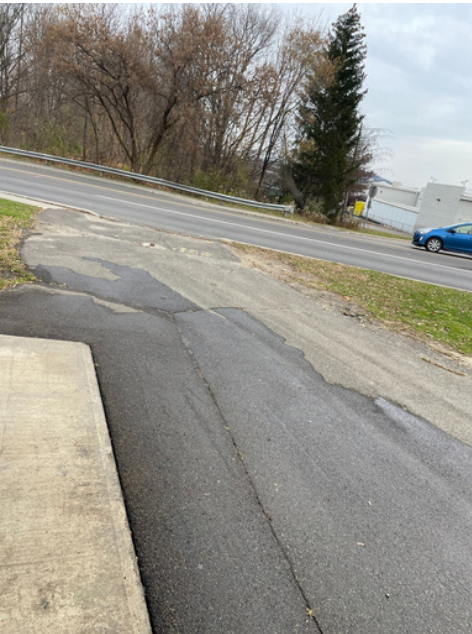
Photo 10: Vestal Rail Trail- Cracking and depressions at east entrance by African road

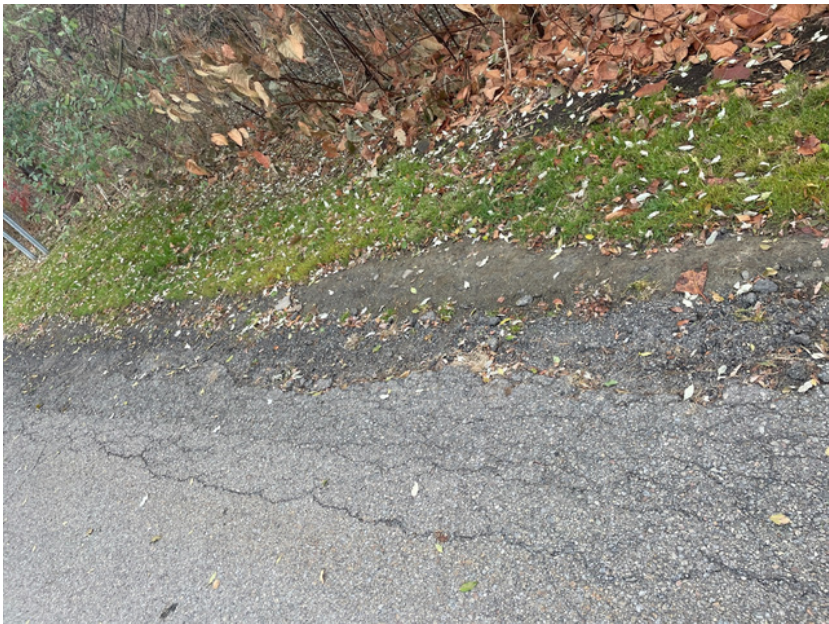
Photo 11: Vestal Rail Trail- Cracking by west entrance of west extension of trail

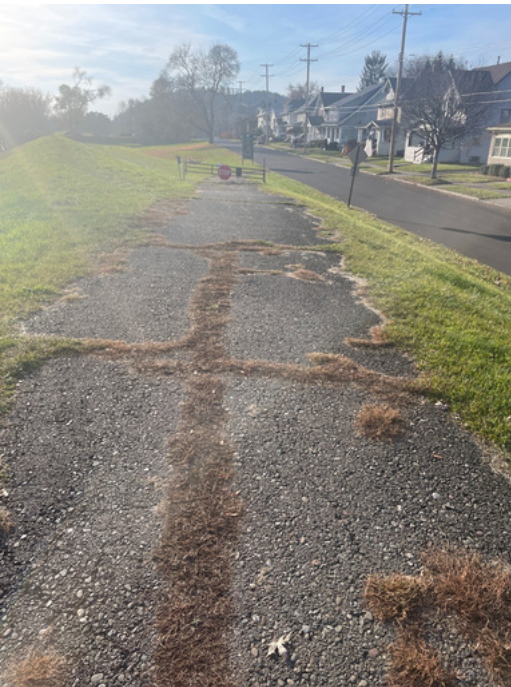
Photo 12: Endicott Chugnut- Cracking and overgrowth near River Terrace

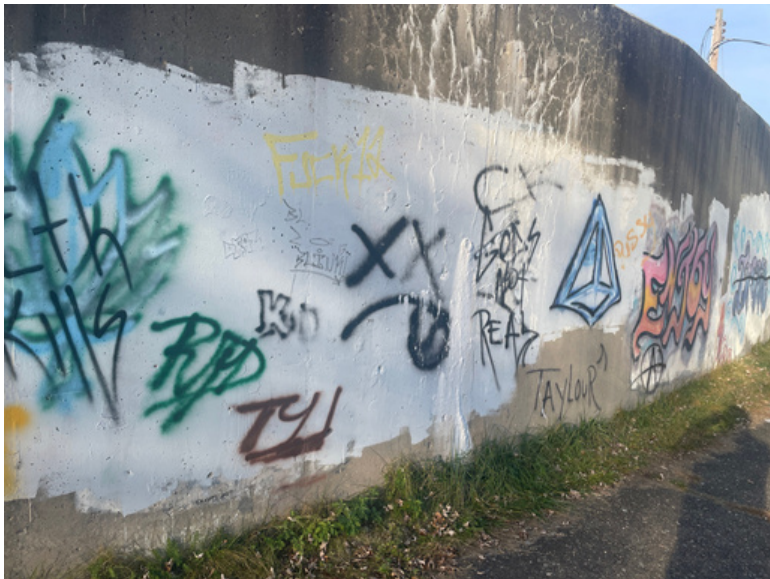
Photo 13: Endicott Chugnut- Graffiti along flood wall

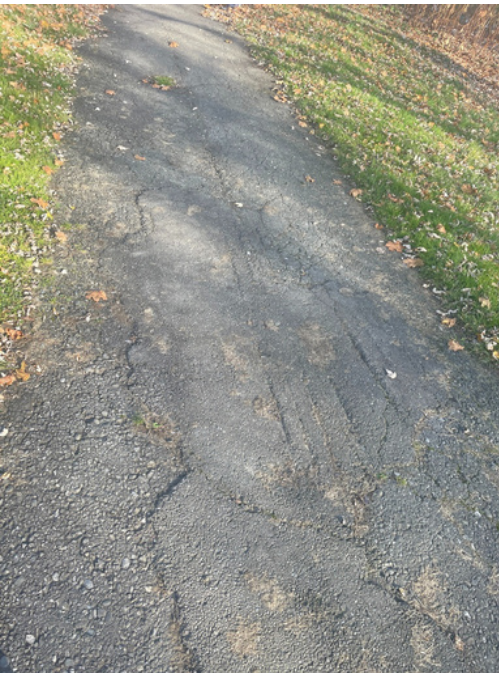
Photo 14: Endicott Chugnut- Severe Cracking behind school

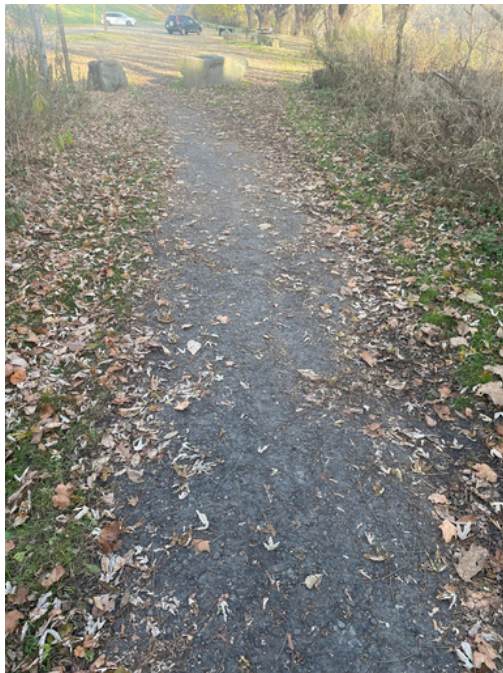
Photo 15: Endicott Chugnut- Severe cracking at east entrance/exit

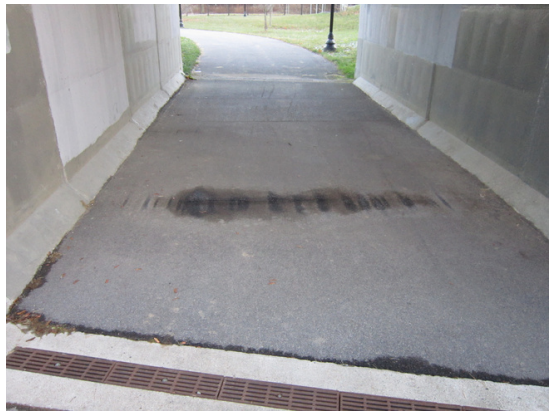
On the underpass that connects Pennsylvania Avenue to Vestal Parkway east, there are depressions and cracking on the pavement, as well as spider webs covering the lights in the tunnel.

Photo 16: 434 Greenway- Pennsylvania Ave to 434 Underpass cracking

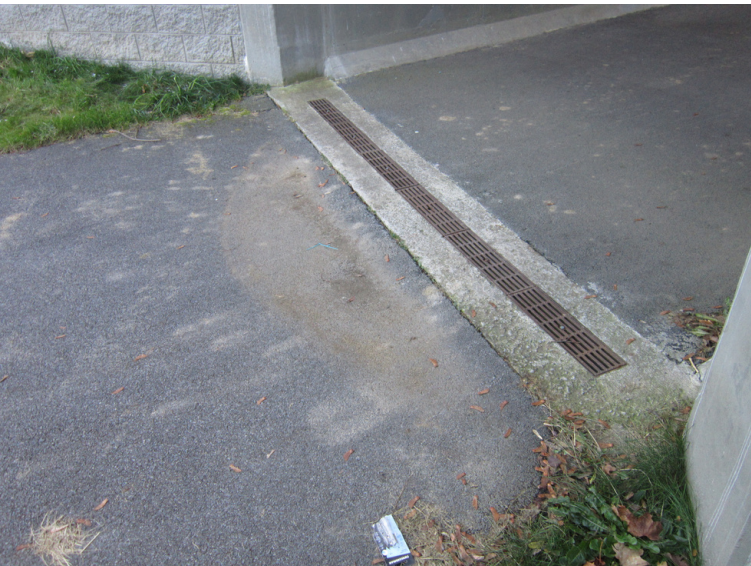
Photo 17: 434 Greenway- Pennsylvania Ave to 434 Underpass depression

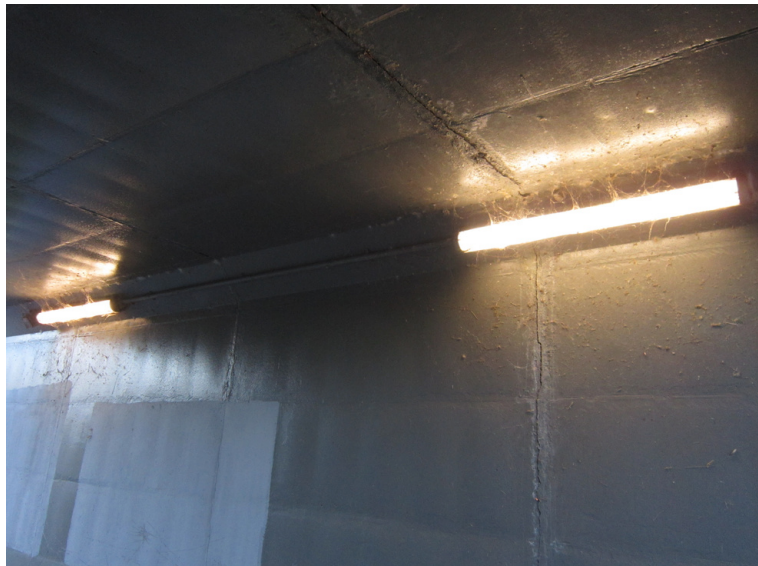
Photo 17: 434 Greenway- Pennsylvania Ave to 434 Underpass spiderwebs covering lights
