**JARVIS STREET
MAIN STREET TO CLINTON STREET
CITY OF BINGHAMTON
ROAD SAFETY ASSESSMENT**

**BINGHAMTON METROPOLITAN TRANSPORTATION STUDY
OCTOBER 2019**

ROAD SAFETY ASSESSMENT

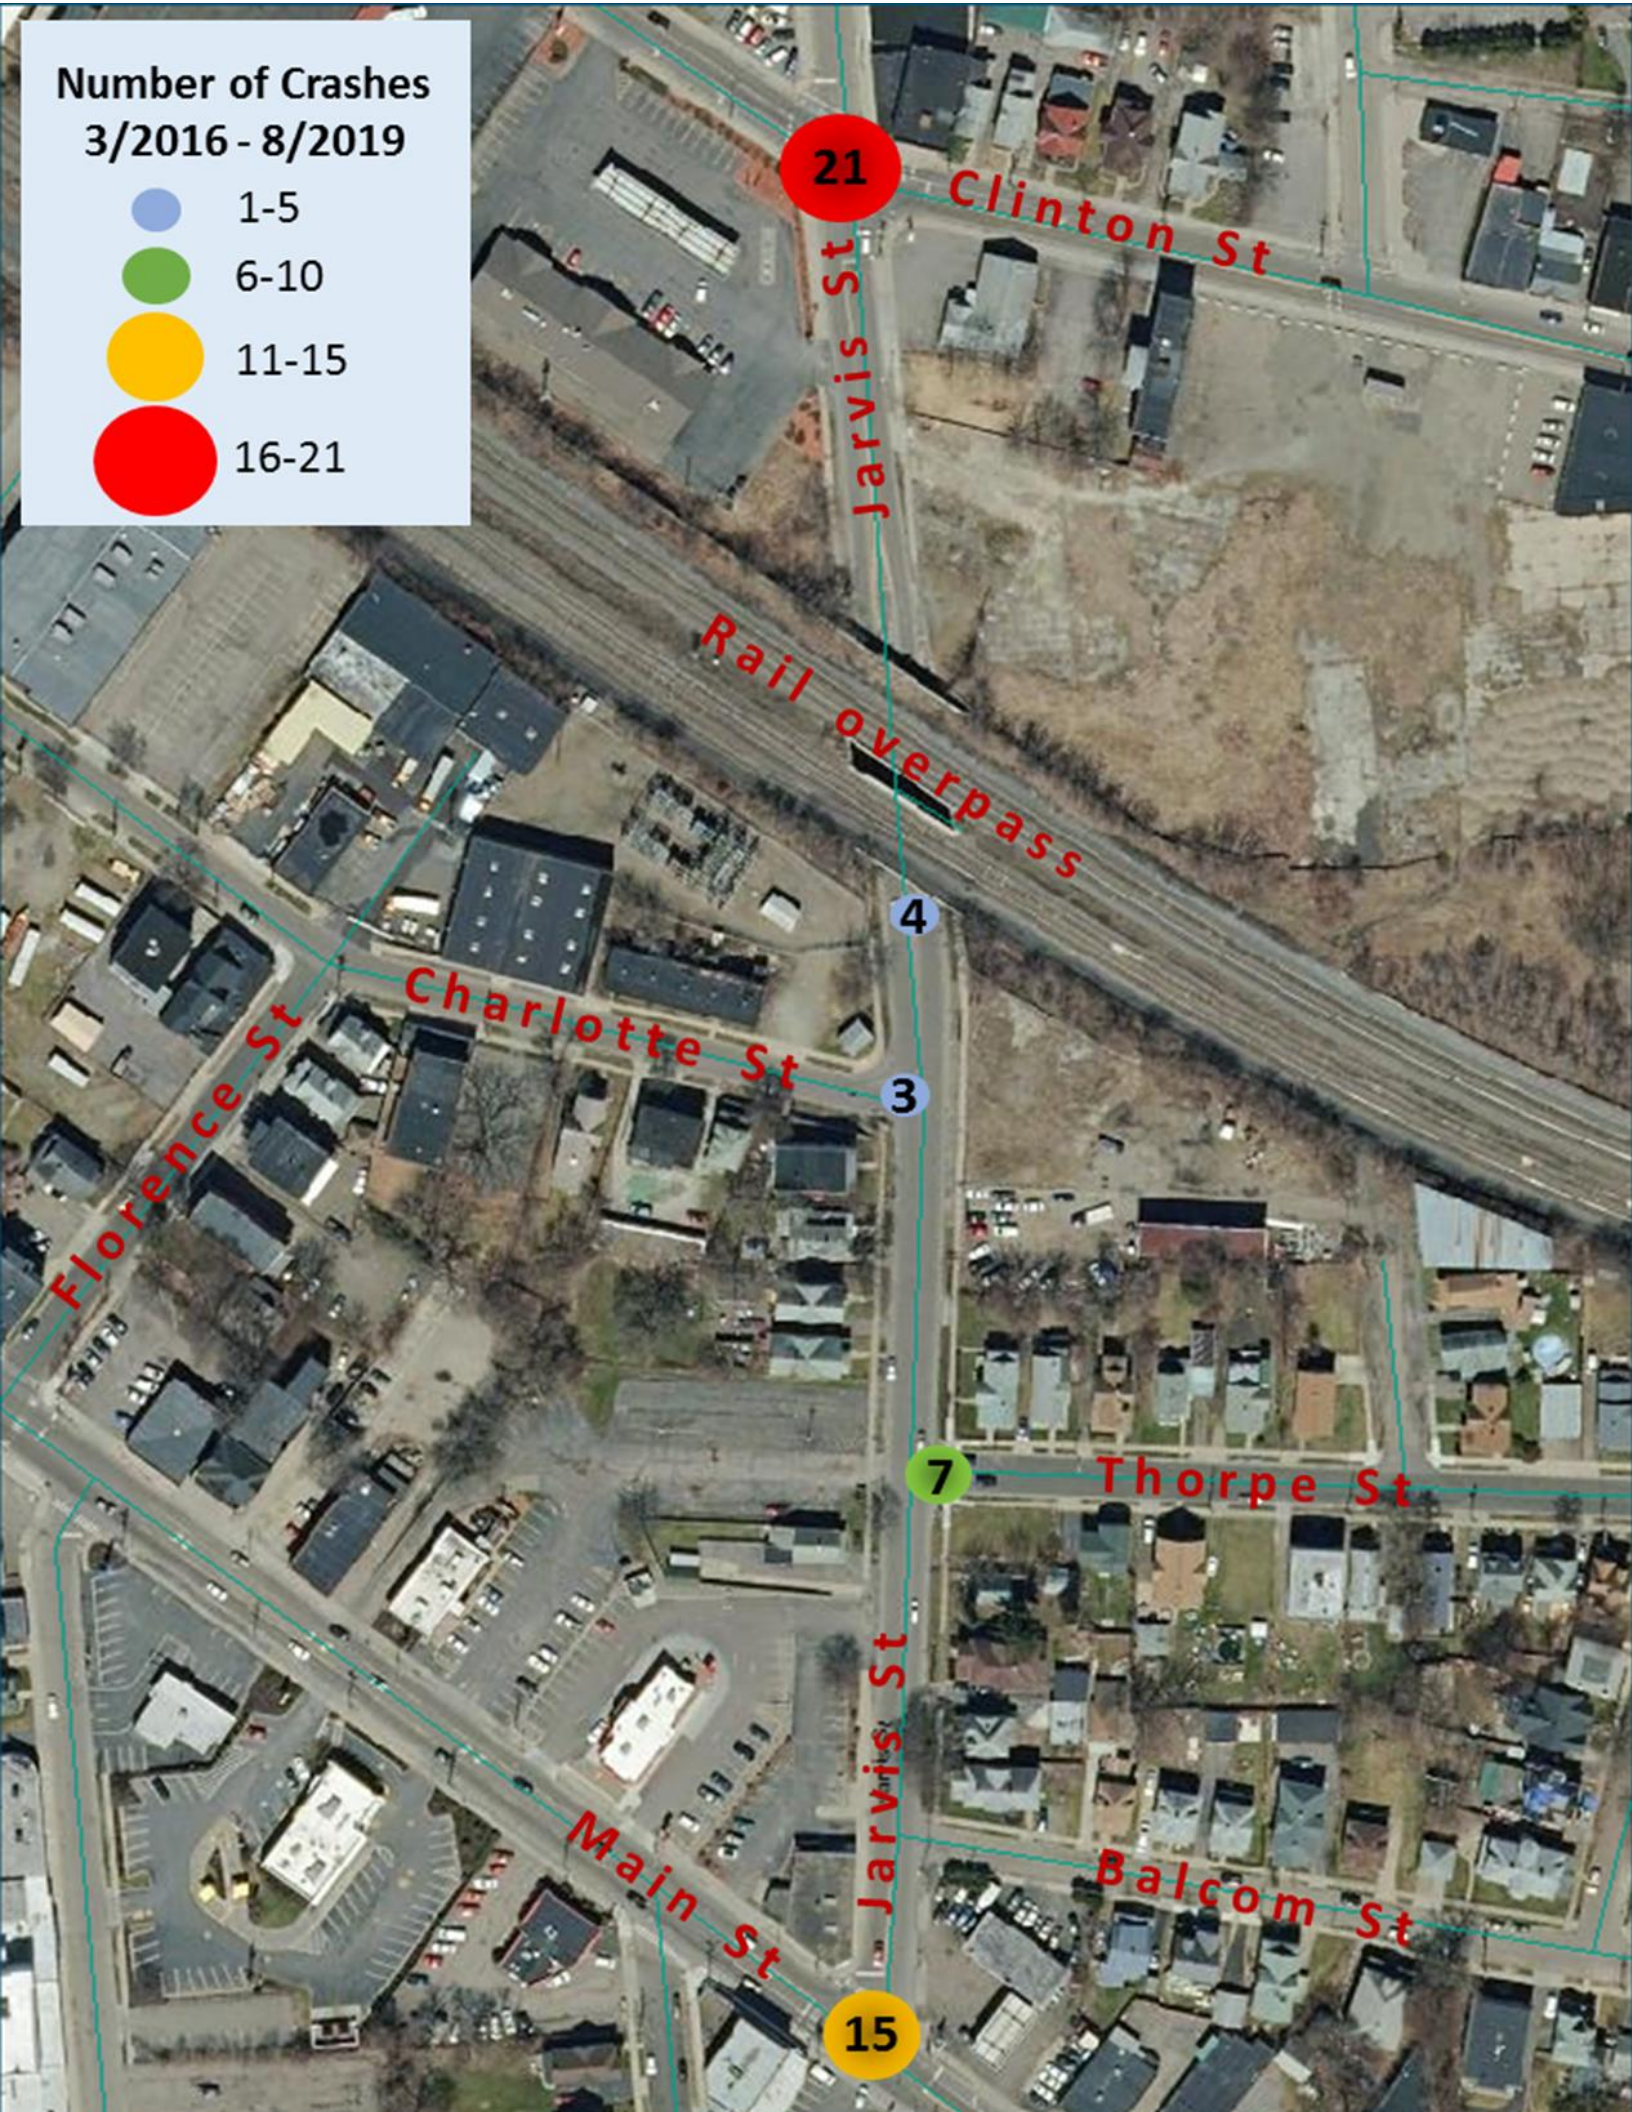
Number of Crashes
3/2016 - 8/2019

The study area involves an approximately quarter mile section of Jarvis Street between Main and Clinton Streets. The corridor contains two signalized intersections, at Main and Clinton Streets, and three t-intersections with stop signs controlling the minor streets. The segment of Main Street near Jarvis has an AADT of approximately 16,700 and Clinton Street's AADT is approximately 10,000. Jarvis Street has an AADT of 6,189. Jarvis Street is posted at 30 mph and the average speed of vehicles is 28 mph during the AM peak and 26 mph during the PM peak hours.

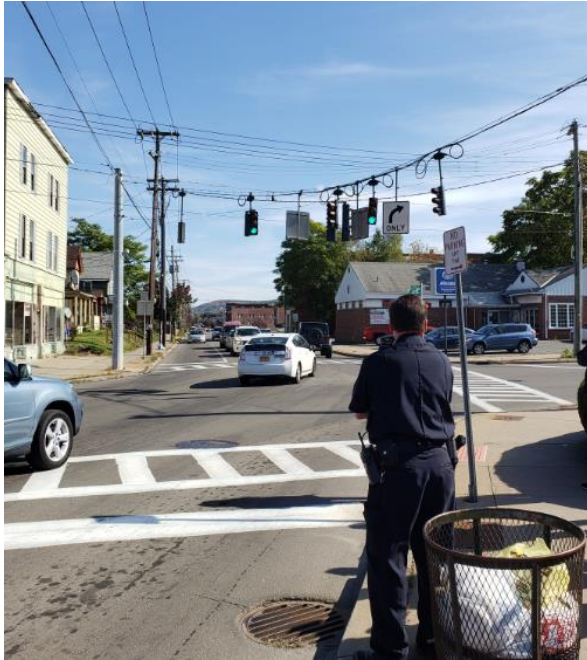
INTERSECTION OF JARVIS STREET AND CLINTON STREET

The geometry of the intersection may contribute to vehicular safety impacts. Pedestrian signals are not up to current standards.

Jarvis and Clinton Streets do not intersect at right angles. The intersection angles, coupled with visual obstructions, impedes the sight distance of drivers. Vehicles traveling east bound on Clinton are currently allowed to turn right on red to travel south bound on Jarvis. To make this turn on red, vehicles must pull out past the stop bar on Clinton Street to see on-coming vehicles traveling south bound on Jarvis.

The right most travel lanes for south, east and west bound traffic are signed as “Right Turn Only” lanes. Right turns during a red light are permitted at each approach. The travel lane configurations limit the turning radius and maneuverability of large trucks through the intersection.

The gasoline station located at the southwest corner of Clinton and Jarvis, has a curb cut that is larger than the City of Binghamton’s standard width (maximum 30’) and does not have the sidewalk extending through it. Vehicles that appear to be unlicensed are parked in the clear site triangle at the northwest corner of Clinton and Jarvis Streets.

During the three- year period that was analyzed there were numerous accidents, including four left turns and ten rear end accidents. Changes to pavement markings and signage could reduce risks. This area also has several pedestrian generators but lacks complete pedestrian accommodations at this intersection.

- Install “No Right Turn on Red” sign for east bound Clinton Street making right turns onto south bound Jarvis Street.

- Move the intersection stop bar for east bound Clinton Street traffic further back from the intersection and make it perpendicular to the curb line.
- Update pedestrian signal heads with countdown timers
- Bring gas station driveway along Jarvis Street into compliance by reducing its width to meet City standards. Continue concrete sidewalk through the driveway apron.

High, due to traffic safety issues and the high number of crashes that were observed during the three-year period analyzed for this assessment.

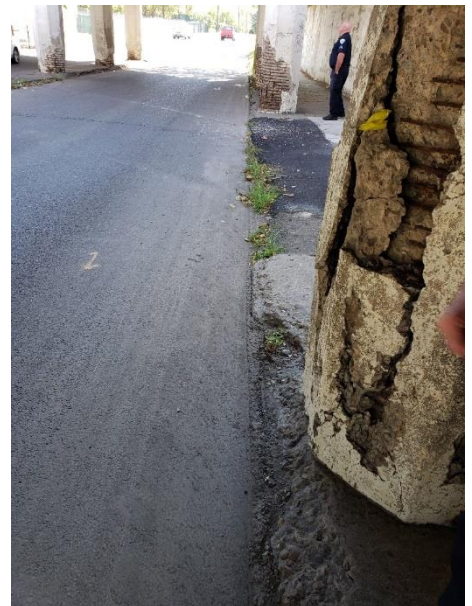
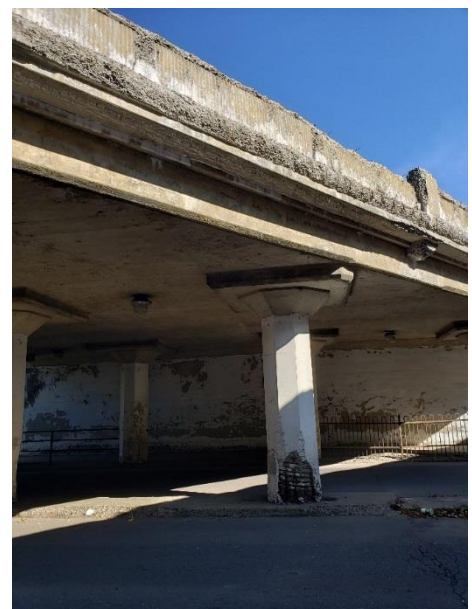
JARVIS STREET RAILROAD UNDERPASS

Basic traffic safety features and signage are missing at the railroad underpass.

The railroad underpass is in severe disrepair. Some elements, such as the structural columns and retaining walls which are crumbling, are the responsibility of the railroad owner to maintain. A structural analysis of the structural features of the overpass fall beyond the scope of this assessment. Other issues, such as curbs and street signage, fall within the jurisdiction of the City and are discussed below.

Large sections of the curb are either missing, have been paved over with asphalt, or are crumbling. Sections of the sidewalk have been paved over with asphalt and are generally in disrepair. Lighting is inadequate. Required regulatory signage of the bridge and object markers for the bridge columns are missing or inadequate. Sections of iron fencing intended to separate the sidewalk from the travel lanes are missing or in disrepair.

The lack of proper signage, object markers, curbing and lighting increase the chance of vehicular bridge strikes. Sidewalks are not ADA (Americans with Disabilities Act) compliant which reduce adequate access for pedestrians.

- Install MUTCD compliant object markers at the north bound and south bound approaches of the bridge underpass (see Attachment B)
- Install MUTCD compliant 'Keep Right' signage at south bound approach of bridge underpass consistent with the north bound approach signage (see Attachment B and image to the right).
- Install proper MUTCD compliant signage and object markers at raised island located just north of the bridge underpass.
- Replace / repair curbs
- Replace / repair sidewalks to bring them into ADA compliance
- Replace / replace iron fencing
- Update the underpass lighting

Installation of MUTCD compliant object markers and signage are high priorities. Repair of curbs and sidewalks and lighting should be a high to medium priority, whereas the fencing should be considered lower in priority.

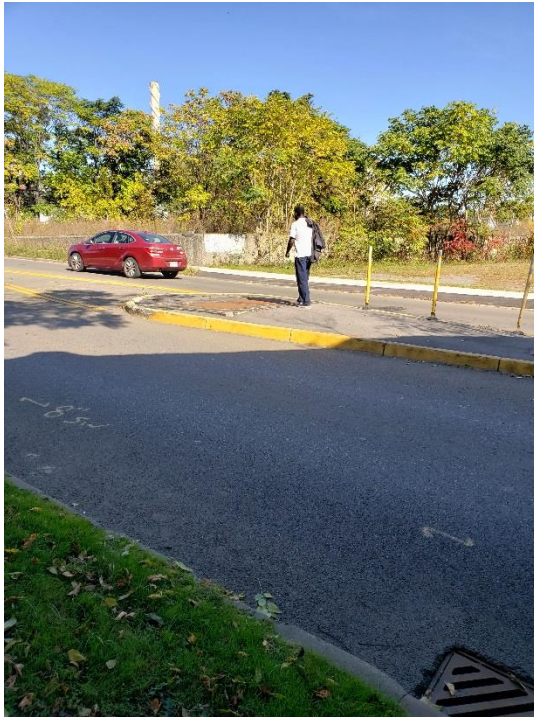
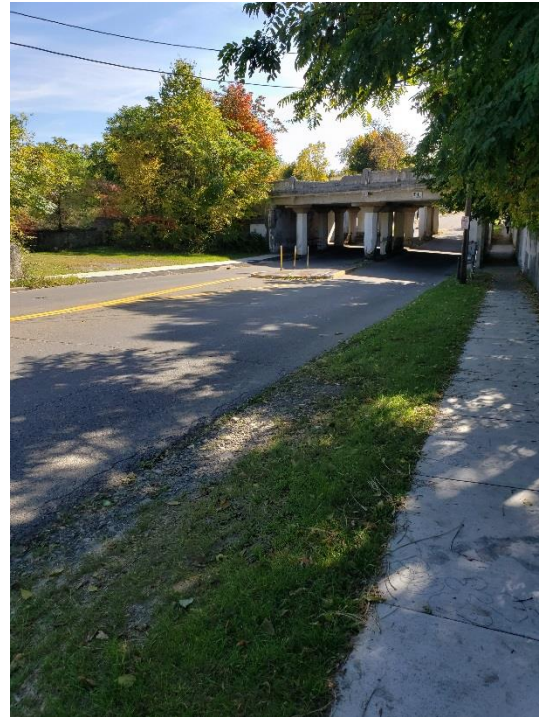
INTERSECTION OF CHARLOTTE STREET AND JARVIS STREET

Site distance for vehicles exiting Charlotte Street is limited. There is not a pedestrian crosswalk or vehicular stop bar at the intersection to protect pedestrians from vehicles approaching the stop sign on Charlotte Street.

Vehicles attempting to turn onto Jarvis Street from Charlotte Street must pull well past the stop sign to see vehicles traveling along Jarvis Street, particularly looking northbound. Given the lack of a stop bar and cross walk, not all vehicles are pulling stopping to first observe whether pedestrians are crossing Charlotte Street prior to pulling past the stop sign in order to see oncoming traffic.

The lack of adequate sight distance poses a risk to vehicles turning from Charlotte Street as well as those traveling along Jarvis Street. Pedestrians are also impacted because vehicles turning from Charlotte Street may not be stopping to observe pedestrians attempting to cross Charlotte Street.

During the three-year crash analysis period that was reviewed there were two left turn crashes at this intersection and one pedestrian involved crash.

- Paint a ladder style crosswalk across Charlotte Street at the intersection with Jarvis Street.
- Paint a vehicular stop bar along Charlotte Street in advance of the crosswalk.

High

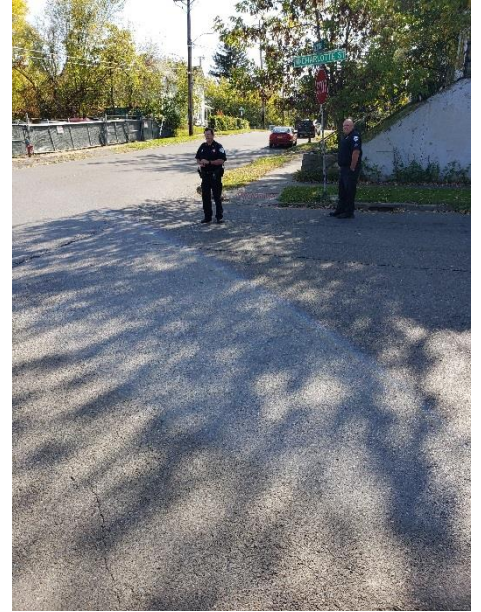
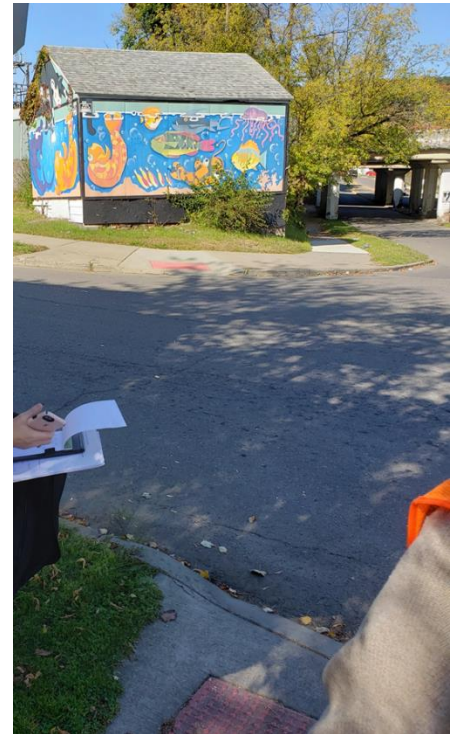
INTERSECTION OF JARVIS STREET AND THORPE STREET

Pedestrian and bicycle safety is of primary concern due to lack of crosswalks and conflicts with vehicles due to private driveway configurations.

There are no crosswalks at the intersection of Thorpe and Jarvis Streets. There is a driveway entrance for a fast food restaurant (Wendy's) just opposite this intersection, which likely compels pedestrians to cross midblock. The driveway for Popeye's, just south of this intersection, does not meet several City standards, including width requirements and materials, and does not include adequate pavements markings.

Pedestrian and bicycle safety are of primary concern due to lack of crosswalks and conflicts with vehicles due to private driveway configurations.

- Paint a ladder style crosswalk across Thorpe Street at the intersection with Jarvis Street.
- Paint a ladder style crosswalk across Jarvis Street, just north of the Thorpe Street intersection.

- Install ADA compliant curb ramps connecting the above suggested crosswalk across Jarvis Street to connect to the sidewalks on either side of Jarvis Street.

- A "Private Driveway" sign should be installed at the Wendy's parking lot entrance and pavement marking in the parking lot should be repainted to better direct traffic (the City should work with the property owner to address these suggestions).
