Road Safety Assessment Hooper Road

BEATRICE LANE TO PRUYNE STREET

BINGHAMTON METROPOLITAN TRANSPORTATION STUDY

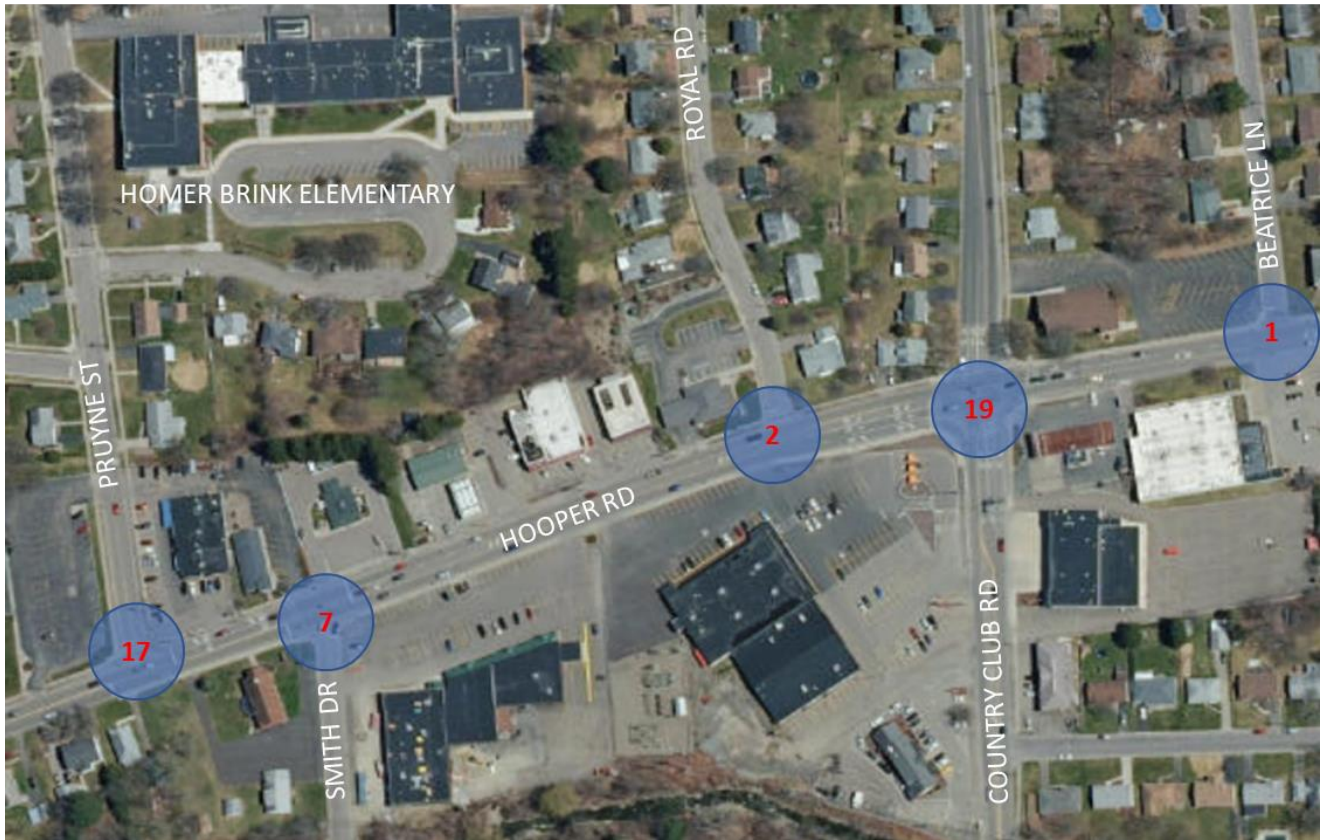
MAP 1: DISTRIBUTION OF INSECTION CRASHES*

A crash analysis, for a three-year period between January 2017 through December 2019, was conducted. The data indicates there were 42 total intersection crashes. Pruyne Street, Smith Drive and Country Club Road experienced intersection collision rates that exceed typical statewide averages for similar facilities (see Map 1). Many of the accidents were rear end collisions which are typically attributed to traffic congestion. In addition, there were 15 additional crashes along the segment not attributed to an intersection. These crashes primarily involved vehicles entering and existing Hooper Road from commercial parking lots. Please see appendix A for the complete crash analysis.

*Illustrates location of 42 intersection crashes from Jan. 2017 – Dec. 2019; does not include 15 additional crashes not attributed to an intersection. See appendix A for complete crash analysis.

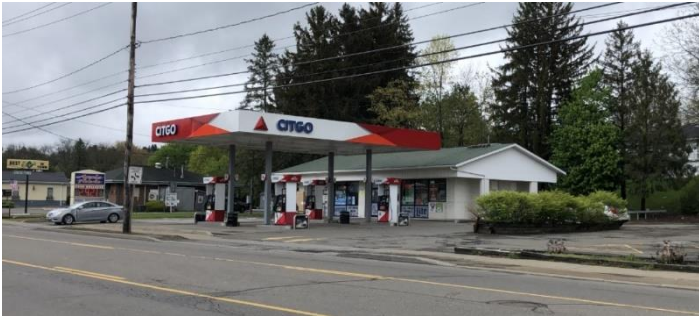
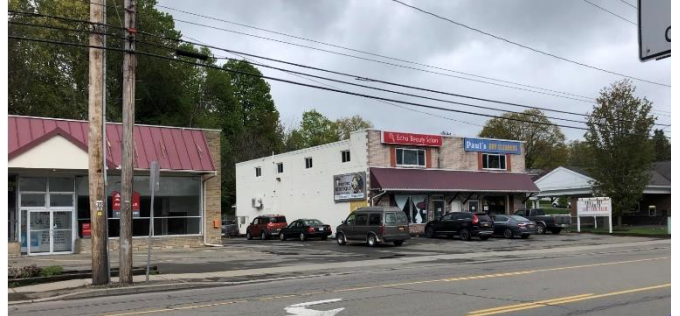
516-522 Hooper Road access

- 516-522 Hooper Road. These three commercial sites have approximately 330 feet of frontage on Hooper Road, with approximately 186 feet of that frontage being open to vehicular access. In fact, the entire length of 516 Hooper is open to the street with parking spaces situated so that vehicles are

potentially backing over the sidewalk and into oncoming traffic. These sites appear to informally share access.

Risk Analysis: Traffic and pedestrian safety impacts and congestion due to the volume and location of access points

- **Implement Access Management techniques.** Managing access by defining the location, number, spacing and design of access points from private properties to streets can reduce conflicts between turning vehicles, through traffic, pedestrians and cyclists. Remove abandoned curb cuts.

- **Bring driveways and parking areas into compliance with Section 300 51.6 of the town of Union zoning code.** At a minimum, driveways should be brought into compliance with the Town's zoning code, as well as parking areas to the extent practicable.

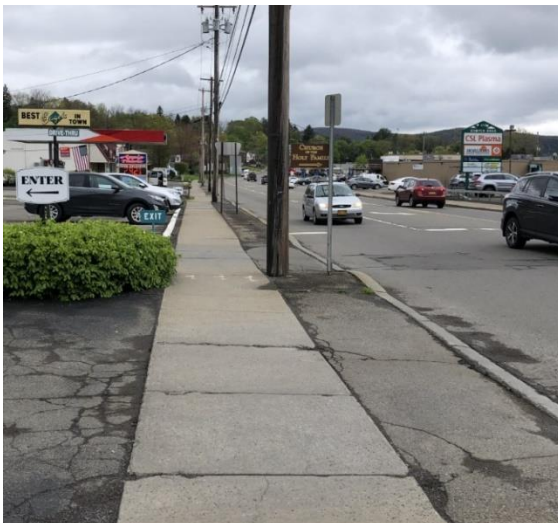
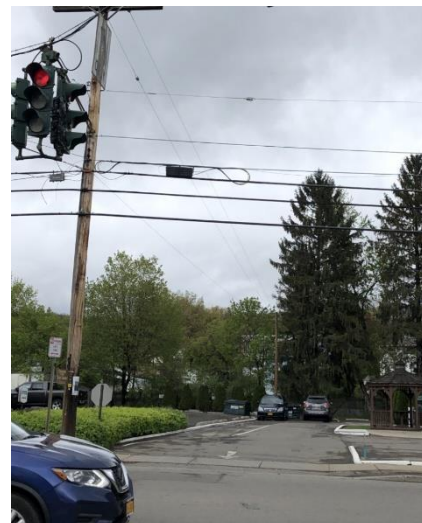
526-532 Hooper Road Access

- Hooper Road Plaza southern driveway, and Rite Aid northern driveway. These driveways are very close together and the parking lots they serve are only separated by a metal highway barrier.
- 520 and 532 Hooper Road. There are abandoned curb cuts in front of the buildings at these locations.
- 526-534 Hooper Road. There are 6 driveways (including the above-mentioned abandoned driveway) between these sites. At 526 Hooper Road (currently Best Bagels) the exit driveway comes out immediately across from Smith Drive. Although there is currently a signal at Smith and Hooper, there is not a signal head facing this exit driveway which creates traffic conflicts. Opportunities exist to share access between these businesses and to remove curb cuts as a result. It appears that access may already be shared (at least informally) between 532 and 534 Hooper.

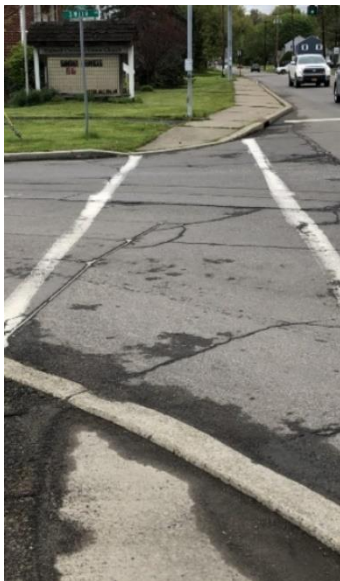
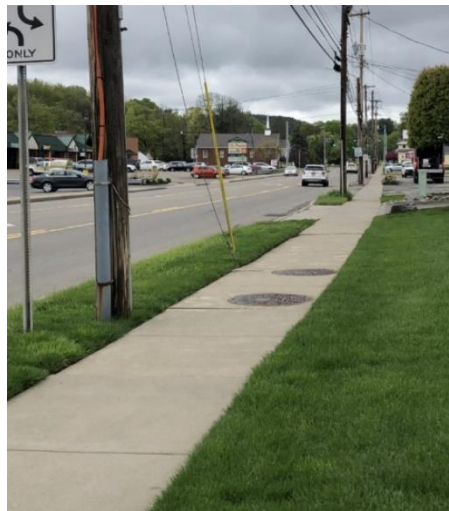
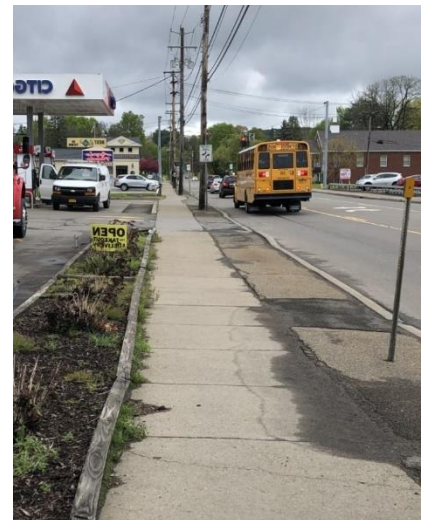
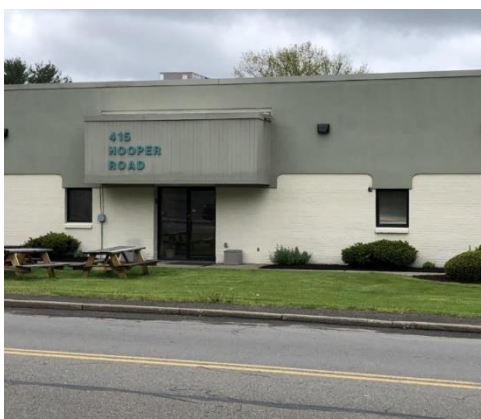
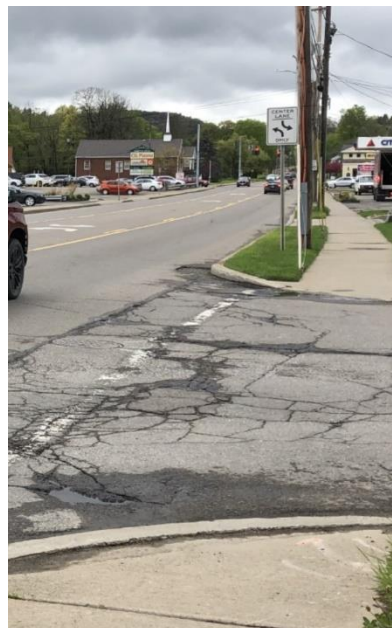
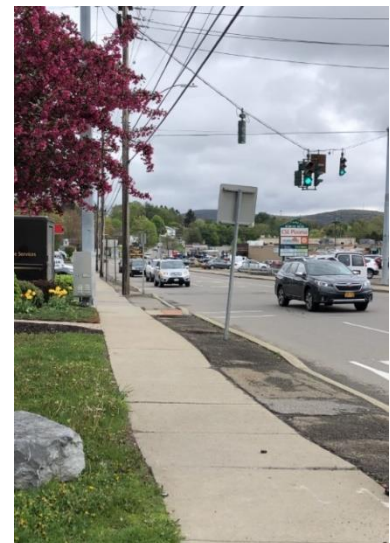
Sidewalk and Curb Ramps - various conditions

Incomplete Pedestrian Accommodations: The traffic signals at Smith Drive and Pruyn Street do not include adequate pedestrian accommodations. Most of the curb ramps and painted crosswalks are not compliant with ADA standards.

There is no sidewalk on the west side of Hooper Road between Country Club and Beatrice Lane (along 418 Hooper Road), although there is a path which indicates that people do walk there. The remainder of the corridor has concrete sidewalks that are generally in good repair. However, there are opportunities to either widen the sidewalks or create landscape buffers where utility strips have been paved with asphalt.

Risk Analysis: Pedestrian safety

- **ADA compliance.** Bring all curb ramps, crosswalks and pedestrian signals into ADA compliance.
- **Sidewalk improvements.** Install a concrete sidewalk along the west side of Hooper Road between Country Club and Beatrice Lane. Widen concrete sidewalks or install landscape buffers in utility strips that have been paved with asphalt.

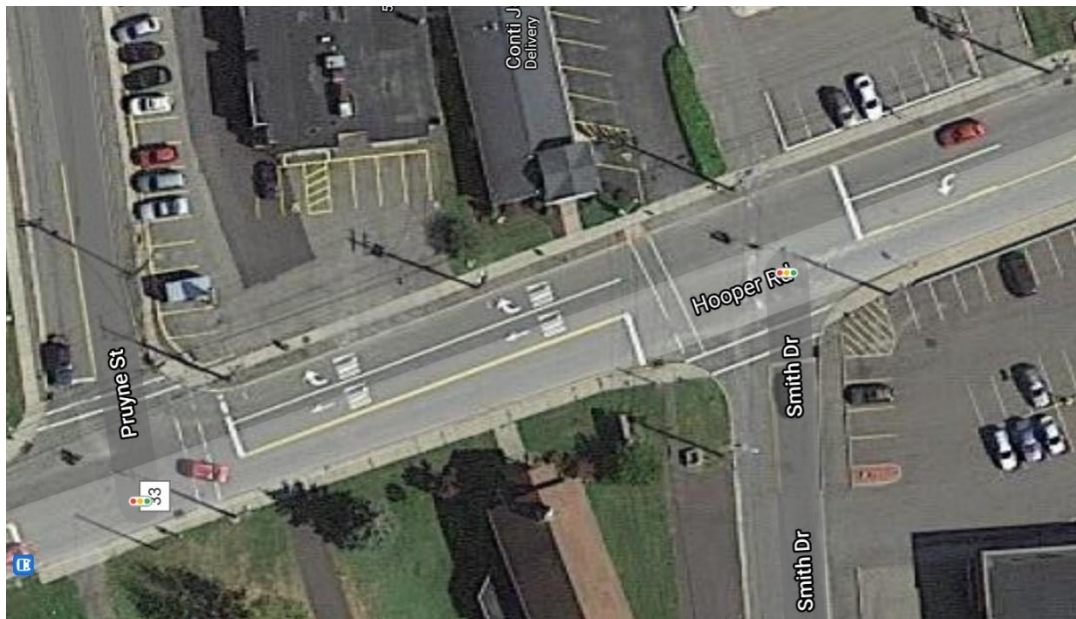
These two signalized intersections are very close together and resulting in a short transition between the lane configurations in the northbound direction. There is a curb cut at 526 Hooper Road (currently Best Bagels) which leads directly to the Smith and Hooper intersection, however there is no signal head oriented in the direction of this driveway.

Lane Changes between Smith and Pruyne (Google Maps)

Risk Analysis: Traffic and pedestrian safety impacts and congestion due to the proximity of the traffic signals and the shifting lane configurations.

Remove the traffic signal at Smith Drive. An in-field go-day signal removal study would need to be completed and any resulting traffic impacts considered prior to removal. In concert with the signal removal, implement Right In/Right Out Only turning movements between Smith and Hooper with the use of signage (and channelization if necessary); remove stop bars on Hooper Road and reconfigure lane striping on Hooper Road.

A signal warrant analysis was conducted to determine the impacts of removing the signal at Smith Street in favor of right in/right out only access to and from Smith Drive. The analysis found that there would be little to no impact on the surrounding intersections and while traffic operations at Smith and Hooper would improve. Specifically, at current operating levels the Smith and Hooper intersection is currently

operating at a Level of Service (LOS) B and the Country Club intersection is also operating at a LOS B (D or better is favorable). With the removal of the signal LOS at Smith and Hooper would improve to an A and Country Club would remain at B.
