TRAFFIC SIGNAL STUDY

VILLAGE OF JOHNSON CITY
BROOME COUNTY, NY

June 2020

Binghamton Metropolitan Transportation Study

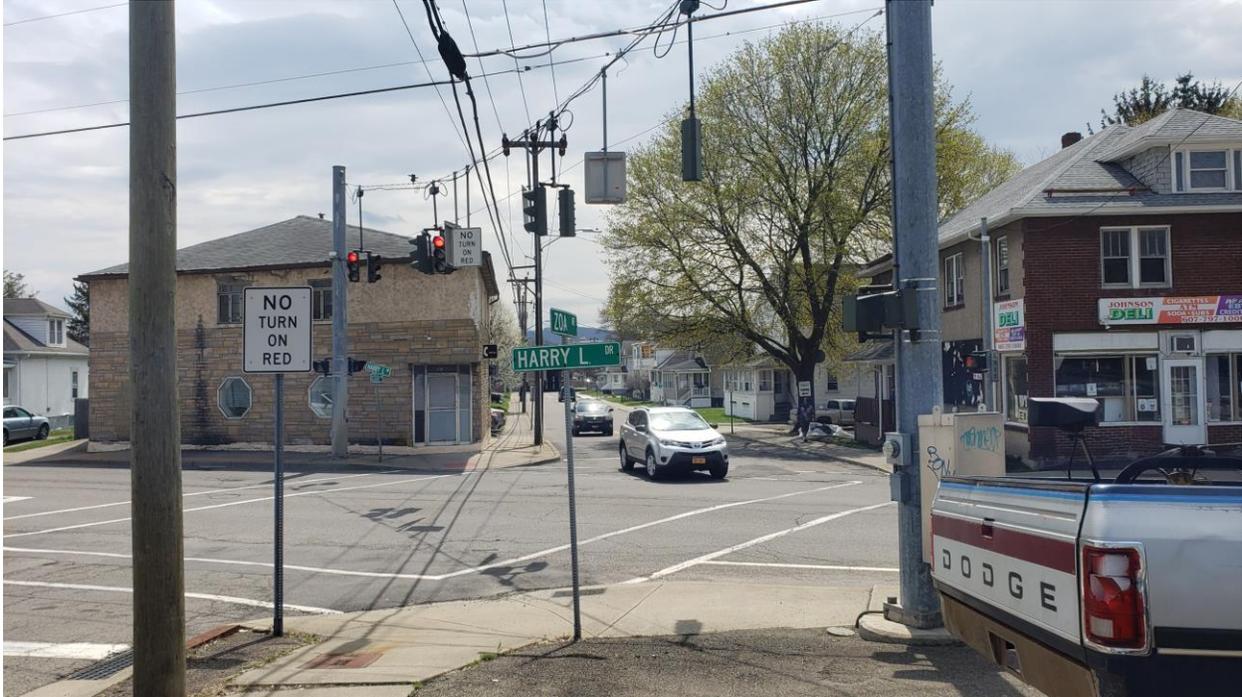
1. Harry L. Drive / Lester Avenue/ Zoa Avenue

Harry L. Drive / Lester Avenue / Zoa Avenue is a four-legged, slightly off-set intersection with Lester Avenue and Zoa Avenue being the minor street with low traffic volumes. None of the signal warrants are met. Traffic volumes are low and most crashes that occurred during the three-year period were not correctable with a signal. However, signal removal is not recommended due to the limited sight distance at the intersection. The signal is actuated, so the delays at the intersection are minimal. Pedestrian access at the intersection could be improved with count down pedestrian signals and ADA (Americans with Disabilities Act) accessible curb ramps on all corners. This intersection received a rating of 3 in the Johnson City ADA Transition Plan.

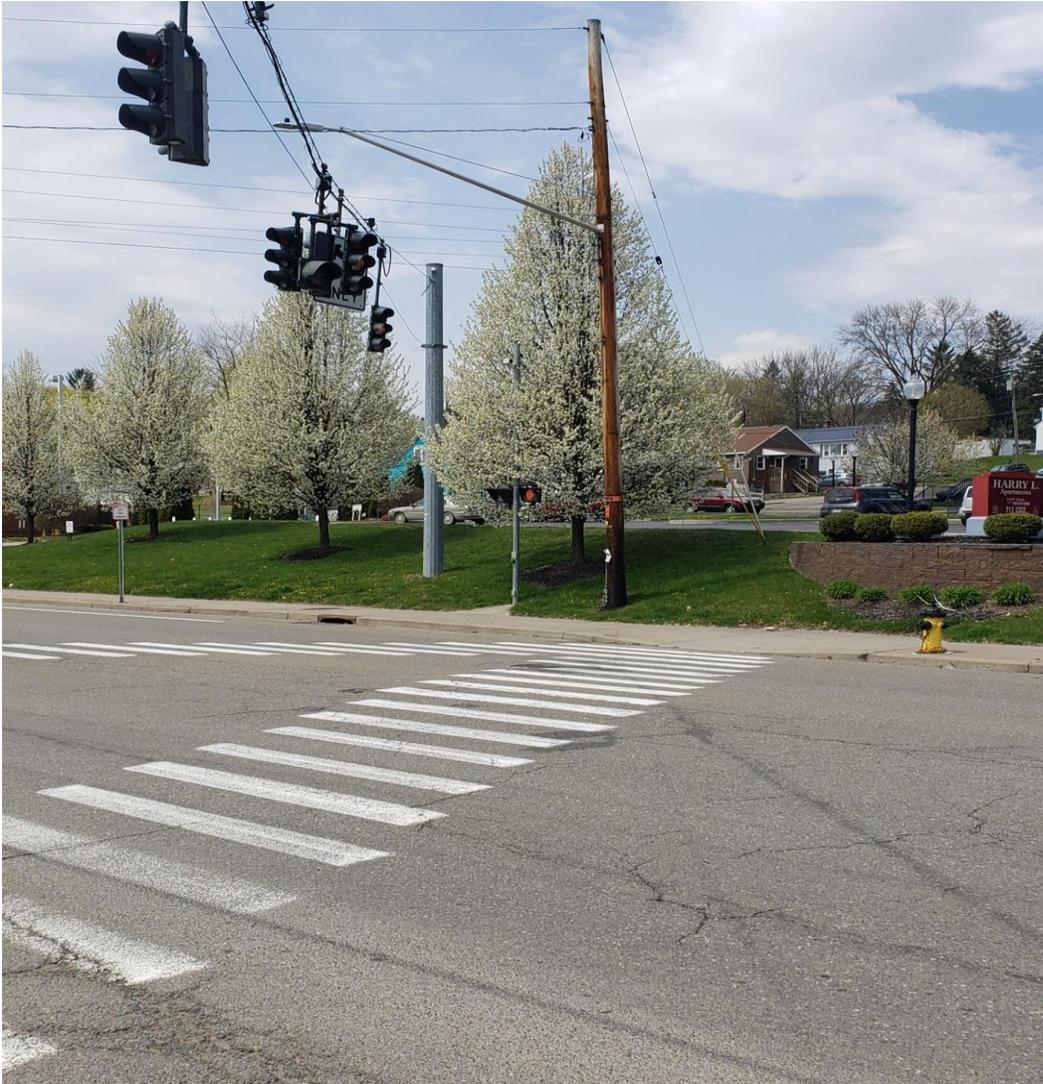
2. Harry L. Drive / N.Broad Street

Harry L. Drive and N.Broad Street is a T-intersection with a low volume of traffic on Broad Street. There were no crashes at the intersection that could be attributed to the traffic signal. Sight distance at the intersection is adequate. The signal warrants at the intersection are not met.

The intersection was probably signalized when the C Fred Johnson Elementary School was operational. The school has been closed and is now senior living housing. The signal is not being recommended for removal because of the pedestrian activity generated by this housing complex. The intersection has cross walks, some ADA curb ramps and countdown signals. It received an ADA rating of 3. The only other recommendation for this intersection is to consider the installation of a "No Right Turn on Red" sign for northbound N.Broad Street. A no right turn on red sign is recommended because of the seniors from the Harry L. Apartments and the residents of the apartment complex on the north east corner of the intersection. Section 2B.54, No Turn on Red Signs (R10-11), of the MUTCD, states that the signs should be considered if there are pedestrian conflicts, especially with children or older adults. Motorists tend to look to their left for approaching traffic and may not notice pedestrians on their right. Motorists tend to pull into the crosswalk to wait for a gap in traffic, blocking pedestrian crossings.

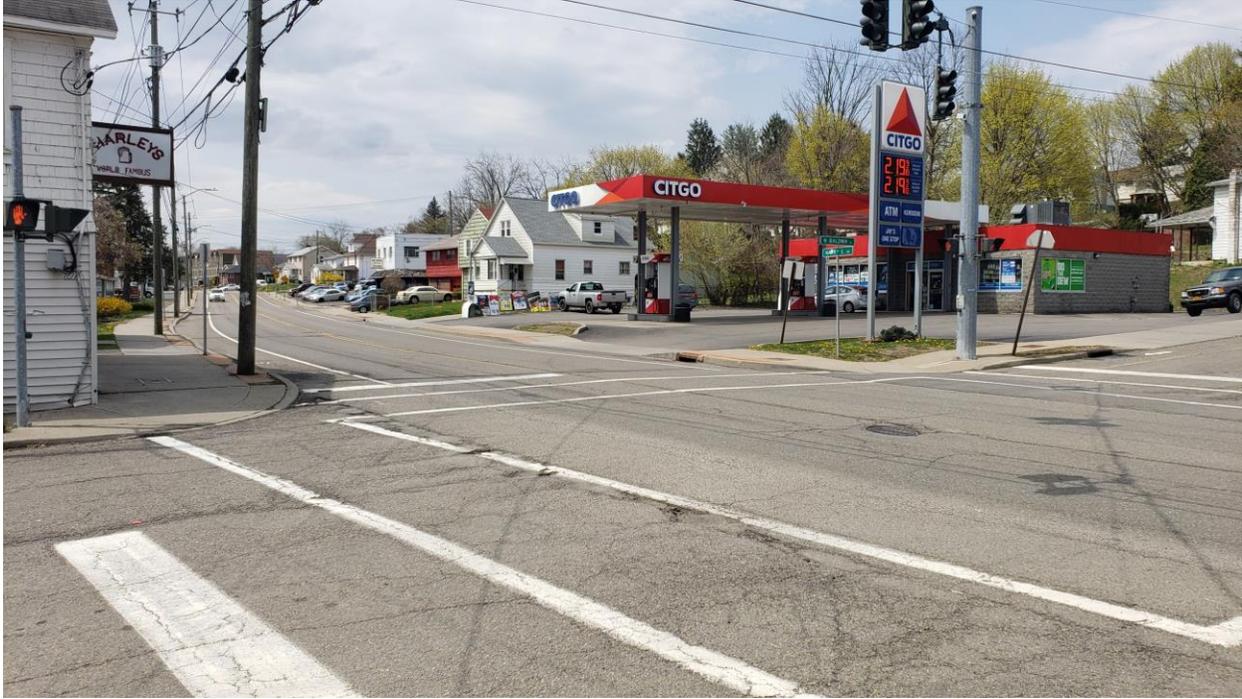
3. Harry L. Drive / N. Baldwin Street

Harry L. Drive / N. Baldwin Street is four-legged intersection with Baldwin Street being the minor road with low traffic volumes. The crash warrant is not met for this intersection, but there was one pedestrian crash during the study period. Overall, signal warrants are not met. The signal is not recommended for removal due to sight distance limitations caused by the buildings on the southside of the street. The signal is actuated so there are minimal delays at the intersection.

Pedestrian improvements that could be made are count down signals and high visibility cross walks and curb ramps. It received a rating of 3 in the ADA Plan.

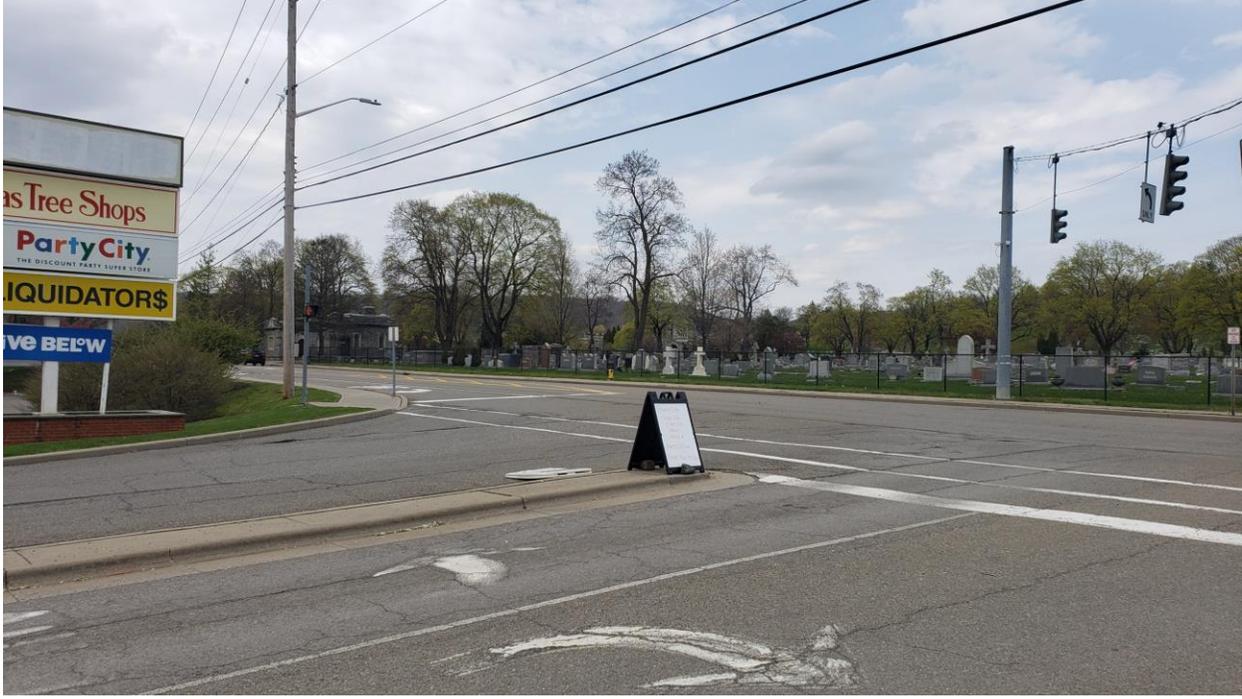
4. Harry L. Drive / Christmas Tree Plaza

The intersection is a T-intersection of Harry L. Drive and the Christmas Tree Plaza driveway. This signal was installed when the retail development was first built and included Toys R Us. Toys R Us has since closed and the volume of traffic into this area has decreased. The signal warrants at this intersection are not met. The incidence of crashes is low with only 2 rear-end type accidents occurring in the three-year study period. The signal is actuated, so the vehicular

delays are minimal. There are pedestrian signals at the intersection, but they are not count down signals. ADA ramps are needed. It has an ADA rating of 1.

The signal is not recommended for removal at this time. However, if retail occupancy decreases or land use changes occur at this site, the signal need should be reevaluated. Count down pedestrian signals, ADA ramps and high visibility crosswalks should be added along with restriping worn pavement markings.

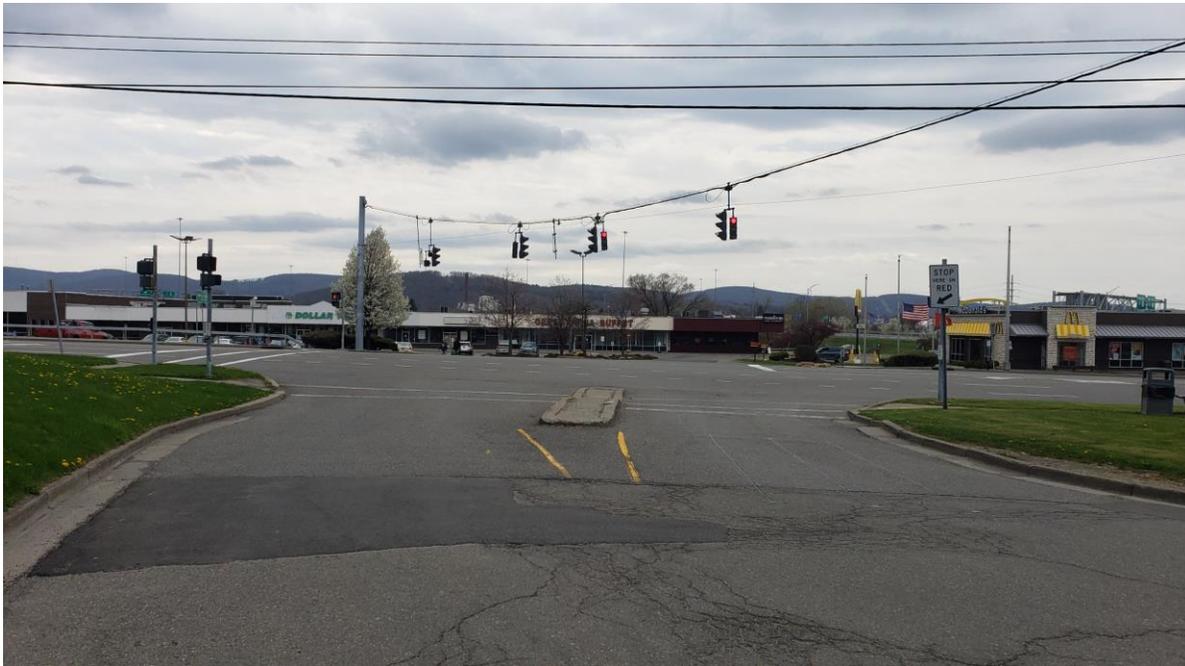
6. Harry L. Drive / Wegmans Entrance / Oakdale Mall

This four-legged intersection is the main entrance to Wegmans on the south side of the intersection and on the north side of the intersection is one of the two main entrances to the Oakdale Mall. Traffic volumes at this intersection have decreased over the last few years because of retail closures at the Mall. However, signal warrants are met at this intersection due to the high volume of traffic generated by Wegmans. During peak periods traffic going into Wegmans sometimes creates long queues of vehicles sometimes even backing up to the adjacent Harry L. Drive Reynolds Road intersection. One possibility to mitigate this condition is

there 6 right angle and 6 left turn accidents that occurred in the three-year study period. Due to these factors and the configuration of the intersection, signal removal is not recommended.

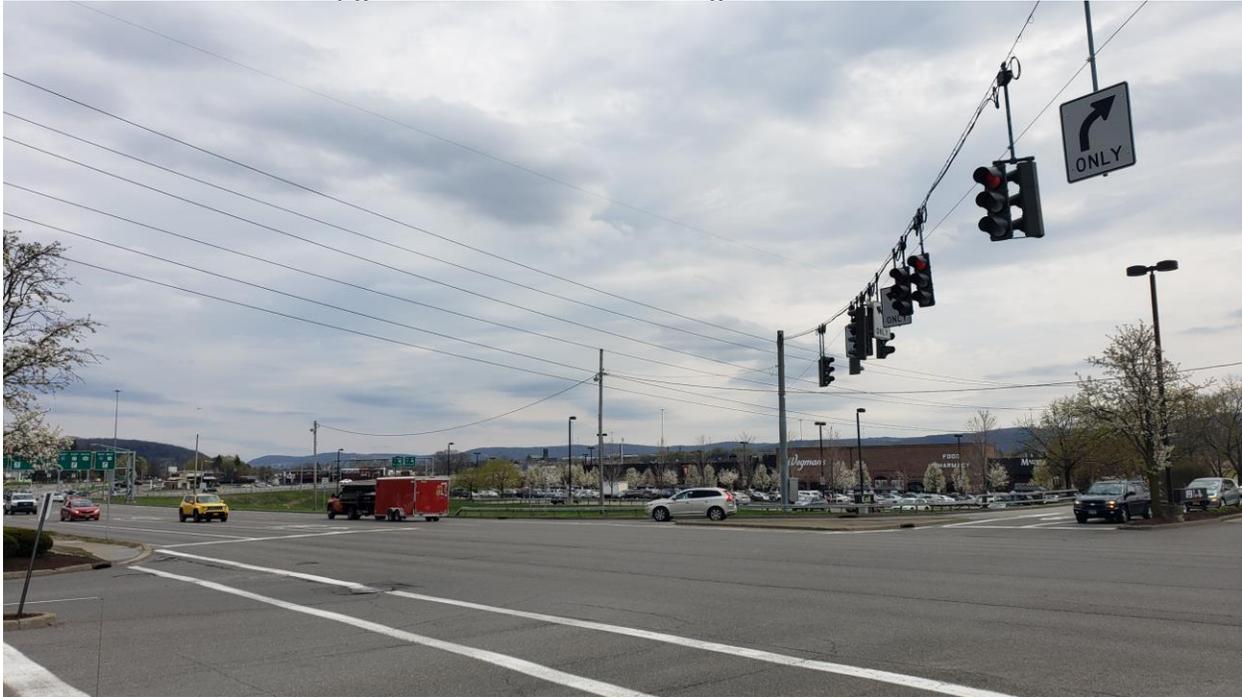
to create a double left into Wegmans. There are pedestrian signals at the intersection, but the intersection needs ADA upgrades. It has an ADA rating of 4.

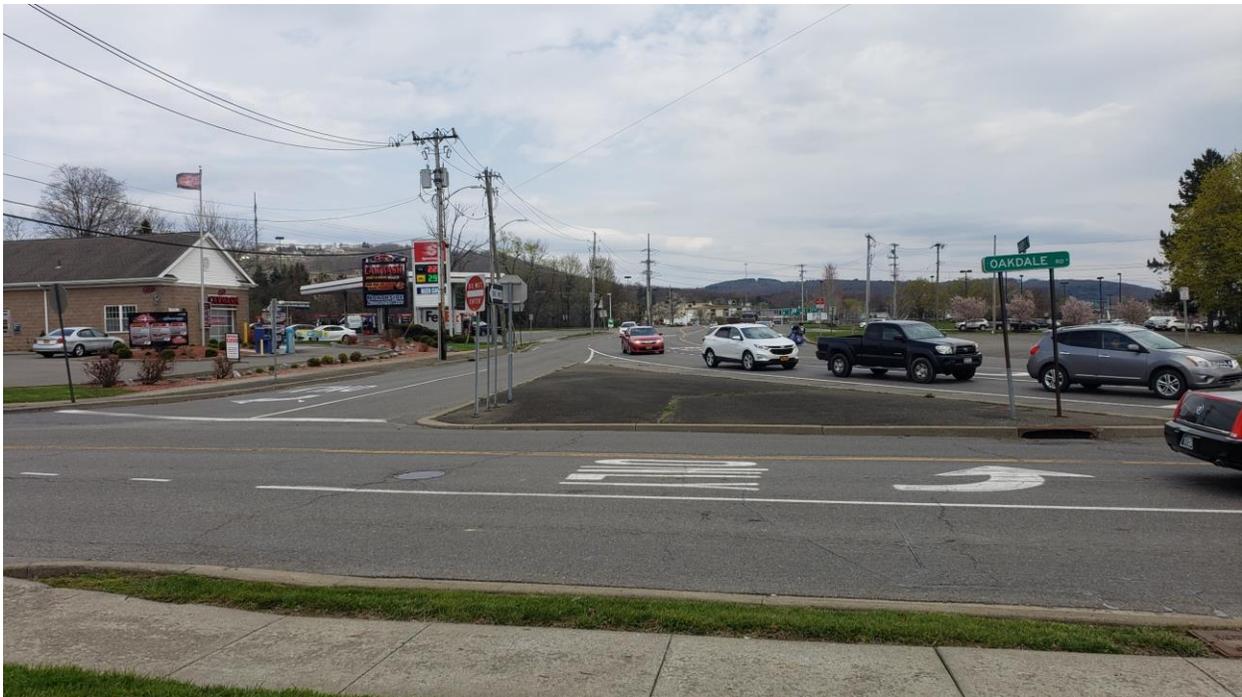
7. Harry L. Drive / Oakdale Road

Harry L. Drive and Oakdale Road is a four-legged intersection but does not have the typical configuration. The westbound right turn is stop sign controlled and separated by an island from the signalized portion of the intersection. This intersection, while not totally meeting the signal warrants, does come close to the volume warrants, and while not meeting the accident warrant

The intersection does need pedestrian improvements. There are no pedestrian signals, crosswalks or ADA curb ramps. There are sidewalks in this area and many pedestrian generators. The intersection has an ADA rating of 2.

This intersection would be an appropriate place for a roundabout if the Village was interested in a future project that could eliminate the awkward configuration of the intersection, eliminate the signal, improve pedestrian access and reduce accidents.

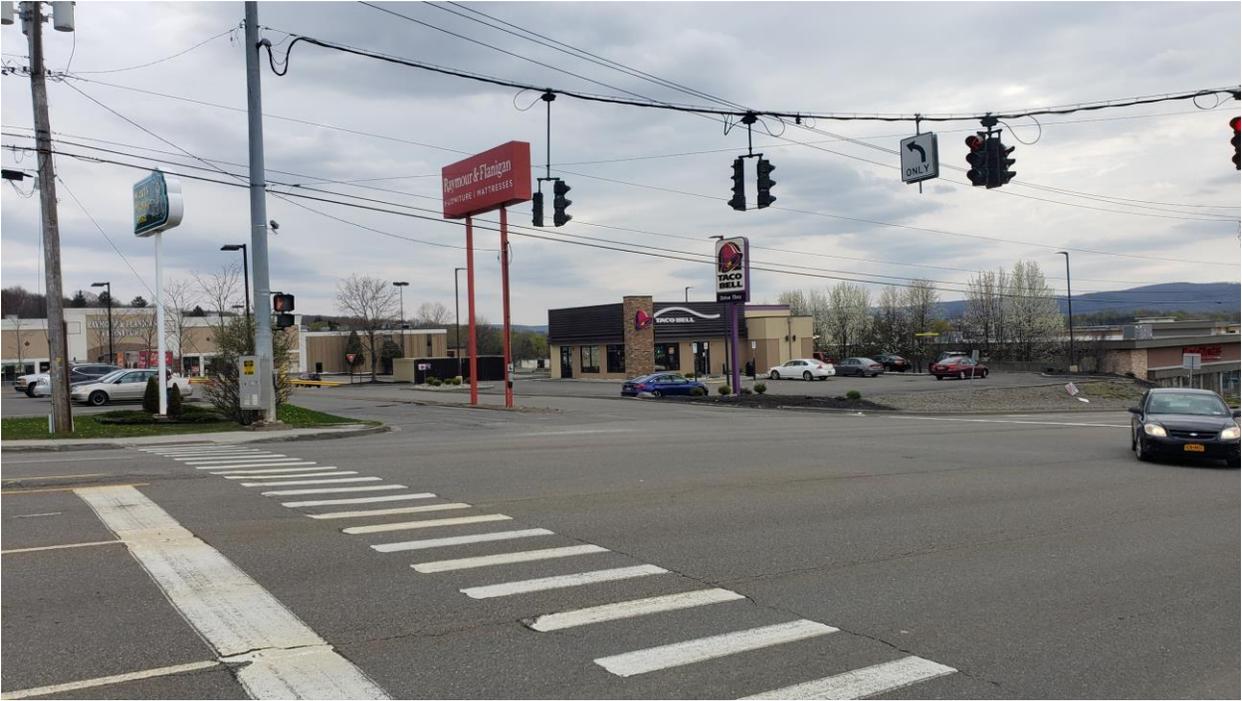
10. Grand Avenue / Willow Street

The intersection of Grand Avenue and Willow street is a four-legged intersection with fairly even traffic volumes on each approach. The intersection had one accident during the study period, and it was a bicycle accident. The signal warrants at the intersection are not met. However, because the sight distance at the intersection is limited the signal is not recommended for removal.

The signal at this intersection is fully actuated and it rests in an all red phase when there are no vehicles traveling through the intersection. It operates like an all way stop. The delays at the intersection are minimal. There are pedestrian signals and ADA curb ramps. High visibility crosswalks are recommended. It has an ADA rating of 5.

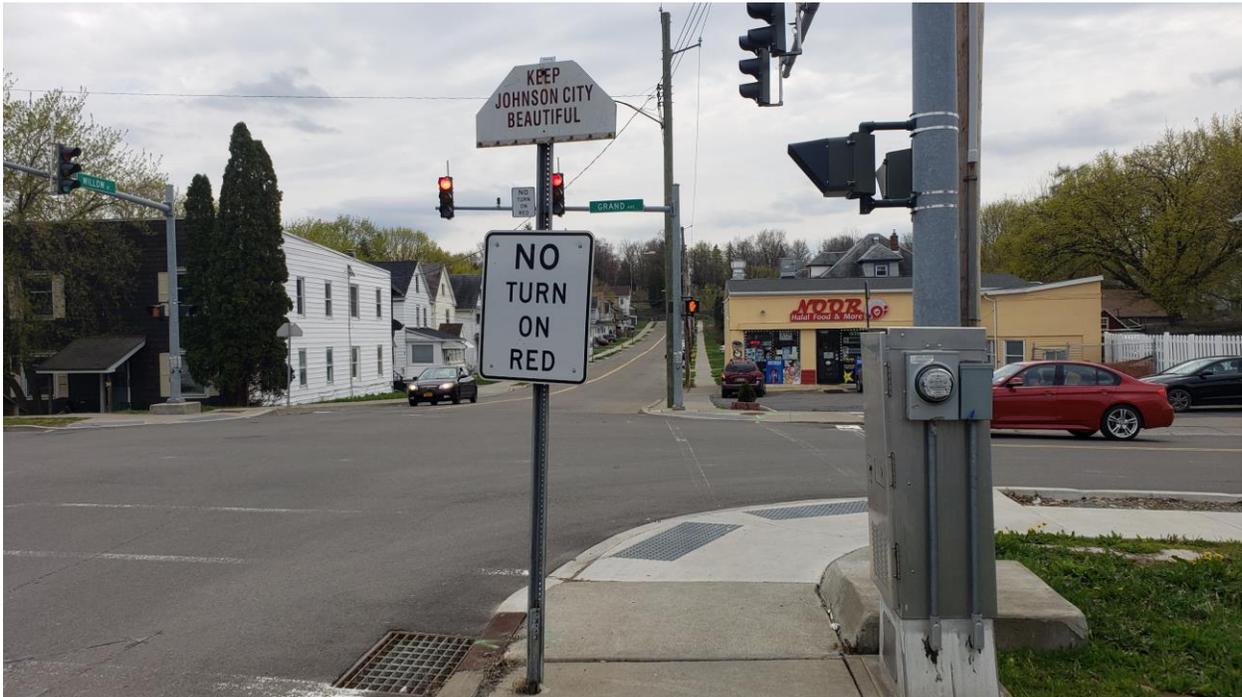
11. Grand Avenue / Baldwin Street

Grand Avenue and Baldwin Street is a four-legged intersection with Baldwin Street being the higher volume road. There were two accidents at the intersection during the study period with one being a pedestrian accident. Signal warrants are not met at this intersection. Like the intersection of Grand Avenue and Willow Street there is limited sight distance, so the signal is not recommended for removal.

The signal at this intersection was replaced at the same time as the signal at Grand Avenue and Willow Street. It operates in the same manner with the signal being fully actuated and resting in an all red phase. There are pedestrian signals and ADA curb ramps. Adding high visibility crosswalks is the only recommendation. It has an ADA rating of 4.

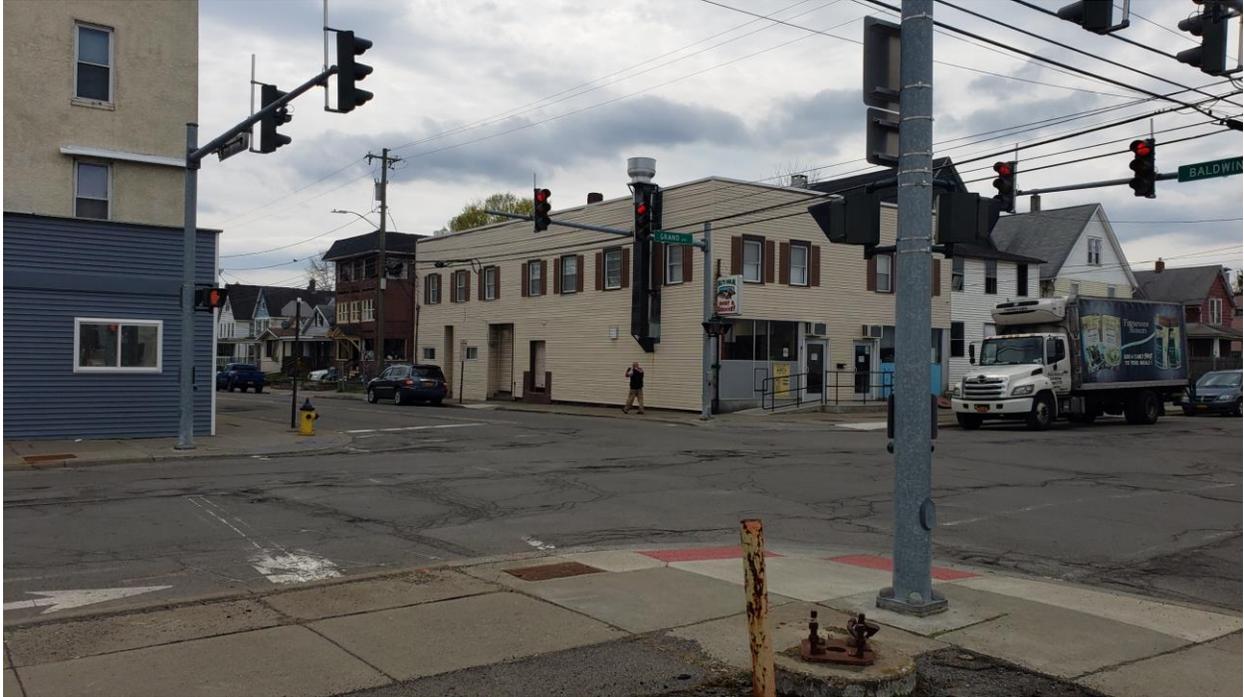
12. Floral Avenue / Burbank Avenue

Floral Avenue and Burbank Avenue is a four-legged intersection with restricted sight distance at the intersection from the stone wall at the Floral Avenue Cemetery. The signal does not meet warrants but is not recommended for removal because of the sight distance issue. During the study period there were 10 crashes at the intersection: 2 rear-end, 3 right-angle, 1 left turn, 2

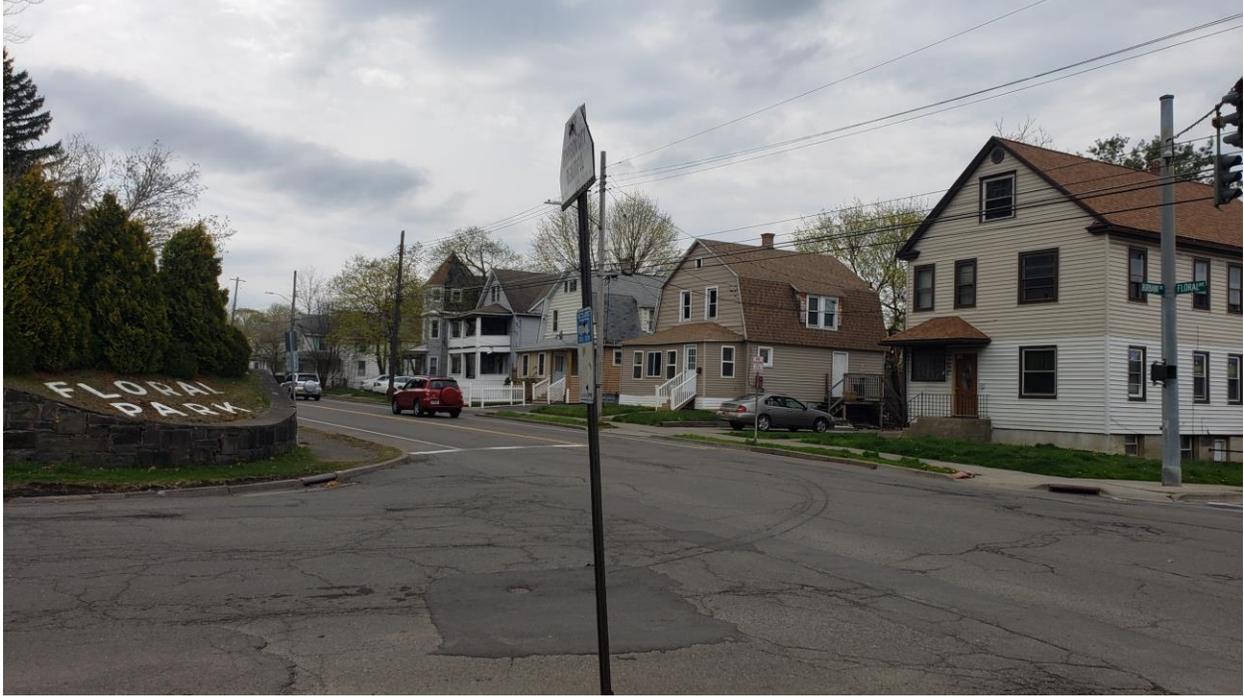
parking/backing crashes and one bicycle crash and one overtaking/sideswipe crash. There were no clusters or patterns of crashes.

The operation of the signal could be improved with the installation of an actuated traffic signal. There are pedestrian signals, but these should be upgraded with countdown signals. ADA curb ramps are needed as are high visibility crosswalks. The ADA rating is 2.

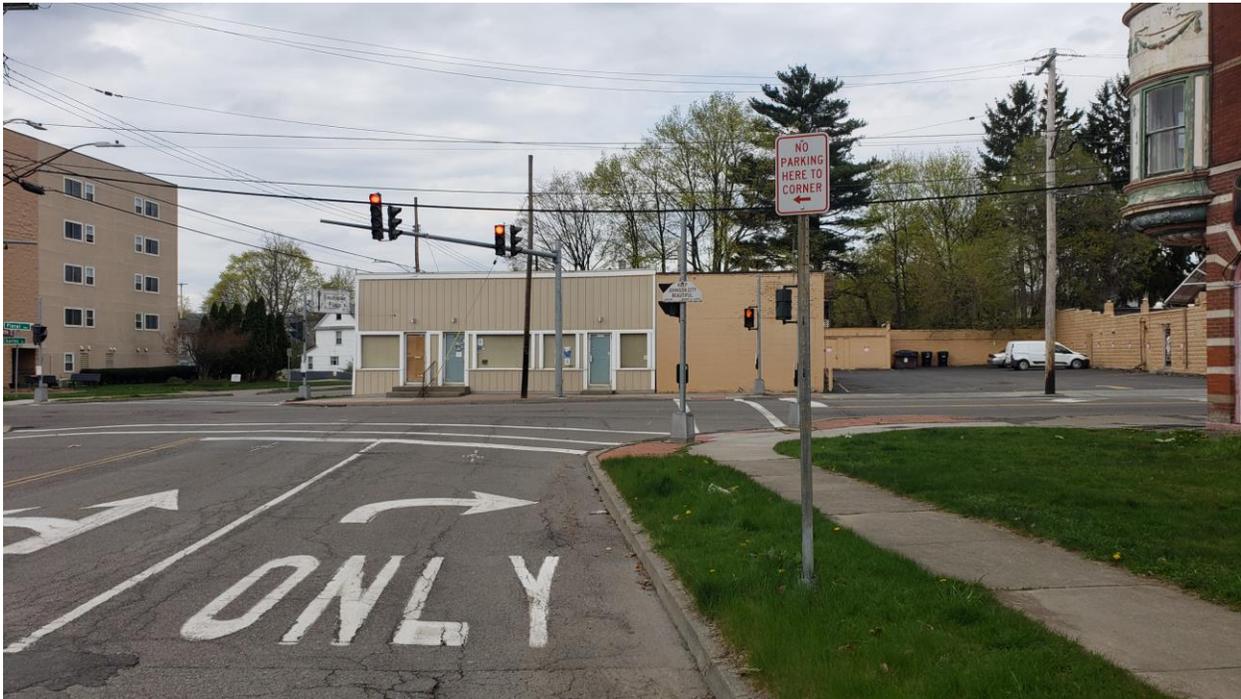
14. Lester Avenue / CFJ Boulevard

Lester Avenue and CFJ Boulevard is a four-legged intersection, with the eastbound leg of the intersection being a very low volume commercial driveway. Located on the southeast corner of the intersection is the CFJ Park. The signal warrants at the intersection are not met, but the signal is not recommended for removal because of the Park. There are count down pedestrian signals at the intersection, but ADA upgrades are needed as are high visibility crosswalks. The ADA rating is 3.

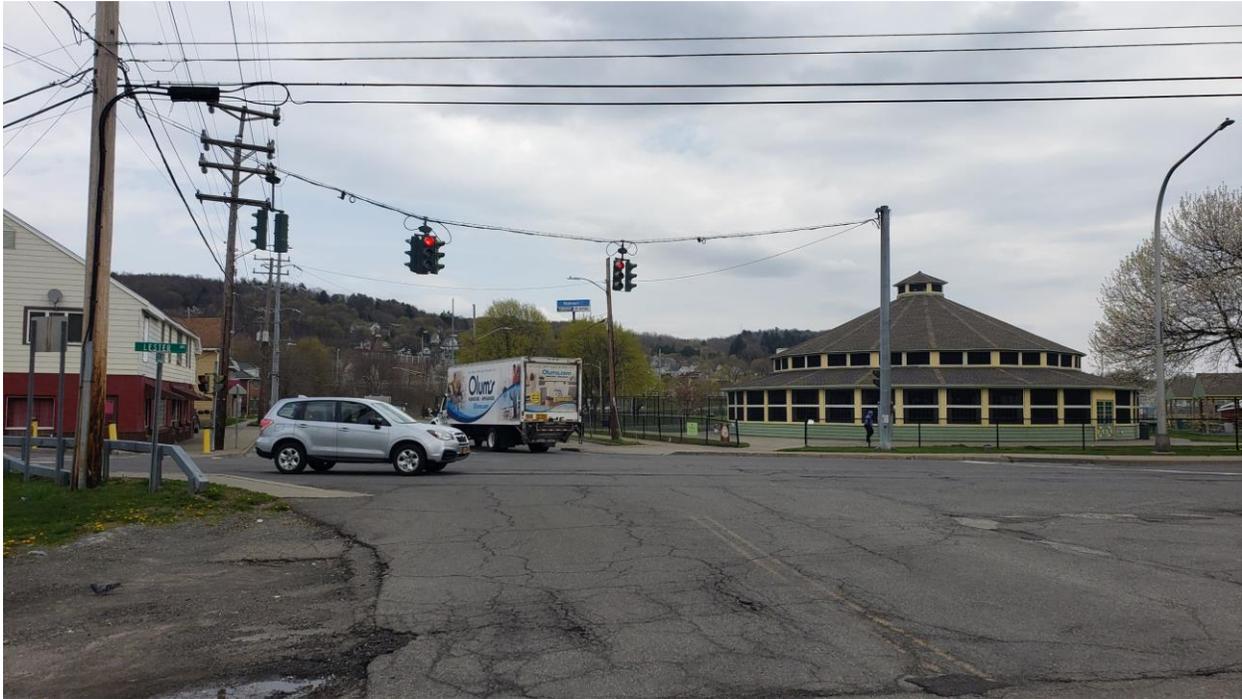
The signal at this location is fixed time signal without vehicle actuation. In order to minimize vehicular delays, the signal should be upgraded with vehicle detection.

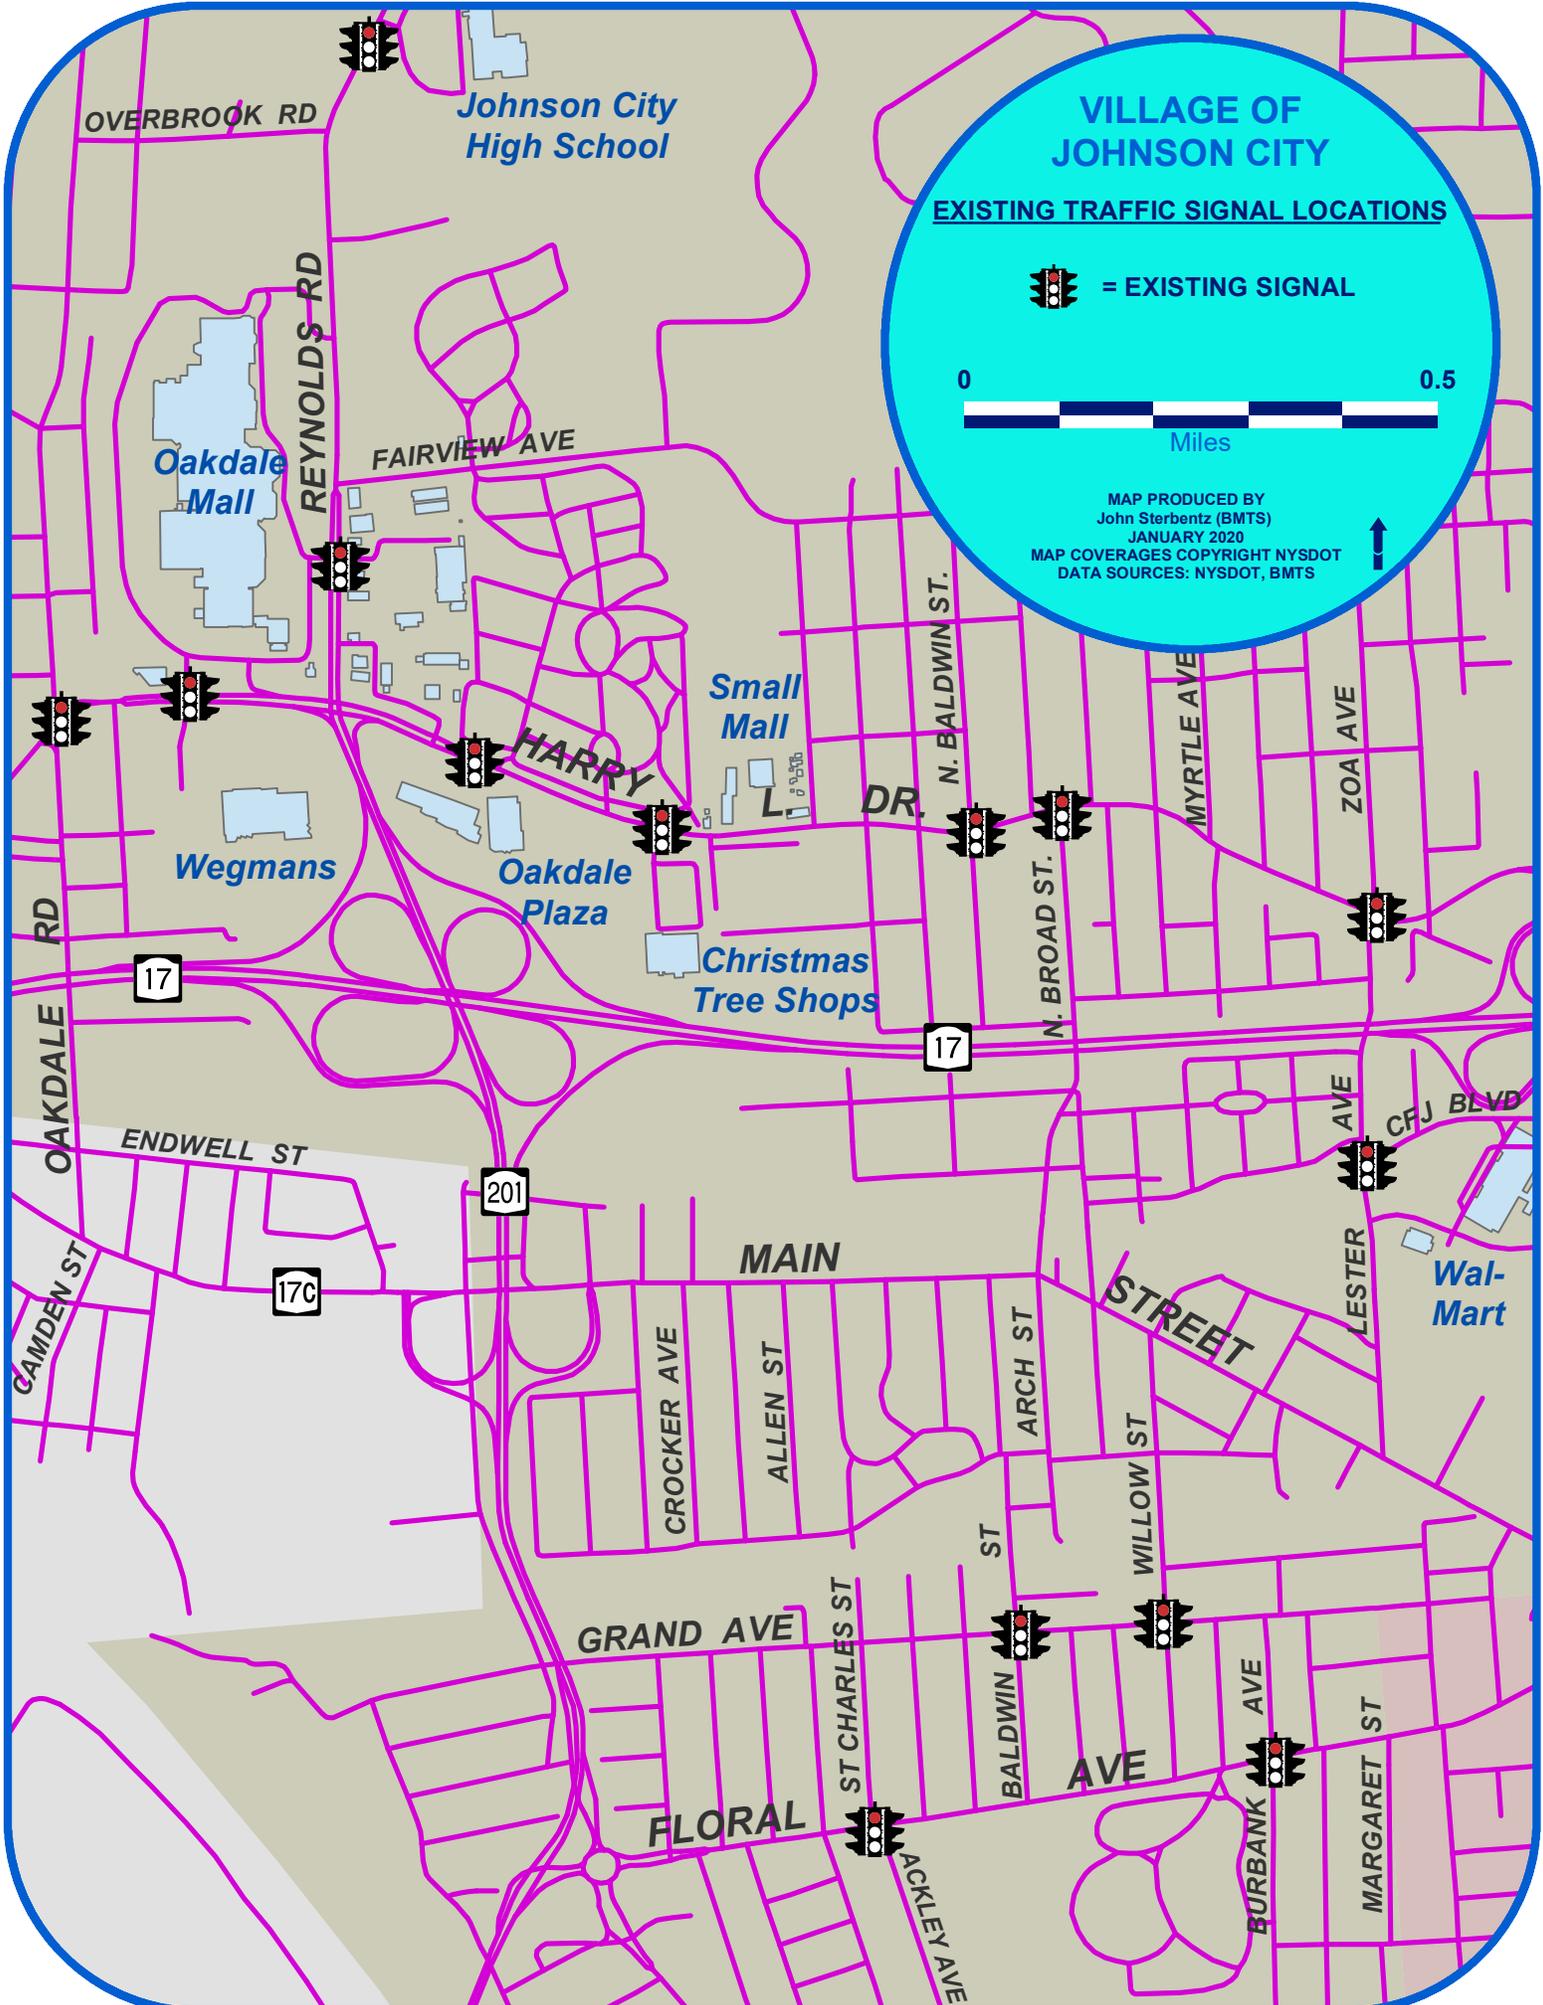
VILLAGE OF JOHNSON CITY
EXISTING TRAFFIC SIGNAL LOCATIONS

= EXISTING SIGNAL

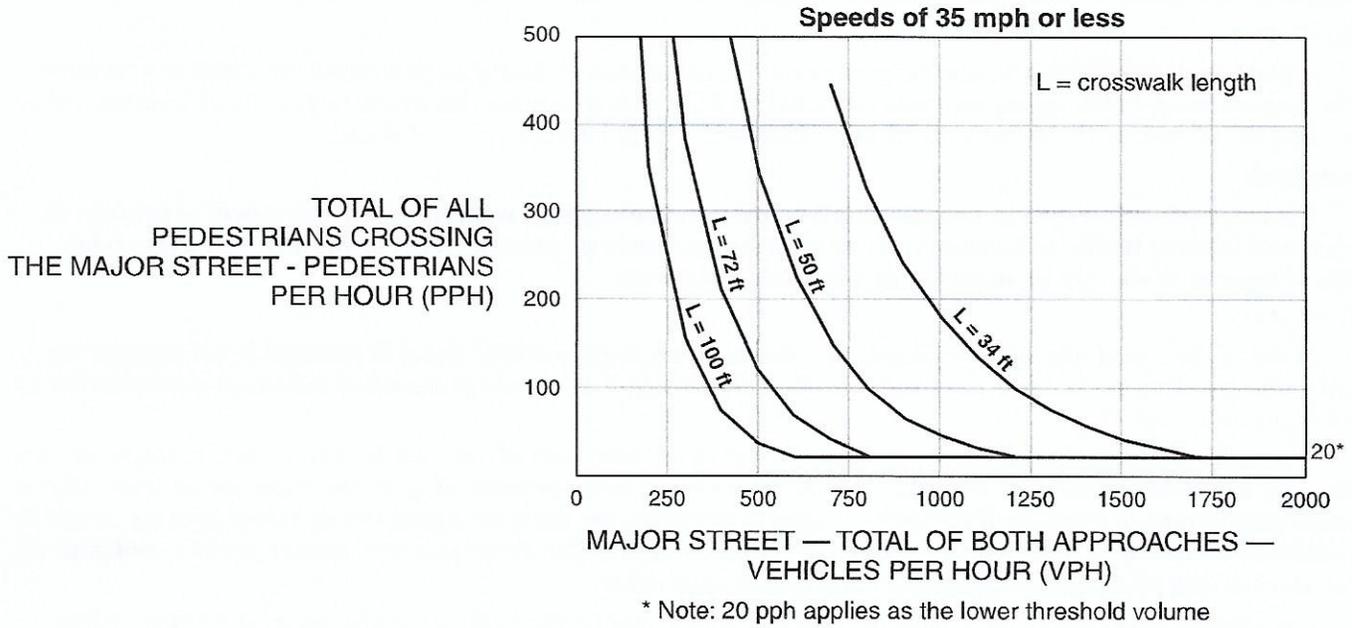
Figure 4F-1. Guidelines for the Installation of Pedestrian Hybrid Beacons on Low-Speed Roadways

- 06 *For a major street where the posted or statutory speed limit or the 85th-percentile speed is 35 mph or less, the need for a pedestrian hybrid beacon should be considered if the engineering study finds that the plotted point representing the vehicles per hour on the major street (total of both approaches) and the corresponding total of all pedestrians crossing the major street for 1 hour (any four consecutive 15-minute periods) of an average day falls above the applicable curve in Figure 4F-1 for the length of the crosswalk.*

- 08 *For crosswalks that have lengths other than the four that are specifically shown in Figures 4F-1 and 4F-2, the values should be interpolated between the curves.*

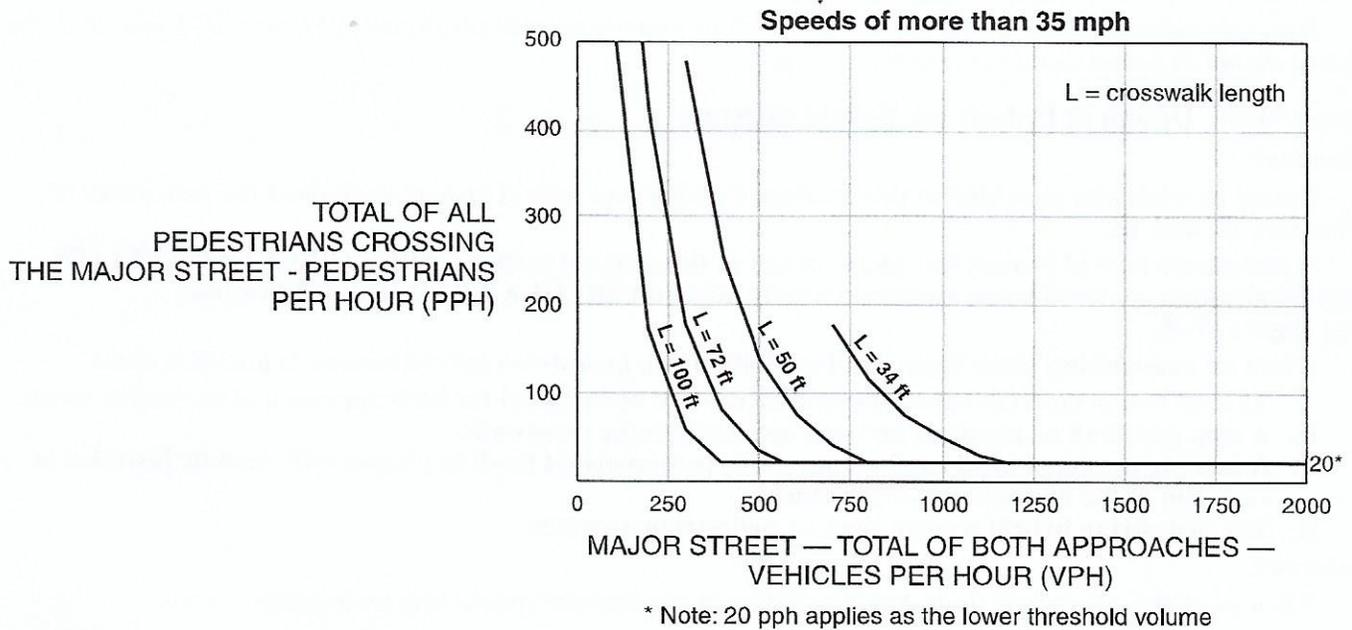
Figure 4F-2. Guidelines for the Installation of Pedestrian Hybrid Beacons on High-Speed Roadways

- 07 *For a major street where the posted or statutory speed limit or the 85th-percentile speed exceeds 35 mph, the need for a pedestrian hybrid beacon should be considered if the engineering study finds that the plotted point representing the vehicles per hour on the major street (total of both approaches) and the corresponding total of all pedestrians crossing the major street for 1 hour (any four consecutive 15-minute periods) of an average day falls above the applicable curve in Figure 4F-2 for the length of the crosswalk.*

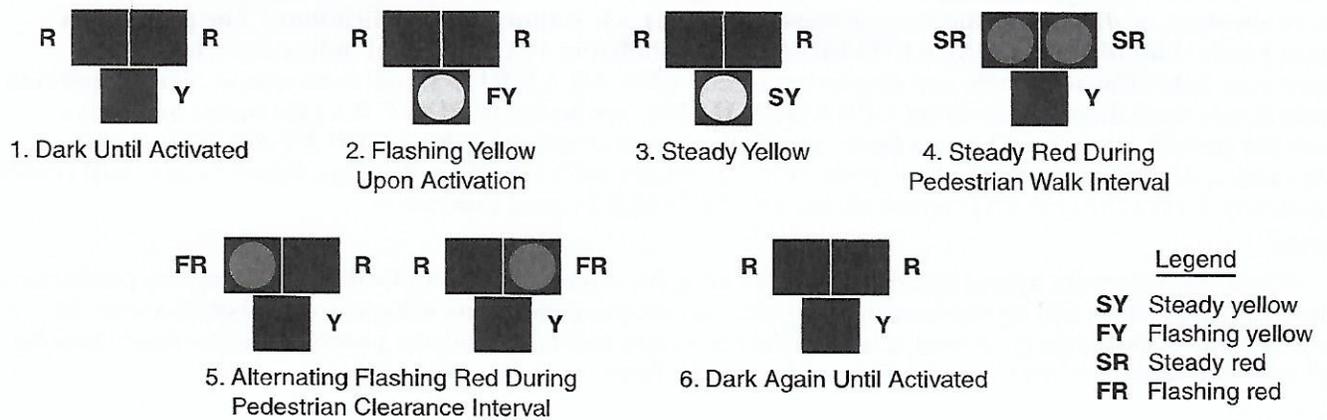
Figure 4F-3. Sequence for a Pedestrian Hybrid Beacon

- 01 **Pedestrian hybrid beacon indications shall be dark (not illuminated) during periods between actuations.**
- 02 **Upon actuation by a pedestrian, a pedestrian hybrid beacon face shall display a flashing CIRCULAR yellow signal indication, followed by a steady CIRCULAR yellow signal indication, followed by both steady CIRCULAR RED signal indications during the pedestrian walk interval, followed by alternating flashing CIRCULAR RED signal indications during the pedestrian clearance interval (see Figure 4F-3). Upon termination of the pedestrian clearance interval, the pedestrian hybrid beacon faces shall revert to a dark (not illuminated) condition.**

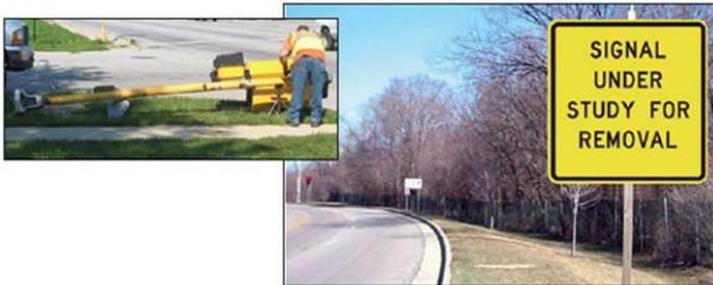
1. Public Notification - Newspaper notification to the public will be issued in addition to a direct outreach to businesses, institutions and residents within a two-block proximity to the intersection under evaluation.
2. Advance Notification Signs - Signal under Study signs will be installed at the evaluation intersection and will remain in place for at least a 30-day period. During this period a survey of the intersection will be performed to determine appropriate traffic control signs to be used after signal removal. The survey will also identify any changes necessary affecting line of sight or any sight distance restriction. Implementation of those changes will occur prior to the covering of the signal lights.
