THE TWO RIVERS GREENWAY TRAIL MAINTENANCE PLAN  
JULY-AUGUST 2019  
BINGHAMTON METROPOLITAN TRANSPORTATION STUDY

APPENDIX & TRAIL ASSESSMENTS

### Two Rivers Greenway Trail Maintenance Assessment

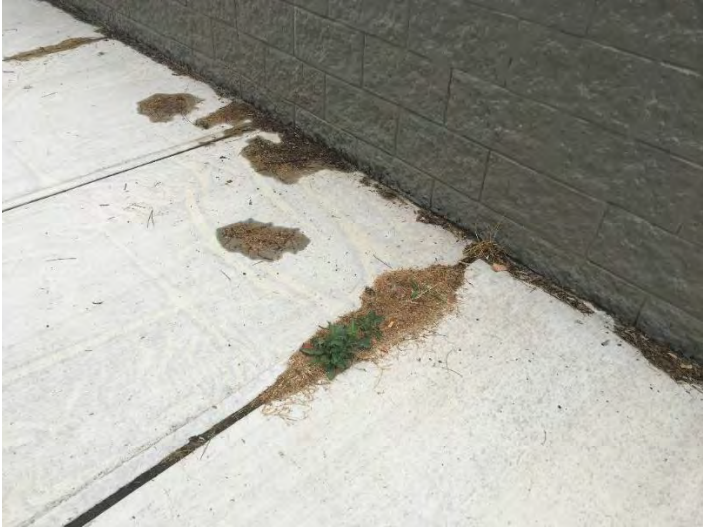
Figure 4 Dead Grass Residue Along Cement Trail Portion
