Road Safety Assessment Lester Avenue

MAIN STREET TO PAVILION ROAD

VILLAGE OF JOHNSON CITY

BINGHAMTON METROPOLITAN TRANSPORTATION STUDY

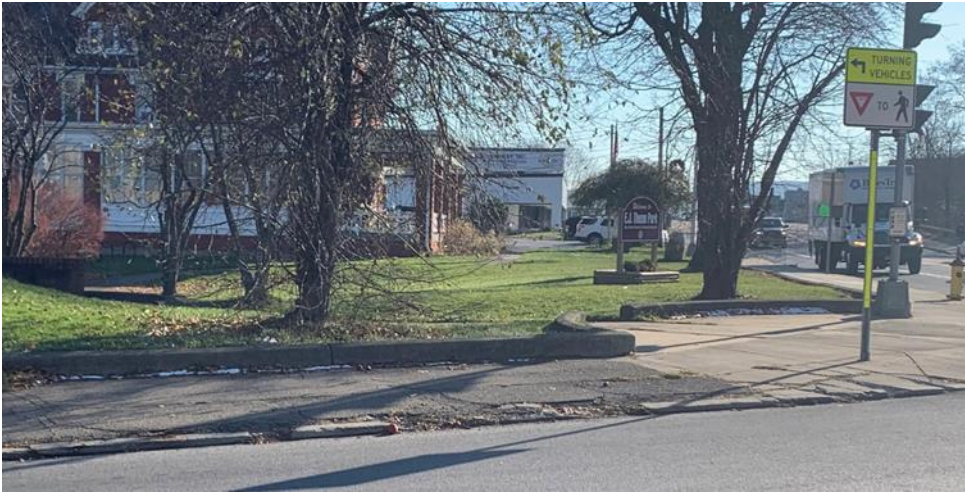
Sidewalk and Curb Conditions west side Lester Ave at Main St

- **ADA compliance.** Bring all curb ramps, crosswalks and pedestrian signals into ADA compliance.
- **Sidewalk improvements.** Repair/replace sidewalks where needed.

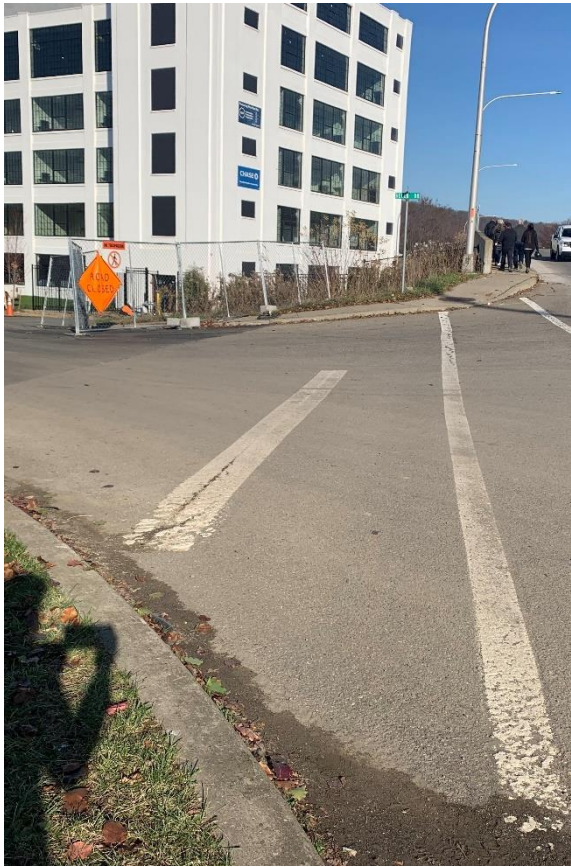
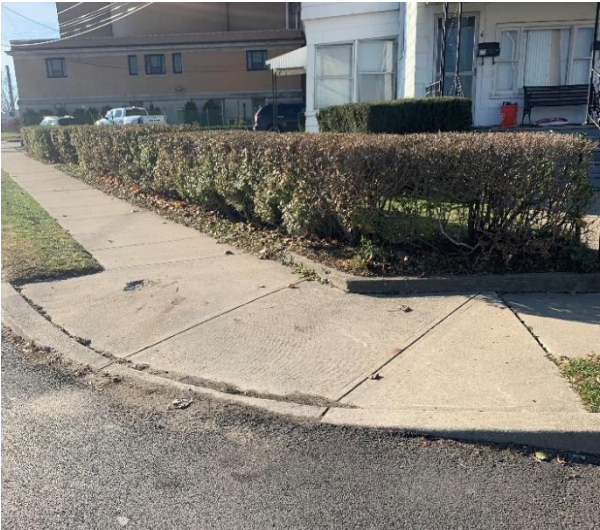
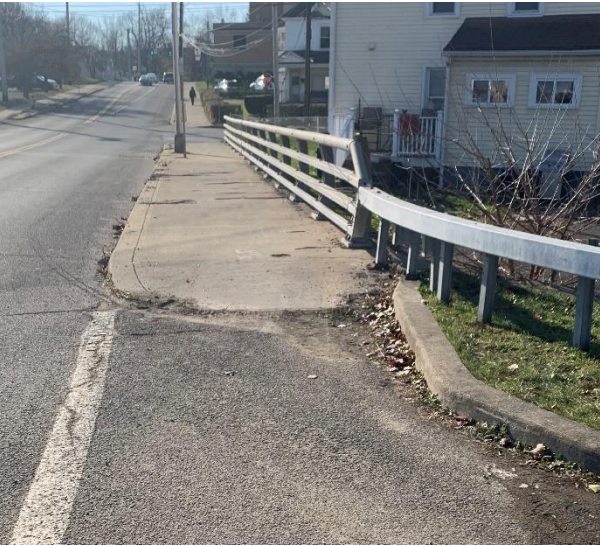
- Lack of marked mid-block pedestrian crossing. This is of particular concern given the anticipated increase in pedestrian. The assessment team considered several locations for a new crossing, including between Laurel Street and the southern approach to the bridge, near the crest of the bridge, and between the northern bridge approach and Pavilion Drive. The team considered sight distance for pedestrians and vehicles, and roadway user behavior including driver speeds and potential pedestrian crossing behavior.
- Various sections of sidewalk and curbing are in disrepair. It was noted during the walking audit that the sidewalk on the east side of Lester from Main to the JH Robotics driveway and the curbing along the east side of the bridge will be replaced as part of the Lester Avenue bridge rehabilitation project.
- ADA compliant curb ramps are missing at Laurel Street and Helen Drive.

Lack of ADA compliance curb ramps at Laurel St and Helen Dr

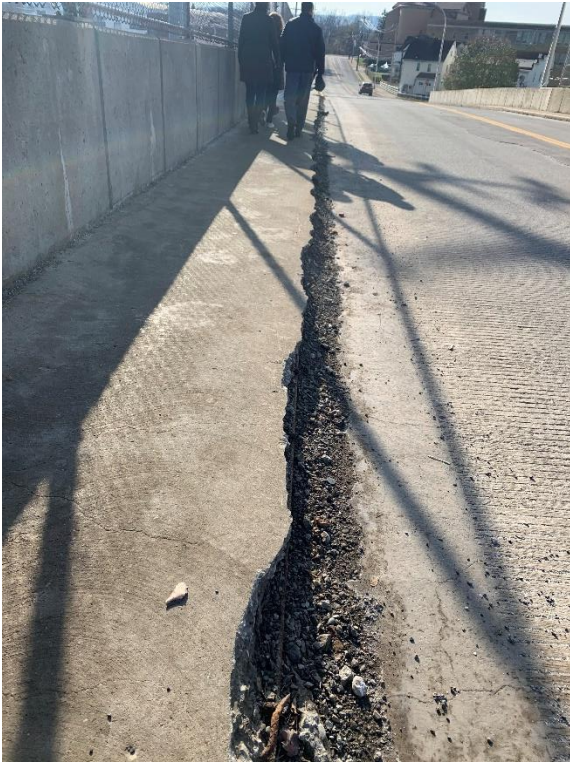
Narrow Sidewalk and Missing Curb on Lester Ave bridge

- **Consider narrowing travel lanes and widen sidewalks across bridge.** As discussed during the walking audit the design of the bridge and the pedestrian crossing should potentially include narrowing the vehicle travel lanes and widening the sidewalks across the length of the bridge. This would slow down vehicle speeds and create a safer walking space for pedestrians.

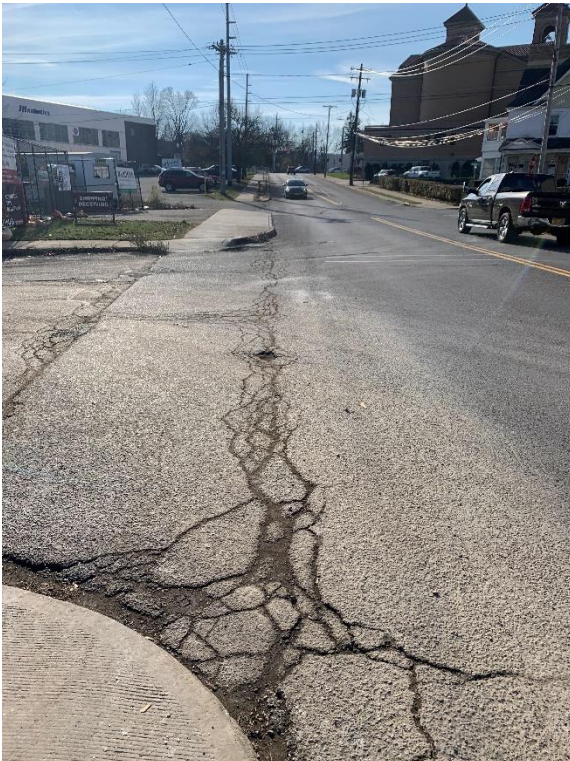
Lack of ADA compliance along westside of Lester Avenue
