THE TWO RIVERS GREENWAY TRAIL MAINTENANCE PLAN  
JULY-AUGUST 2019  
BINGHAMTON METROPOLITAN TRANSPORTATION STUDY

APPENDIX & TRAIL ASSESSMENTS

### Two Rivers Greenway Trail Maintenance Assessment

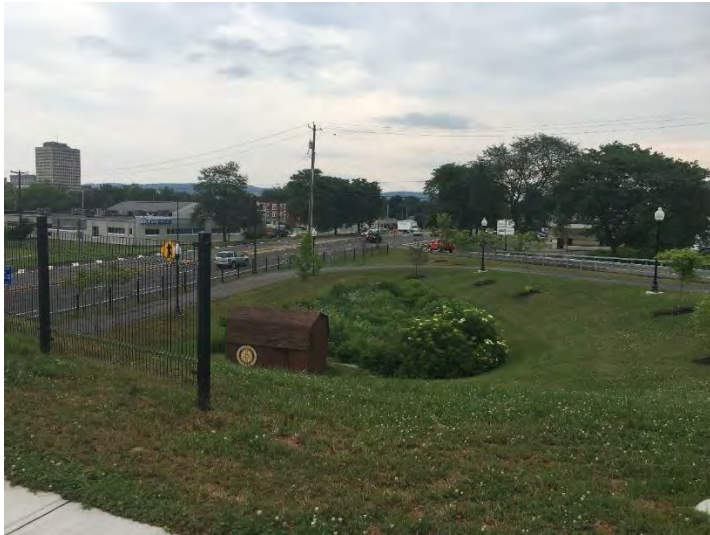
Figure 8 Bike Loop and Rotary Club Shed

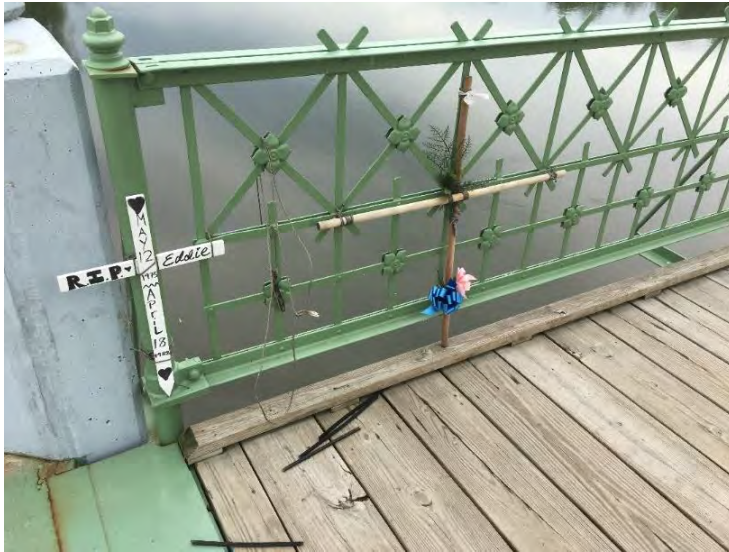
- Evidence of citizens taking ownership of the site through unsanctioned memorials and advertising

Figure 10 Eddie Memorial

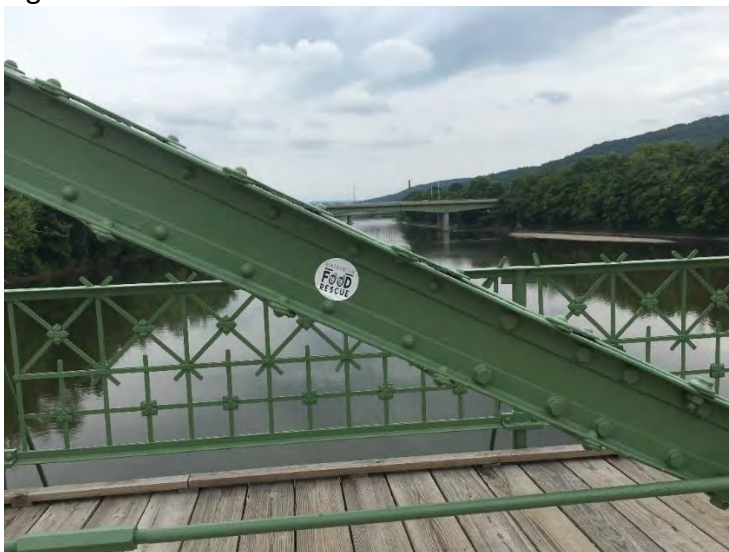
Figure 11 Food Rescue Sticker Advertisement

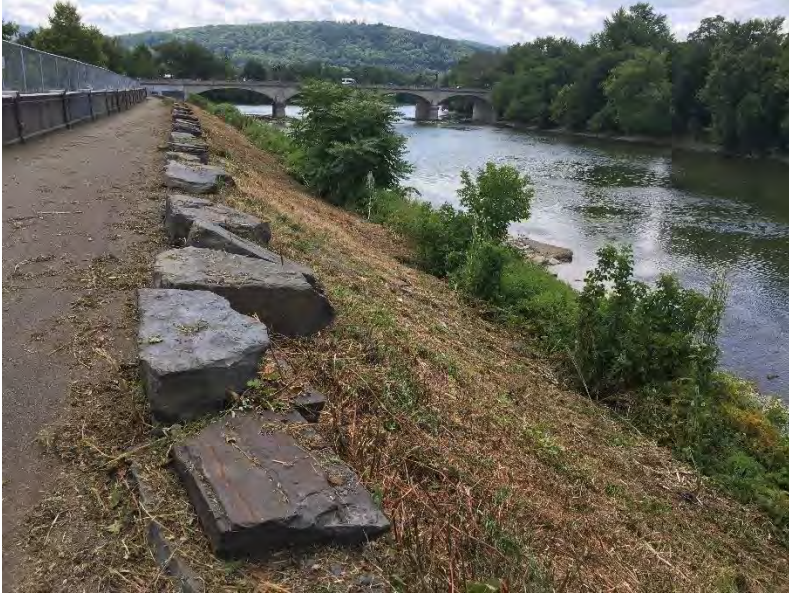
Figure 23 Trail After Vegetation was Cut Down

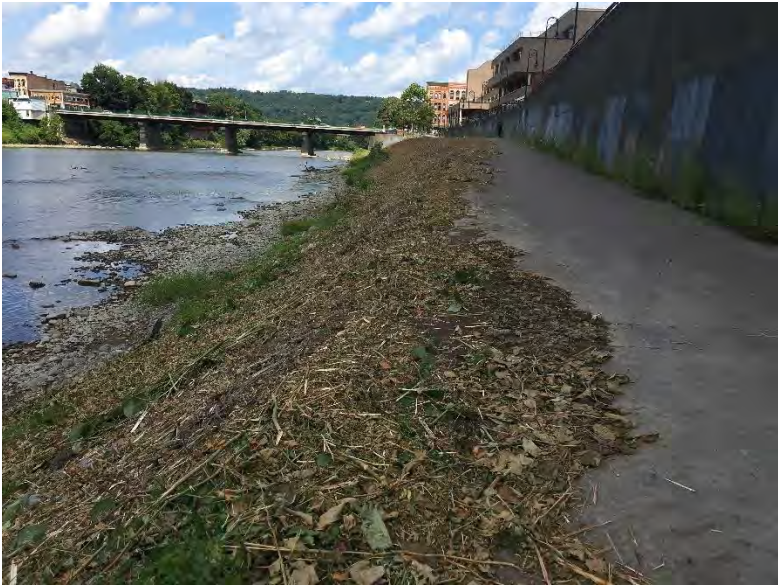
Figure 24 Trail After Vegetation was Cut Down

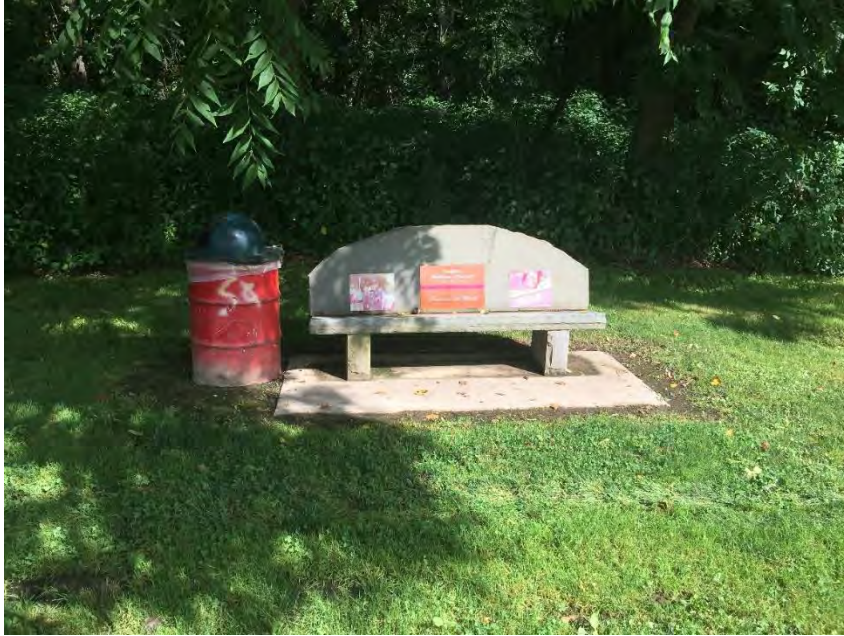
Figure 57 Bench and Garbage Can

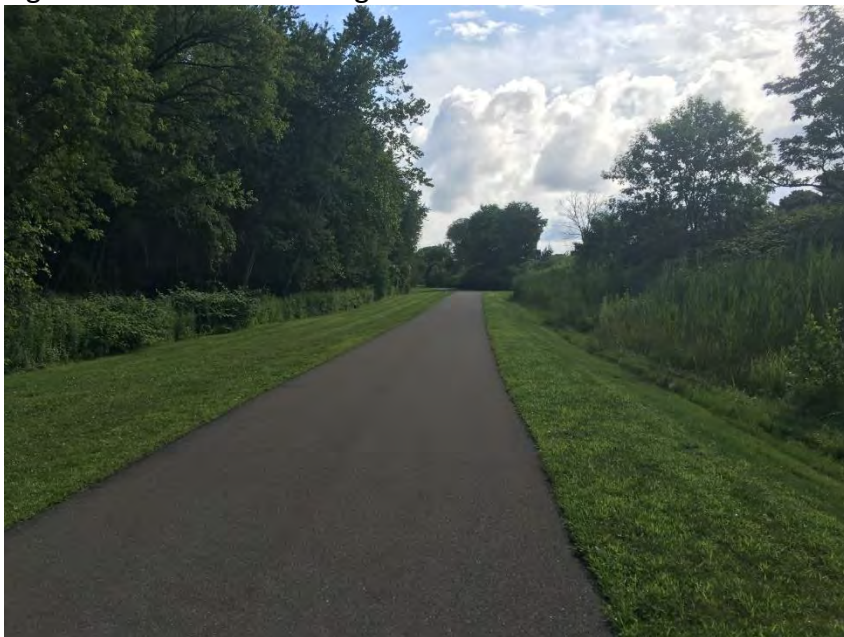
Figure 58 Smooth Pavement
