Two Rivers Greenway Trail Maintenance Report - 2024 Snapshot

About The 2024 Trail Maintenance Report

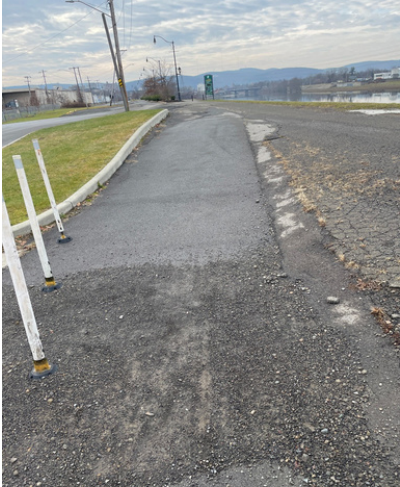
Photo 5: Binghamton- Pavement crumbling near Cheri Lindsey Park
